# Product Safety Recall

## 15816 Front Passenger Air Bag Inflator

Reference Number: N150816

Release Date: April 2018

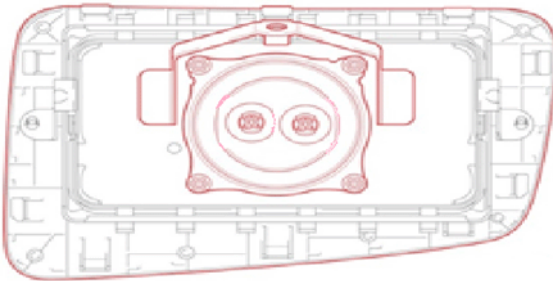
4486640

- 3.4. Inspect the door for damage to the mounting slots.

4. Install the new module.

- 4.1. Carefully slide the new module into the air bag door. Note the mounting direction.
