## **Subject: ParkSmart HVAC Modules**

**Models Affected: Specific Freightliner Cascadia vehicles manufactured March 25, 2014, through November 9, 2015 and equipped with a certain ParkSmart Auxiliary HVAC system.**

FL703A

REVISED NOTICE

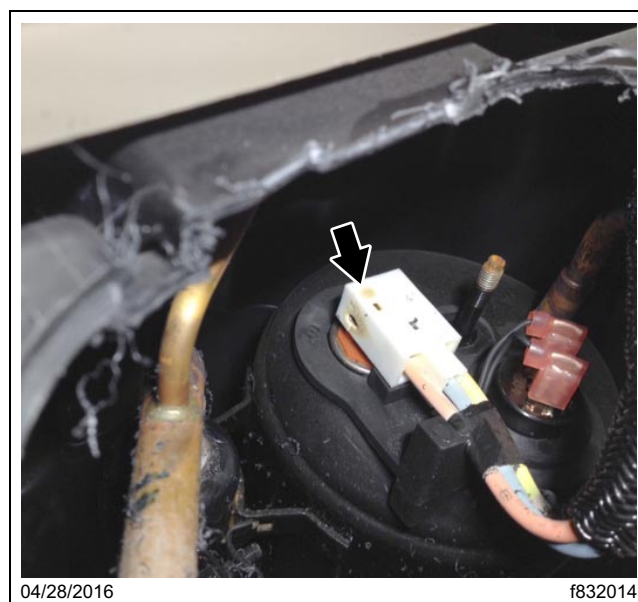
14. Using a mirror as needed, inspect all sides of the block connector for evidence of heat damage such as discoloration and/or melting. See **Fig. 8**.

**Fig. 8, Yellow Discoloration and Melting of the Block Connector**

If the block connector shows evidence of heat damage, go to "Compressor Harness Replacement" on page 12 of these work instructions.

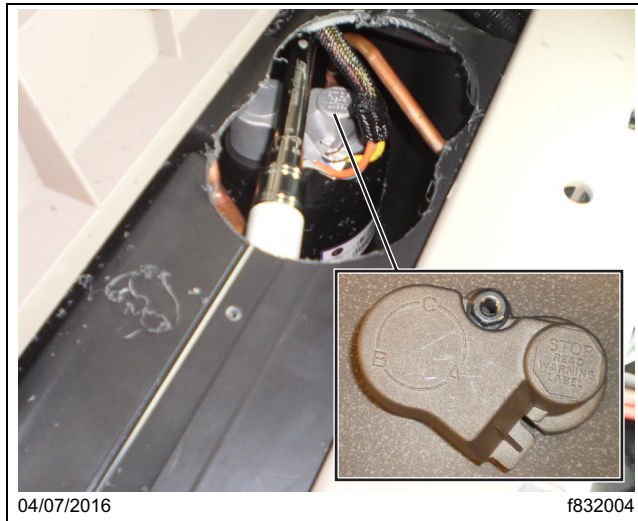
**Fig. 9, Aluminum Connector Cap**

15. Install the new aluminum cap and retaining nut from the kit. Tighten the nut 40 to 45 lbf-in (452 to 508 N-cm). See **Fig. 9**.
16. Install the new compressor access cover from the kit. See **Fig. 10**.

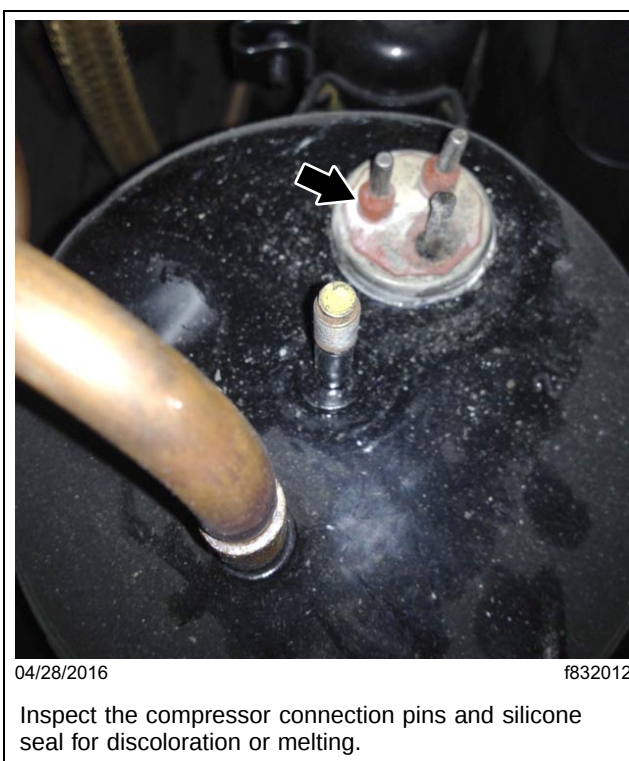
3. Disconnect the harness block connector from the compressor.
4. Clean up any debris around the pins, and use alcohol wipes to clean the pins.
5. Inspect the compressor connection pins and surrounding orange silicone insulator. See **Fig. 11**.

**Fig. 11, Melted Silicone Insulator and Compressor Pin Damage**

If the orange silicone insulator around the compressor connection pins shows evidence of heat damage, go to "Refrigerant Loop Assembly Replacement" on page 16 of these work instructions.
