TO: Mercedes-Benz Dealer Principals, General Managers, Sales Managers, Service Managers, Parts Managers	FROM: Thomas Brunner, Department Manager, Vehicle Compliance and Analysis, Engineering Services
RE: Recall Campaign 2016030004 – Model 253 (GLC-Class), Model Year 2016 Rework Electrical Wiring Harness at Steering Column	DATE: April 15, 2016

Campaign No. 2016030004, April 2016

SUBJECT: **Model 253, Model Year 2016**
Rework Electrical Wiring Harness at Steering Column

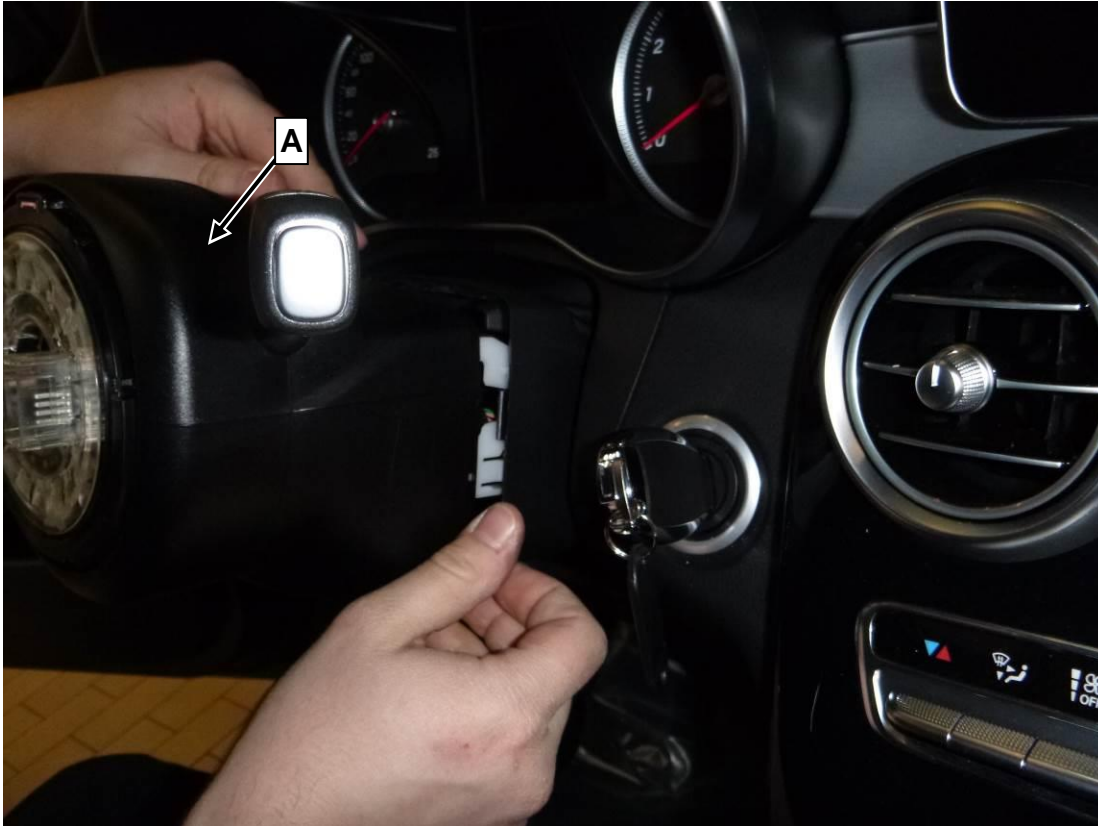
**Figure 1**

Remove steering column cover (A, Figure 1), then

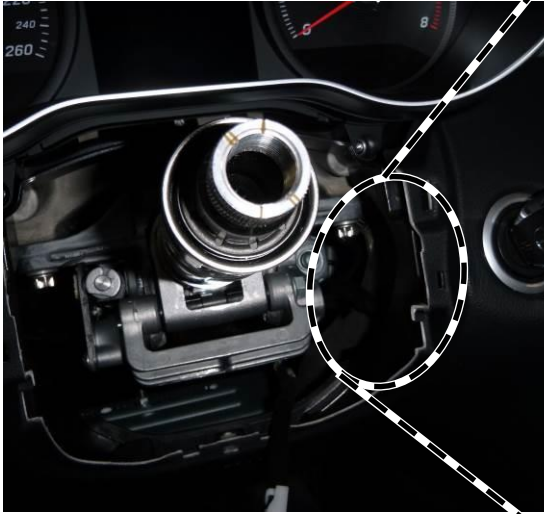
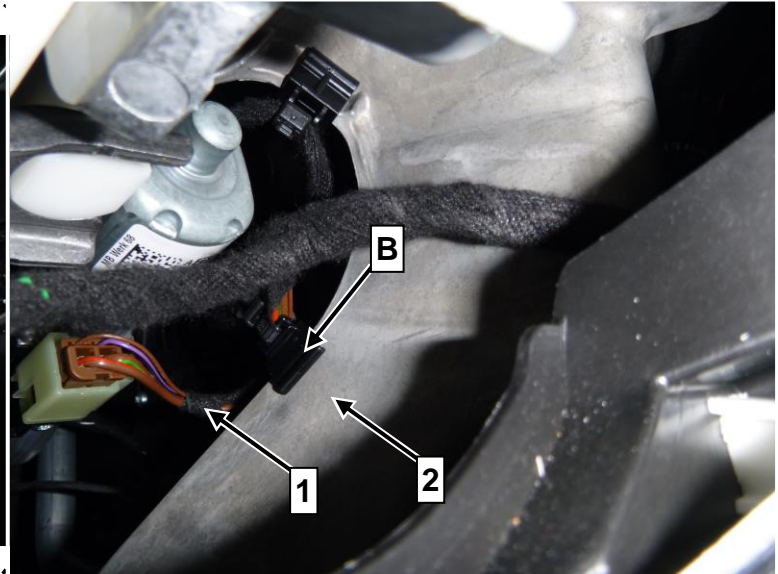
Figure 2

check electrical wiring harness (1, Figure 2) for damage.

The wiring harness (1) must not make contact with the adjusting spindle of the steering column.

Repair damaged wiring harness (if required): refer to WIS: AR00.19-P-0100A (follow instructions for model 205, model 253 will be included in a future WIS release).

- Attach cable tie mounting clip (B, Figure 2) to dash board support (2) then secure adjustment motor wiring harness (1) to mounting clip (B) using cable tie (Figure 2).
