Safety Action Recall Notice 541 Issue 1 - 10.2016

Subject: Fuel Tank Subharness				
Bulletin Number	Models Affected	VIN Range		Markets Affected
541	Bonneville T100	759204	794799	All Markets except Brazil
541	Bonneville T100 Black	765369	794585	All Markets except Brazil
541	Thruxton 1200	743684	793611	All Markets except Brazil
541	Thruxton 1200R	740405	794605	All Markets except Brazil
541	Thruxton 1200 (Dual Seat)	766764	793286	All Markets except Brazil
541	Thruxton 1200R (Dual Seat)	766510	793366	All Markets except Brazil
541	Street Twin	731919	794789	All Markets except Brazil
541	Bonneville T120	739727	794802	All Markets except Brazil
541	Bonneville T120 Black	741136	794575	All Markets except Brazil
541	Street Cup	780697	794796	All Markets except Brazil
541	Thruxton 1200R	740405	795325	Brazil Only
541	Street Twin	731919	795325	Brazil Only
541	Bonneville T120	739727	795325	Brazil Only
541	Bonneville T120 Black	741136	795325	Brazil Only

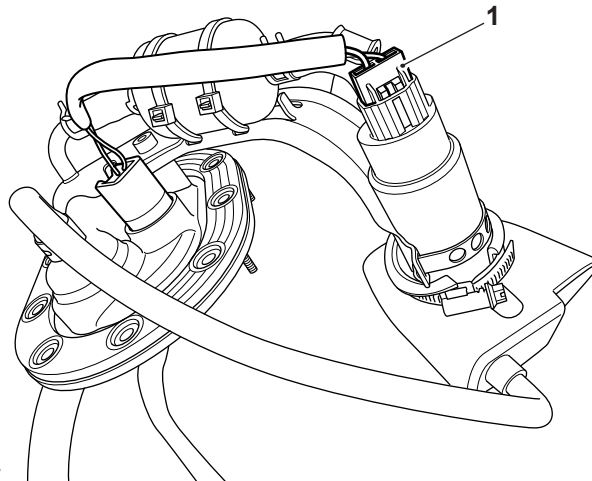
1. Electrical connector

Internal investigations have identified the need to replace a subharness in the fuel tank to prevent a potential fuel leak.

3. Using propriety professional automotive workshop equipment approved for fuel handling, drain all fuel from the fuel tank.
4. Remove the fuel tank. Refer to the relevant Service Manual. Discard the lock nut from the fuel tank mounting bolt.
5. Remove the fuel pump assembly. Refer to the relevant Service Manual. Discard the fuel pump plate seal.
6. Remove the electrical connector from the fuel pump.
