TEREX®

Safety Notice

SN638

SUBJECT: Boom Tip Leveling Sprocket Weldment

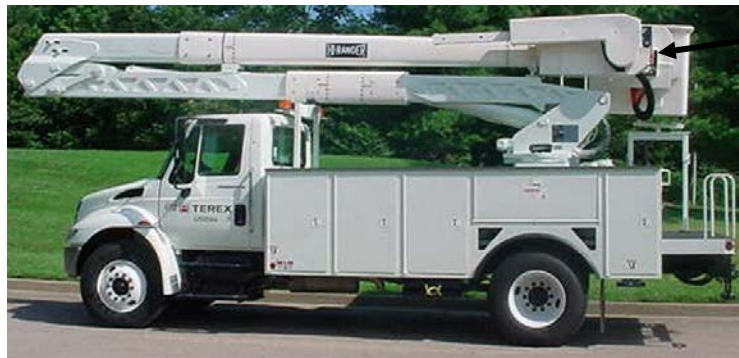
Leveling sprocket weldment at boom tip

Terex has become aware that some aerial devices manufactured from May 2005 through February 2007 and June 2011 through March 2016 which may contain a boom tip leveling sprocket weldment with weld quality that does not meet specification. **Failure of the boom tip leveling sprocket can result in the platform tilting unexpectedly and occupants falling from the platform.**

1. Immediately inspect the leveling sprocket weldment at the boom tip for a cracked weld between the hub and sprocket. Remove cover over boom tip, clean off the sides of the boom tip leveling sprocket, and then inspect the hub to sprocket weld for cracks.

2. If any cracks are detected do not operate the unit, take it out of service immediately. Contact your local Terex dealer or TEREX Utilities at 1-800-982-8975 or email machine information to utilities.warranty@terex.com to arrange repair before further use.
3. If no cracks are detected follow the instructions in the Continued Use section below.
4. Within 45 days of receipt of this bulletin contact your local Terex Utilities dealer, or contact the Terex Utilities Service Department at 1-800-982-8975, or email the machine information to utilities.warranty@terex.com to schedule an appointment to have a repair made.

Terex will provide a new leveling sprocket for any unit with a cracked weld on the leveling sprocket or provide a reinforcement kit for any unit that does not have a cracked weld on the leveling sprocket at no cost to the owner.

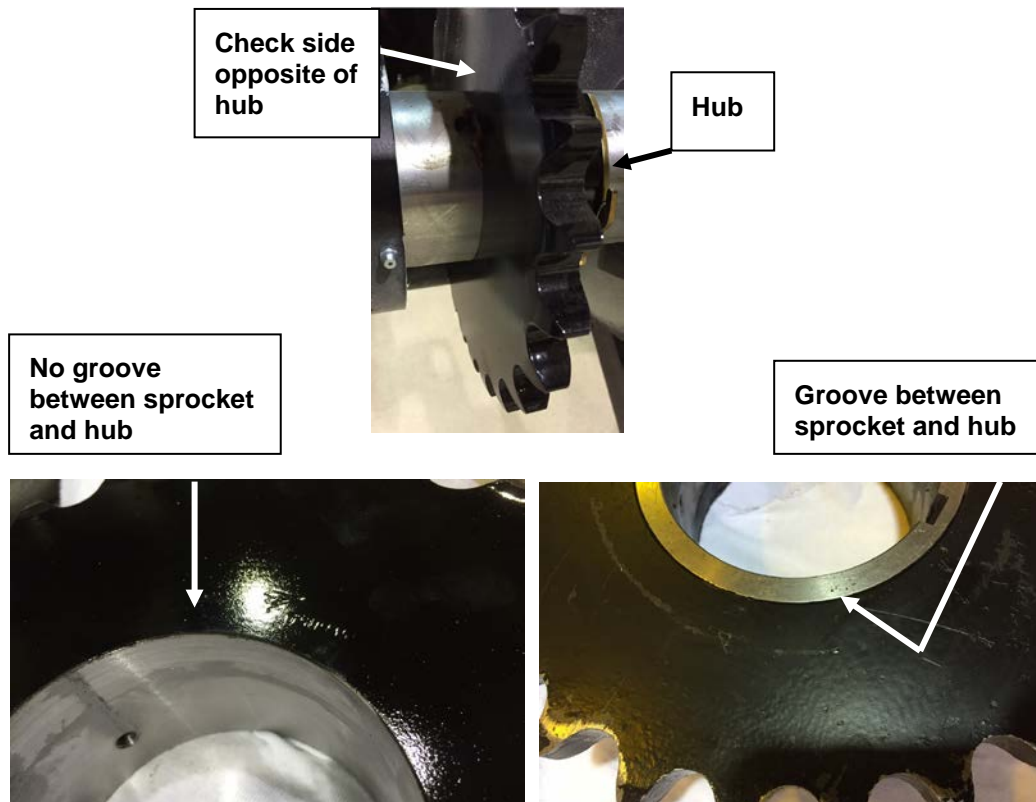
Units built from February 2007 through June 2011 may have a sprocket which is not included in this recall. Units that do not have a groove between the sprocket and the hub are not included in this recall.
