NISSAN BULLETIN

2016 Frontier Starter Motor Wire Harness Voluntary Safety Recall Campaign

Reference: PC440
Date: March 31, 2016

PC440 Frontier (D40) Starter Motor Wire Position Inspection

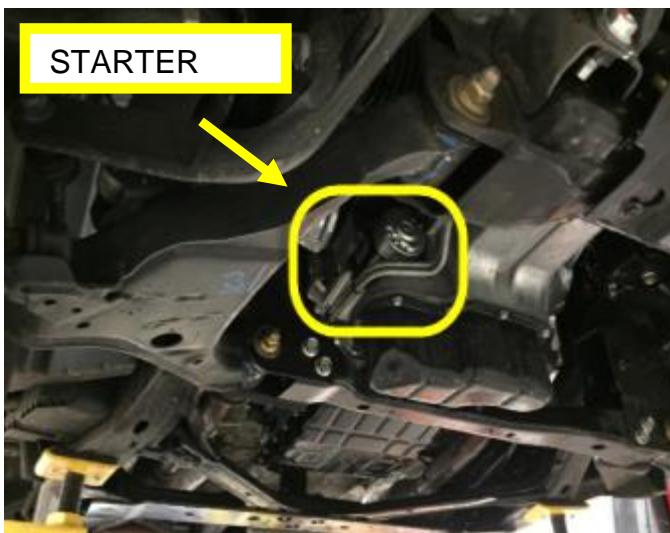
Figure 1
2 Wheel Drive

1. Pull the vehicle into a service bay with a lift.
2. Open the hood and disconnect the negative battery cable.
3. Raise the vehicle using the hoist.
4. Locate the starter motor (passenger side of engine) (Figure 1 & 2).
