Michael A. Berardi
 Director
 Service Engineering Operations
 Ford Customer Service Division

December 19, 2016

SUBJECT: **DEMONSTRATION / DELIVERY HOLD - Safety Recall 16S13 - Supplement #1**
 Certain 2015-2016 Model Year Transit Wagon Vehicles with Low Roof
 Side Curtain Airbag Inspection and Adjustment

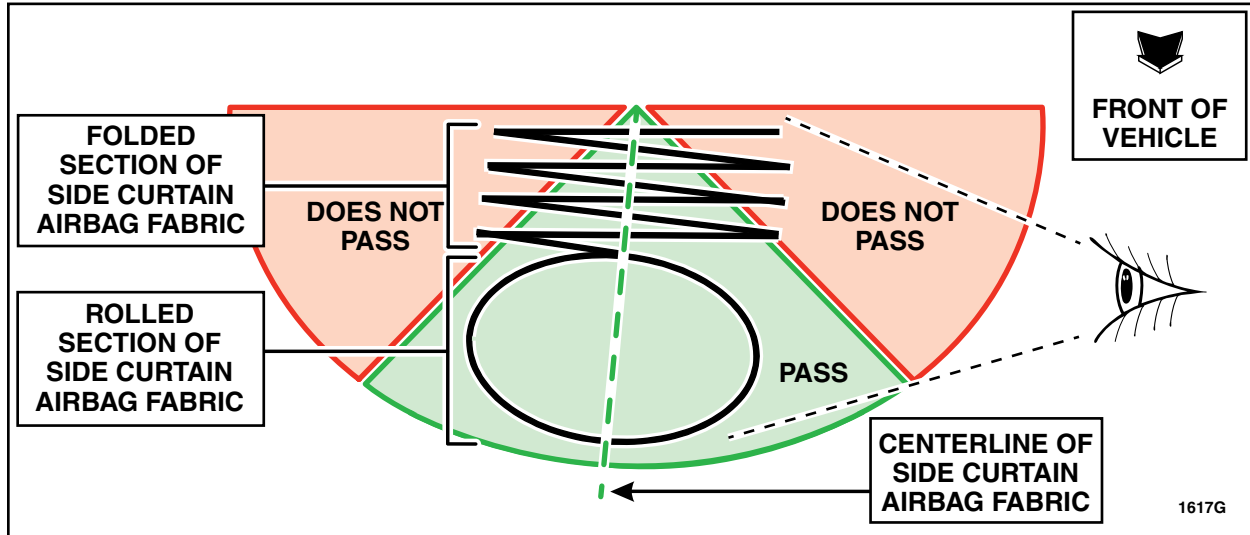
FIGURE 1

2. Inspect the driver and passenger side curtain airbag fold orientation starting at the B-pillar and ending at the rear of the vehicle. When properly positioned, the centerline of each side curtain airbag will have a rolled section of side curtain airbag fabric that should be positioned below the folded section. The side curtain airbag fabric orientation may be positioned anywhere within the acceptable (**PASS**) range illustrated in Figure 1.

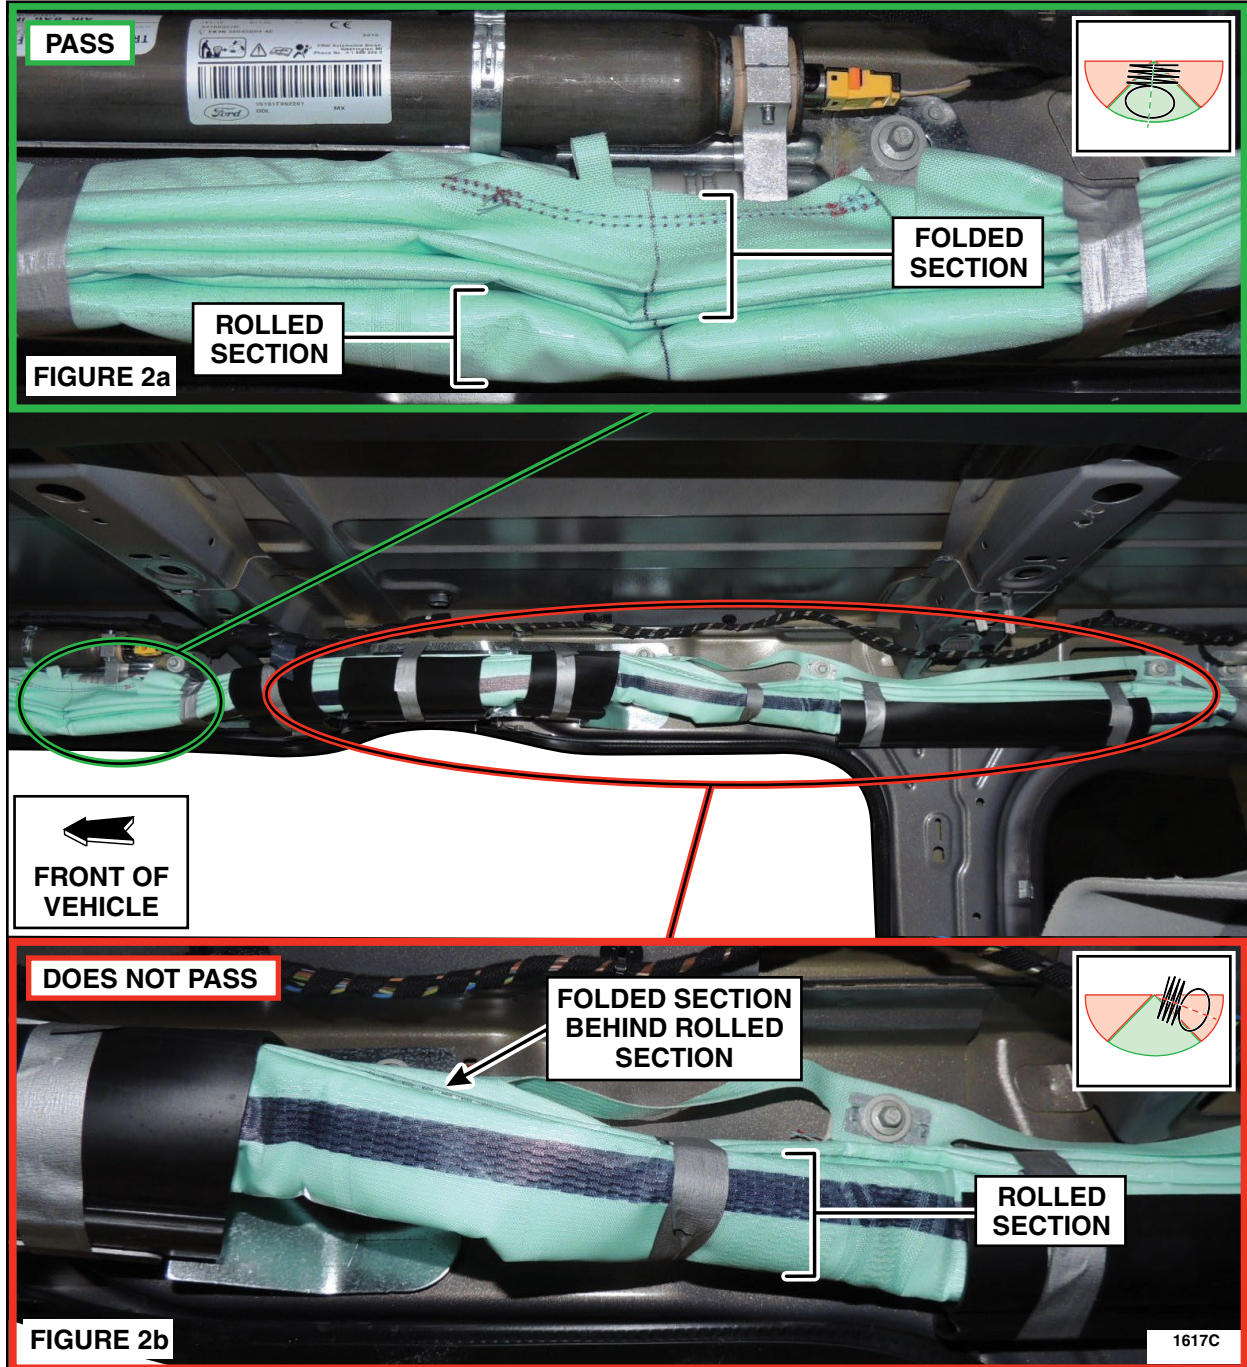
FIGURE 2

The side curtain airbag **PASSES** inspection if the centerline of the rolled and folded sections is within the acceptable (**PASS**) range. See Figure 1 and 2a. If both the driver and passenger side curtain airbags pass inspection, the repair is complete. Install the rear headliner sections. Please follow the WSM procedures in Section 501-05 (rear headliner).

The side curtain airbag **DOES NOT PASS** inspection if the centerline of the rolled and folded sections is **not** within the acceptable (**PASS**) range at any point rearward of the B-pillar. See Figure 1 and 2b. If the side curtain airbag does not pass inspection at any point rearward of the B-pillar, proceed to the Side Curtain Airbag Adjustment Procedure on Page 3.
