Revised June 2016

Dealer Service Instructions for:

## **Safety Recall S24 / NHTSA 16V-202 CAN-C Bus Connector**

**2015-2016 (VM) RAM ProMaster City**

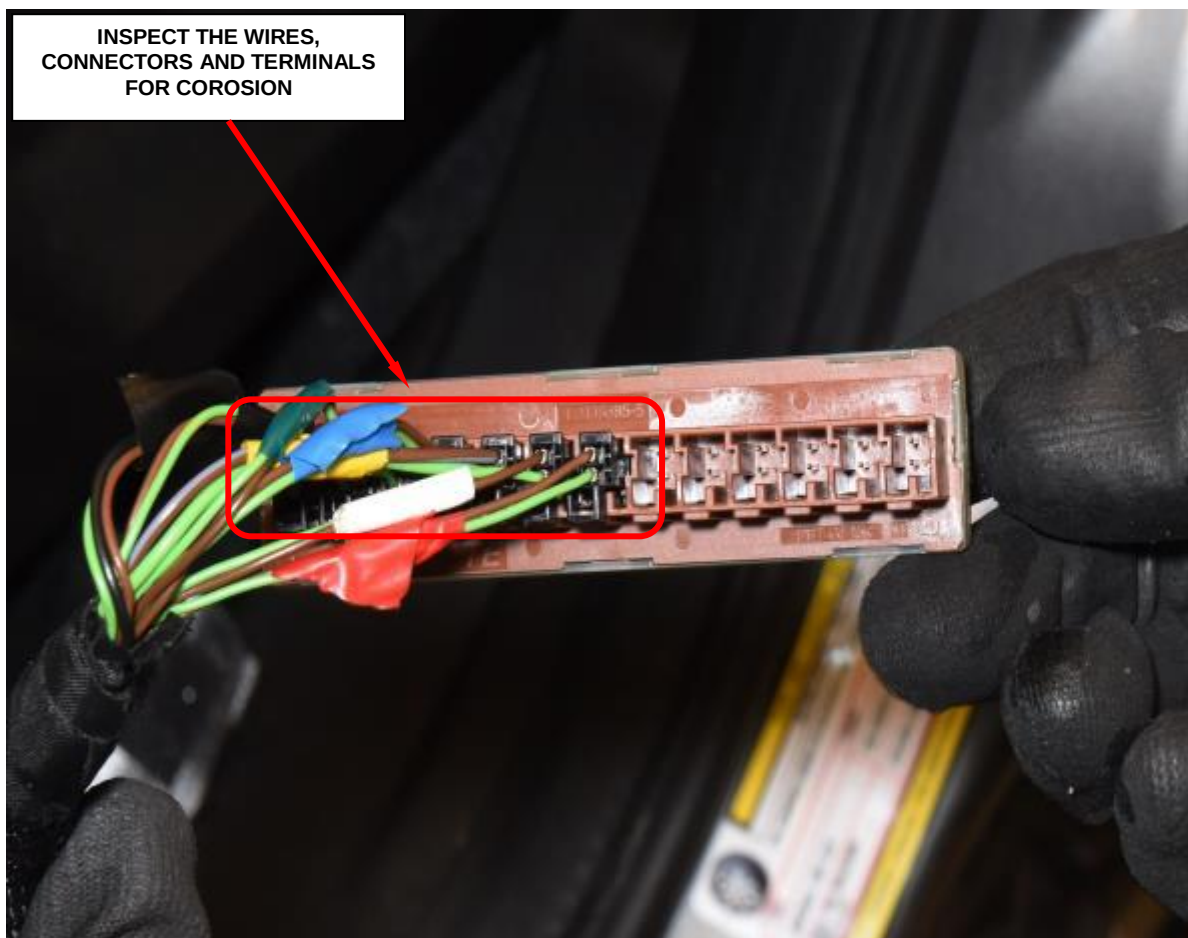
Figure 5 – Inspect for Corrosion

The CAN-C bus communication connector on about 23,900 of the above vehicles may develop internal connector pin corrosion due to moisture.

Corroded CAN-C bus communication connector pin(s) could lead to a loss of electrical contact and/or a loss of communication to the Transmission Control Module (TCM). A loss of communication to the TCM could cause the transmission to perform an unrequested shift into neutral. The vehicle operator would be unable to reengage the transmission. This could cause a crash without warning.

12. Inspect the CAN-C Bus Connector to assure there is no corrosion (Figure 5).

The CAN-C bus communication connector must be inspected for pin corrosion. Vehicles found with corroded CAN-C bus connector pin(s) must have the connector replaced.

- If corrosion **is** present, continue with **Section C. Replace CAN-C Bus Connector.**
- If corrosion **is not** present, continue with **Section B. Relocate CAN-C Bus Connector.**
