GLOBAL SAFETY FIELD INVESTIGATIONS
DCS4165
URGENT - DISTRIBUTE IMMEDIATELY

Subject: 15822B - Safety Recall
Seatbelt Lap Anchor Tensioner Cable – Driver's Side
Important Information - Performing Service Procedure

Models: 2014-2015 Chevrolet Silverado 1500 Series
2014-2015 GMC Sierra 1500 Series

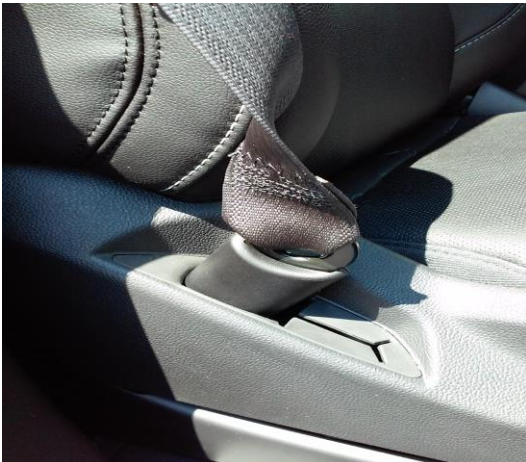
Example of properly executed repair.

The proper execution of this repair requires using the template and following the detailed instructions provided in the recall bulletin without exception. Doing so will ensure that a consistent and uniform repair is performed on each involved vehicle. The images below show a properly completed repair and a repair that was carelessly done not following the instructions.

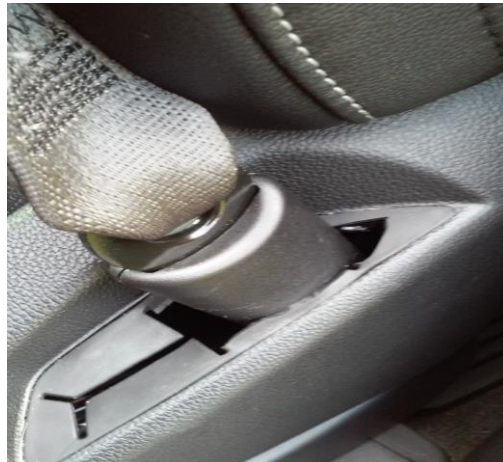
General Motors has received comments from customers regarding the quality of the repair for safety recall 15822B. Specifically, some customers have stated that after the repair was performed, a larger than specified seatbelt trim opening with uneven and jagged edges was visible.

Example of poorly executed repair.

Note excessive opening size with uneven and jagged edges.
