Small EVAP Leak, SCCM, and 8-speed Auto Park

REFERENCE BOOK AND TECH NEWS
October 2016

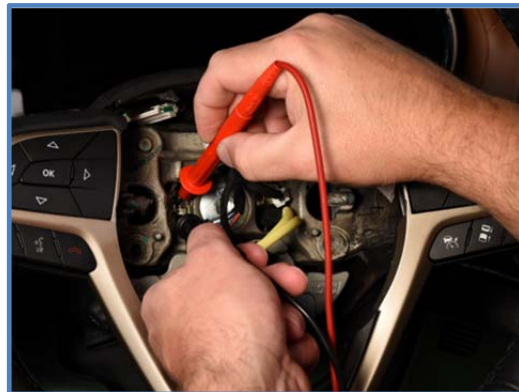
This information allowed the technician to isolate the fault to the LIN bus circuit in the small harness located in the steering wheel. The terminal connection at the SCCM end was intermittent (Figure 6).

Figure 6: *Testing terminal connection at the SCCM.*

The moral of this case is to recognize that, in addition to the LIN bus between the SCCM and the BCM, there is a LIN connection between the steering wheel switch assemblies and the SCCM.

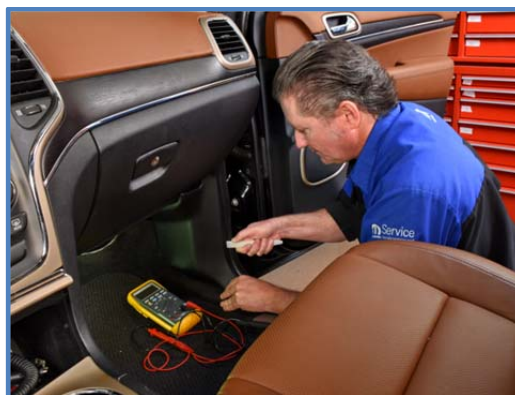
After looking at the service history and the wiring diagrams, the field engineer pointed out that the rear camera and SCCM share a LIN bus to the BCM.

The tech carefully examined the connector at the BCM and found that the LIN terminal was loose, causing a poor connection (Figure 8).

Figure 8: Tech accessing BCM connectors

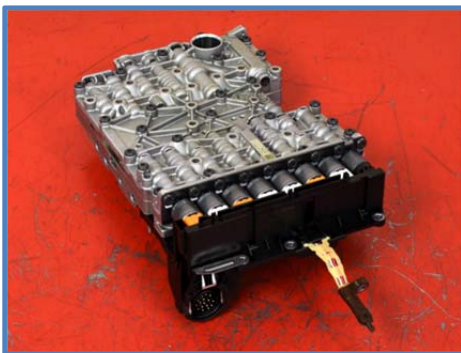
As mentioned earlier, installing the wrong flash file to the TCM when performing an update, will lead to the TCM ECU locking-up. This is a crucial and expensive misstep. The 8-speed ECU and valve body are serviced as a unit. So, the entire assembly must be replaced. Since the issue was caused by a misstep, there will most likely be a chargeback to your dealership.

Figure 12: Avoid costly valve body replacement

Again, anytime multiple flash files are displayed on the scan tool, refer to the sales codes provided in the flash file descriptions before updating the software in the TCM. Failure to use sales codes for determining proper flash file may result in otherwise avoidable costly valve body replacement (Figure 12).

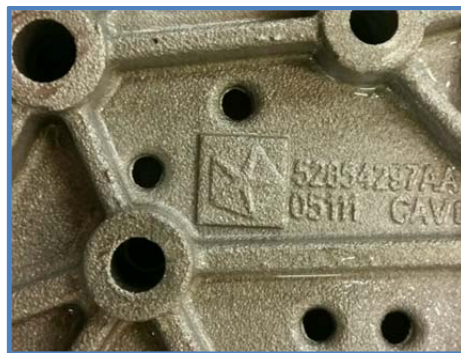
There are two different valve bodies available for 8-speed transmissions depending on the manufacturer. The 8HP45 is manufactured by ZF, while the 845RE is manufactured by FCA. The valve bodies are not interchangeable; installing the wrong one can cause shifting issues and set DTCs.

The valve bodies themselves can also be identified by different markings on the casting of the valve body. The 8HP45 manufactured by ZF, has a “ZF” logo, and the 845RE manufactured by FCA has the familiar Pentastar logo (Figure 15).

Figure 15: Transmission identification

Technicians must verify the transmission manufacturer before ordering any valve bodies from your parts department. Otherwise, you could waste a lot of time and money by installing the wrong part.
