RECALL: This modification has top priority and must be performed immediately to ensure customer safety

Subject: Factory Direct Modification Campaign – New Software Update to the Suspension Control Unit (SCU) and inspection of Shock Absorber for any possible oil leak at the Rebound Damping plug

Affected 2015 & 2016 Model: 1290 Super Adventure

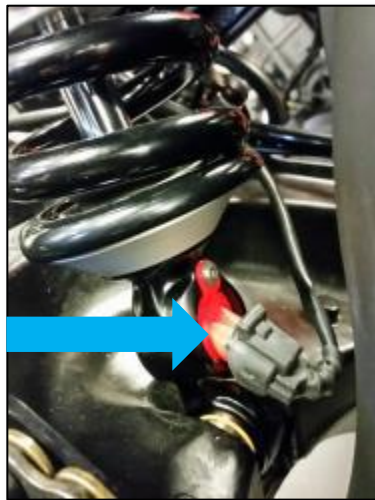
Figure 1.

- » Inspecting the shock for an oil leak.
 1. Remove the Rebound Damping plug connector from the shock absorber.
 2. Inspect for any oil leak visible on the outside and also inside the connection terminal of the rebound damping plug connection (Figure 1.)

3. If leaking is present, replace the shock strut (without preload adjuster and spring) PN# 46812001S1. Follow the latest available repair manual for replacement procedure. If no oil leaking is present, continue to ECU flashing steps below.

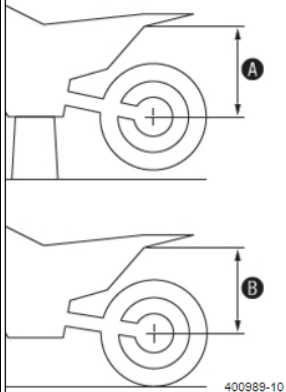
400989-10

- Measure dimension (A) of rear wheel unloaded.
- Hold the motorcycle upright with the aid of an assistant.
- Measure the distance between the rear axle and the fixed point again.
- Note down the value as dimension (B).

i Info
The static sag is the difference between measurements (A) and (B).

Full fuel tank	25 mm (0.98 in)
Empty fuel tank	20 mm (0.79 in)

- » If the static sag is less or more than the specified value:
 - Adjust the spring preload of the shock absorber.
