TO: Mercedes-Benz Dealer Principals, General Managers, Sales Managers, Service Managers, Parts Managers	FROM: Thomas Brunner, Department Manager, Vehicle Compliance and Analysis, Engineering Services
RE: Recall Campaign 2016050007 Model 172 (SLK-Class), Model Year 2016 Replace Tie Rod Nut on Left and Right Rear Axle Wheel Carrier	DATE: June 17, 2016

Campaign No. 2016050007, June 2016

SUBJECT: **Model 172, Model Year 2016**
Replace Tie Rod Nut on Left and Right Rear Axle Wheel Carrier

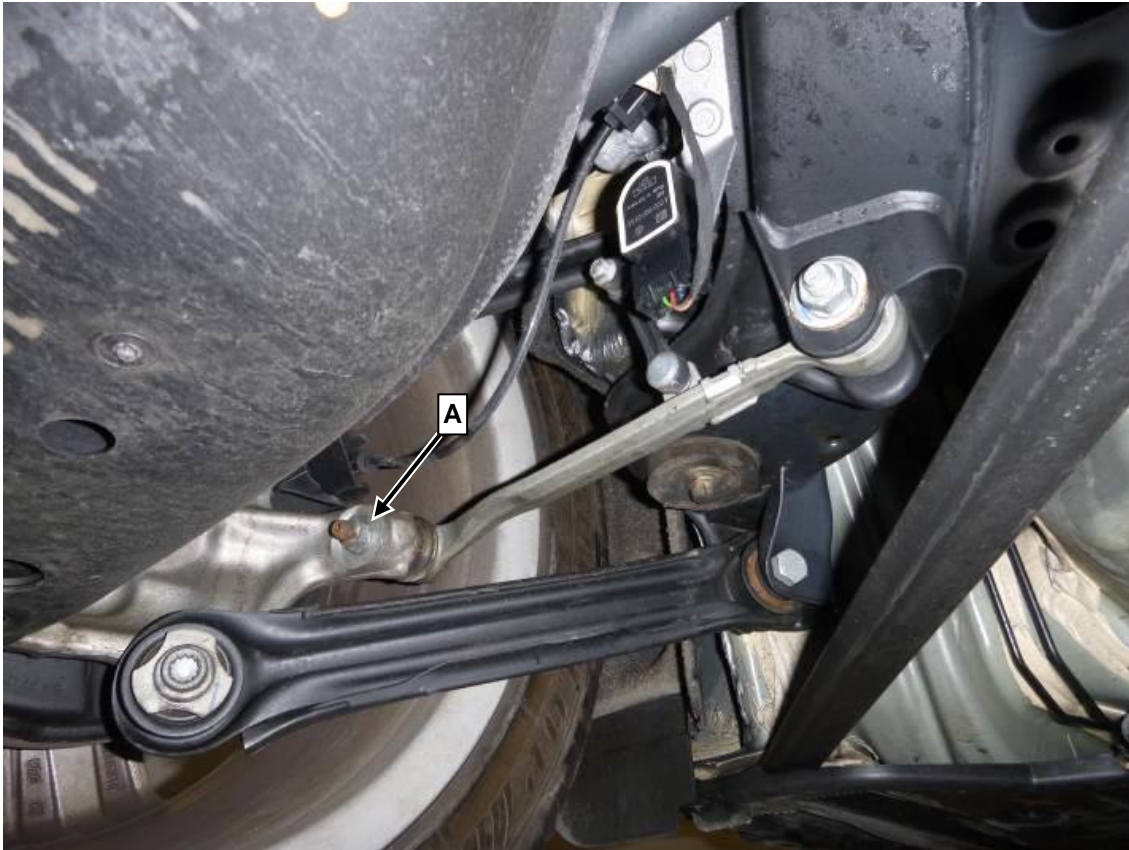
Figure 1

Daimler AG (DAG), the manufacturer of Mercedes-Benz vehicles has determined that on certain SLK vehicles (172 platform), improperly manufactured locknuts might have been used on the tie rod screw-connection to the rear axle wheel carrier. These potentially affected locknuts may not fulfill the required pre-tension force despite the correct tightening torque.

1. Replace tie rod nut on right and left rear axle wheel carrier (A, Figure 1).

Nm Torque nut: 1st stage 30 Nm, 2nd stage 90°.
