TO: Mercedes-Benz Dealer Principals, General Managers, Sales Managers, Service Managers, Parts Managers	FROM: Thomas Brunner, Department Manager, Vehicle Compliance and Analysis, Engineering Services
RE: <b>Recall Campaign 2016050008 – Check and Replace Drive Shaft on Model 190 (AMG GT-Class) MY 2016</b>	DATE: July 22, 2016

Campaign No. 2016050008, July 2016

SUBJECT: **Model 190, Model Year 2016**  
**Check Drive Shaft, Replace if Necessary**

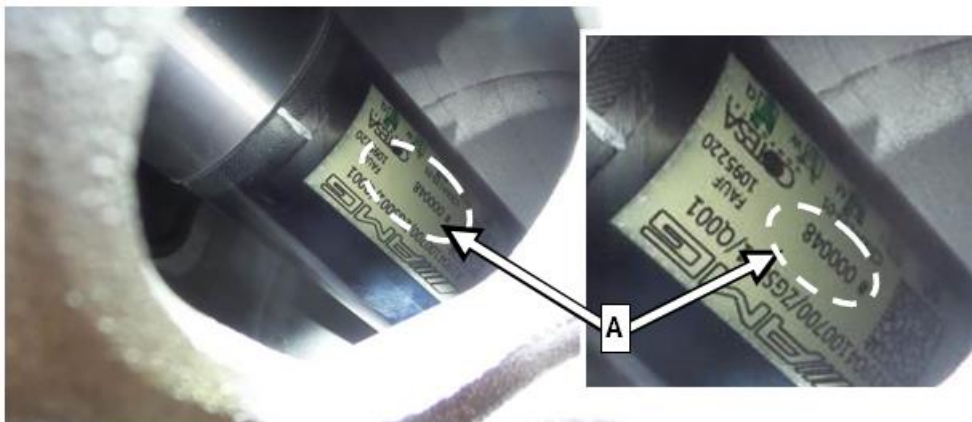
Figure 1

Check drive shaft production number (A, Figure 1).
  - If production number is **greater** than **000322 (OK)**: Procedure is complete.
  - If production number is **less** than or **equal** to **000322 (NOT OK)**: Proceed to step 3 (below).

If label is not visible start engine briefly then turn off engine and check again (repeat as necessary until label is visible).

Replace drive shaft, refer to WIS: AR41.10-P-0051MNB.
