# Product Safety Recall

## 15826 Front Passenger Air Bag Inflator

**Reference Number:** N150826000

**Release Date:** April 2018

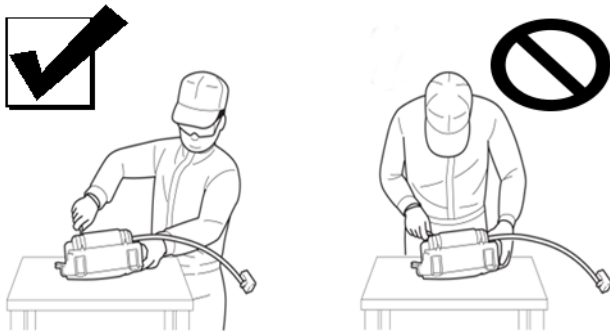
4751076

**Warning:** Confirm the stopper plate to inflator fitment is correct. **DO NOT** pinch the harness between the inflator and the stopper plate.

**Warning:** When working with the airbag module, avoid standing directly in front of the parts.

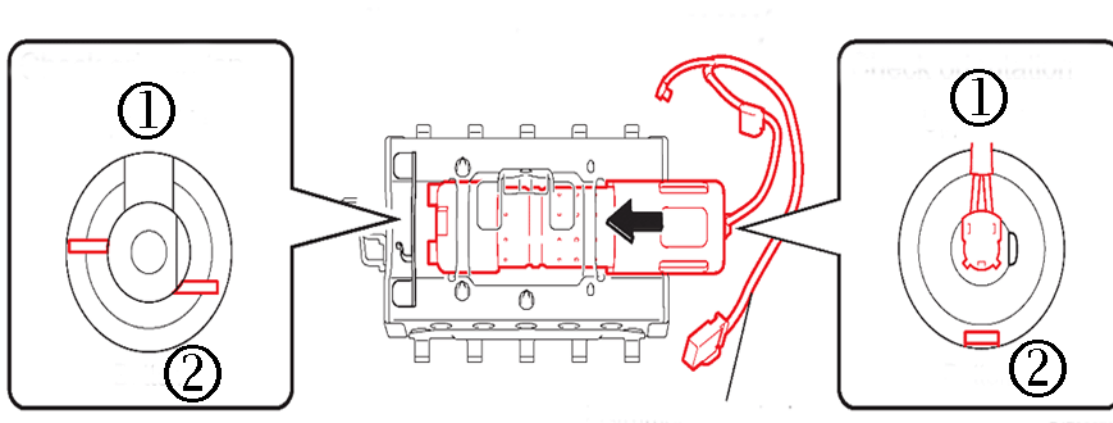
4751078

**Important:** DO NOT insert the inflator fully.

4. Insert a NEW inflator to the center of the airbag case with the correct orientation as shown (1) Upper side (2) Bottom.

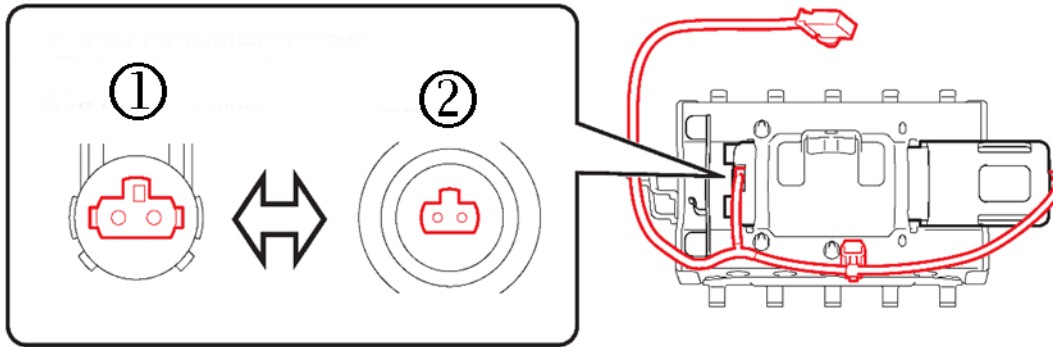
4751079

- If the passenger airbag inflator is upside down, it will not be able to be fully inserted.
- Make sure that the passenger airbag inflator is oriented correctly as shown, not upside down.

5. Connect the connector and push in each airbag connector lock as shown (1) Wire harness side (2) Inflator side.

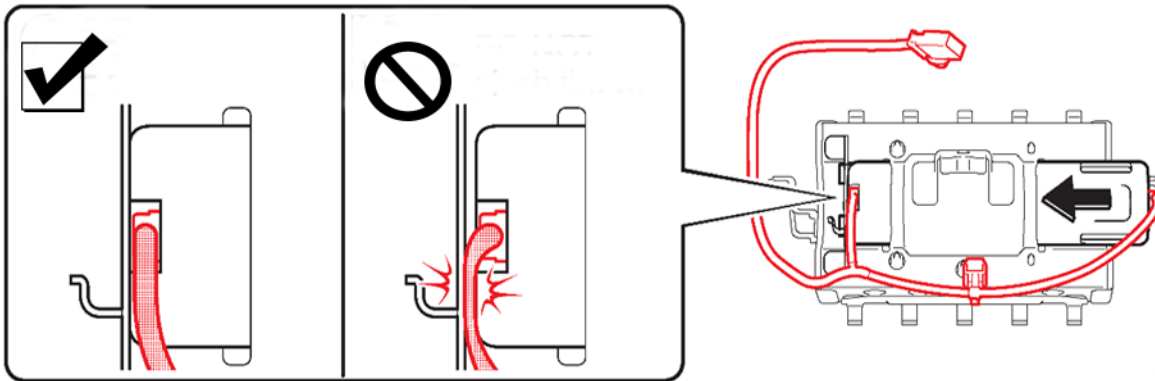
4751080

**Important:** Make sure that the inflator is oriented correctly as shown in the illustration, not upside down. If the passenger airbag inflator is upside down, it will not be able to be fully inserted.

6. Insert the inflator fully with the correct orientation as shown. DO NOT pinch the wire.

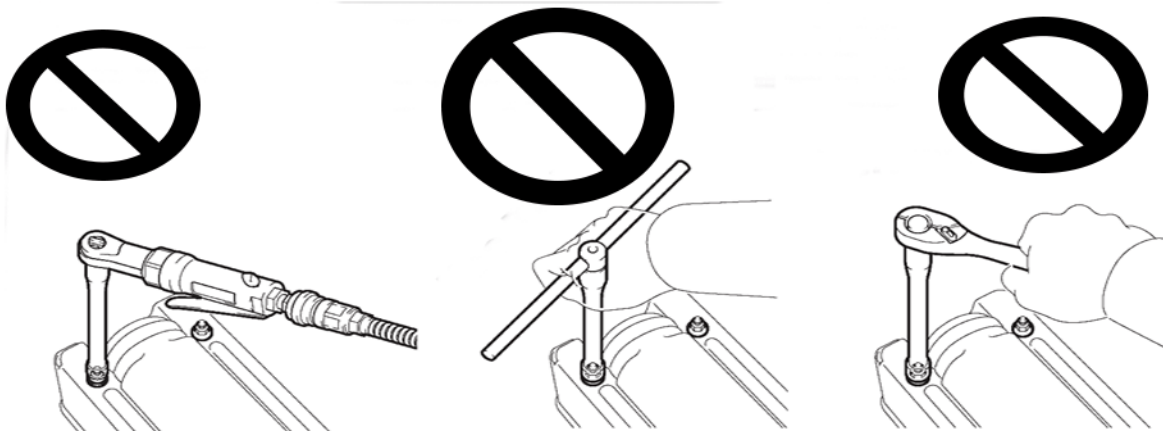
4751084

**Important:** The tightening torque is low (3.9 N·m). Use of an air ratchet wrench or tightening strongly with a T-handle wrench or a ratchet handle may cause deformation of the stud bolt.
