Product Safety Recall

15826 Front Passenger Air Bag Inflator

Reference Number: N150826000

Revision: 04

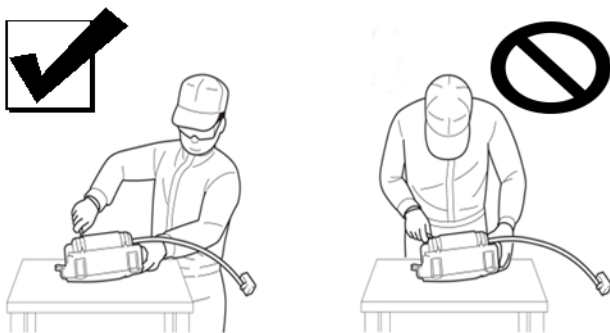
4751076

Warning: Confirm the stopper plate to inflator fitment is correct. **DO NOT** pinch the harness between the inflator and the stopper plate.

Warning: When working with the airbag module, avoid standing directly in front of the parts.
