TO: All Mazda Dealership General Managers, Service Managers, and Parts Managers

DATE: July 2016

SUBJECT: Passenger Air Bag Inflator Replacement - Safety Recall 9416E

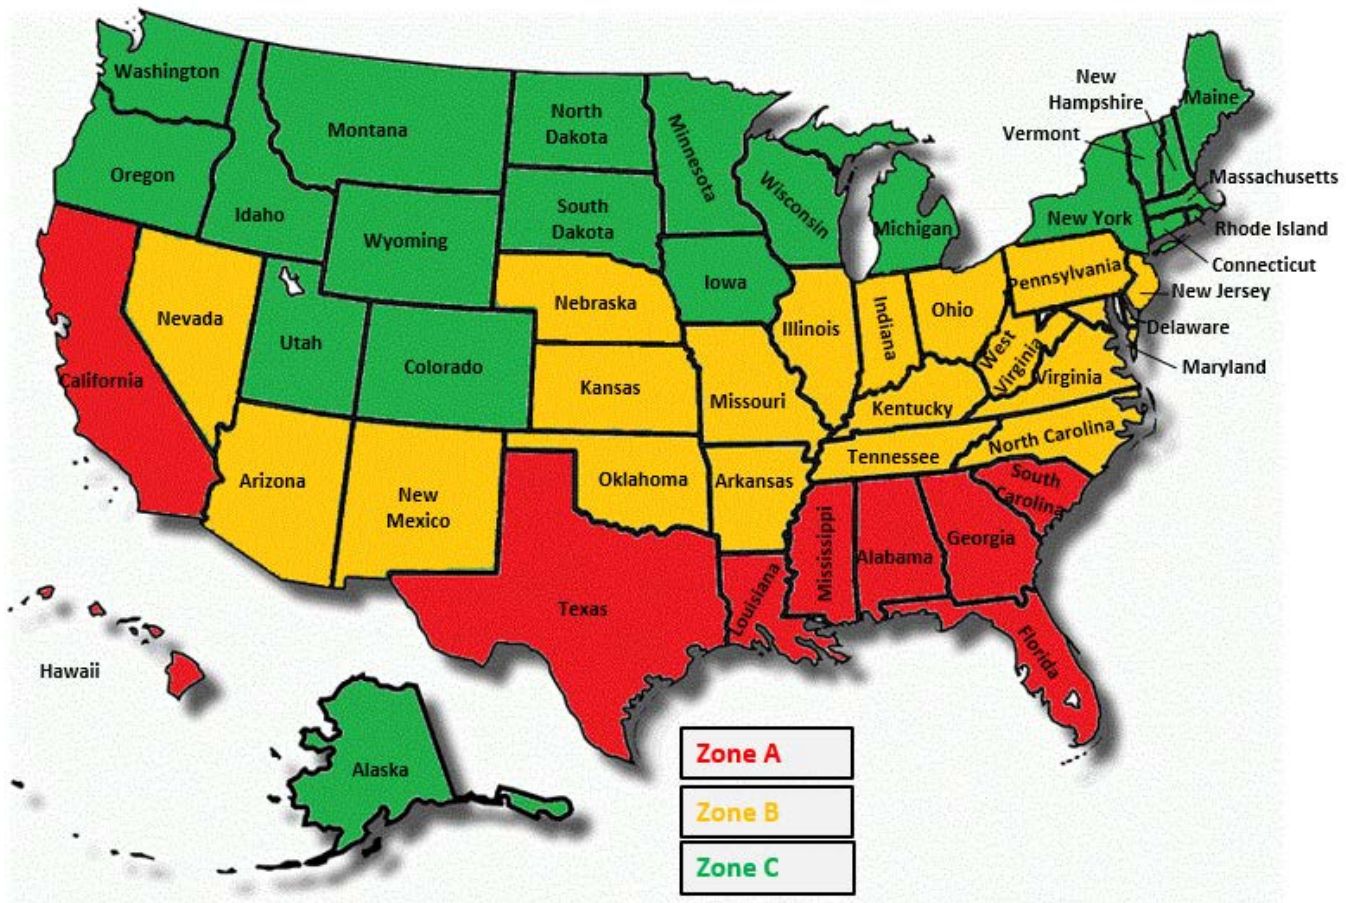
Zone A - States with high temperature cycling and humidity (includes Puerto Rico, Guam, and Saipan). Time in service until significant propellant degradation may occur is projected at between 6-9 years.
