SUBJECT: Passenger Air Bag Inflator Replacement - Safety Recall 9516E

Mazda Motor Corporation has decided that a defect which relates to motor vehicle safety exists in vehicles equipped with certain type of passenger frontal air bag inflator, and to conduct a recall campaign expanded to include 2007-2011 CX-7, 2007-2011 CX-9, and 2009-2011 Mazda6 vehicles.

2007-11 CX-7, 2007-11 CX-9, 2009-11 MAZDA6 - PASSENGER AIR BAG SAFETY RECALL 9516E

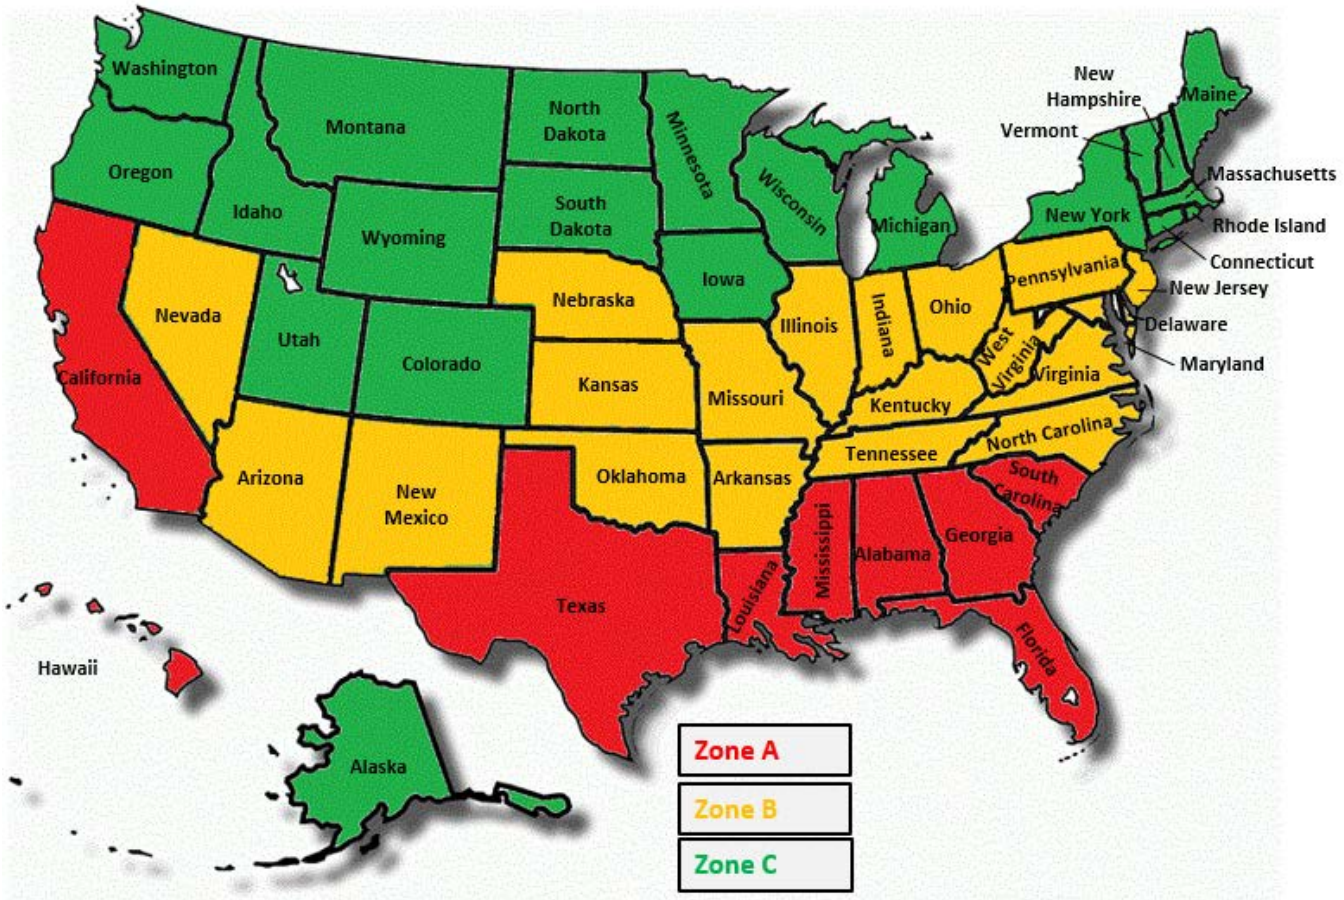
Zone A - States with high temperature cycling and humidity (includes Puerto Rico, Guam, and Saipan). Time in service until significant propellant degradation may occur is projected at between 6-9 years.

Zone B - States that have moderate temperature cycling and humidity. Time in service until significant propellant degradation may occur is projected at between 10-15 years.

Zone C - States with lower temperature cycling and humidity. Time in service until significant propellant degradation may occur is projected at between 15-20 years.

NHTSA has structured this expansion with 5 phases and 3 geographic zones, based on temperature and absolute humidity factors in each Zone, and analysis of expected rate of inflator degradation. Time, temperature, and humidity have been found by NHTSA and independent investigations to contribute to significant propellant degradation, which can lead to high risk of inflator rupture.
