| RE: <b>Recall Campaign 2018120017 Takata- Priority Group 5 Phase 2 All Zones Replace Driver-side and Passenger-side Airbags</b> -Certain MY11 W207 (E-Class Coupe/Cabrio), MY10 204 (C-Class), and MY 2011 X204 (GLK-Class) vehicles | DATE: December 27, 2018 |

# RECALL CAMPAIGN LAUNCH

| Campaign No. : | Campaign Desc. : | Takata Recall– Priority Group 5<br>Driver and Passenger-side Airbags |

SUBJECT: **Model 204, X204 and 207**  
**Model Years 2010 – 2011**  
**Replace Driver-Side and Front Passenger-side Airbag**

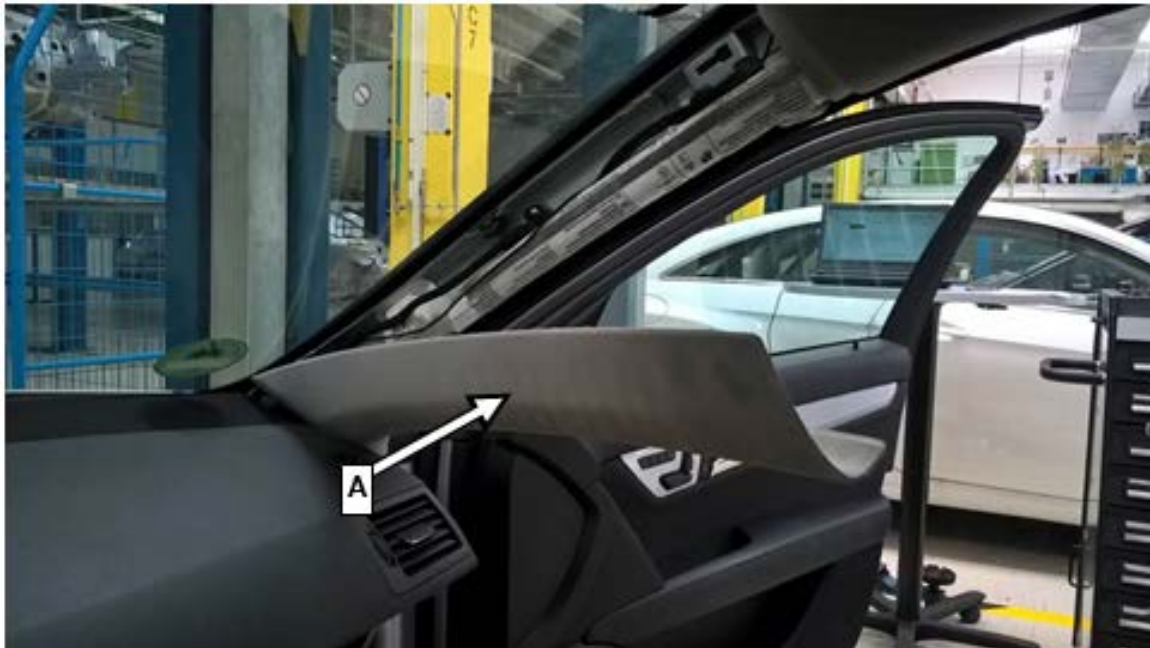
Figure 2

3. Remove right A-pillar trim (**A**, figure 2).

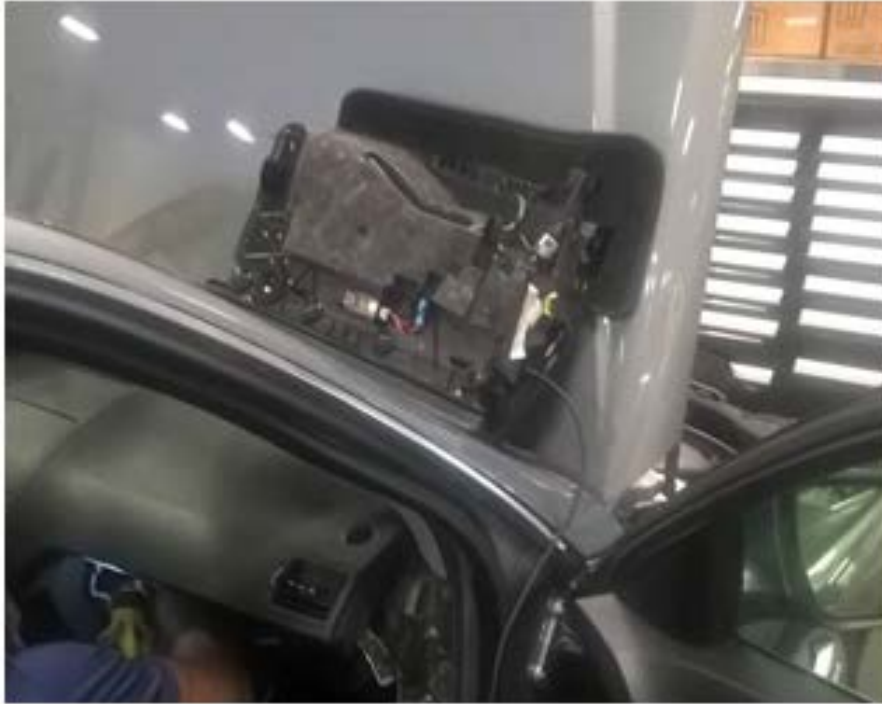
Figure 4

**i** Pull out the iPod cable as far as possible and set down glove box housing on the windshield **with** exterior iPod cable connected (**figure 4**).

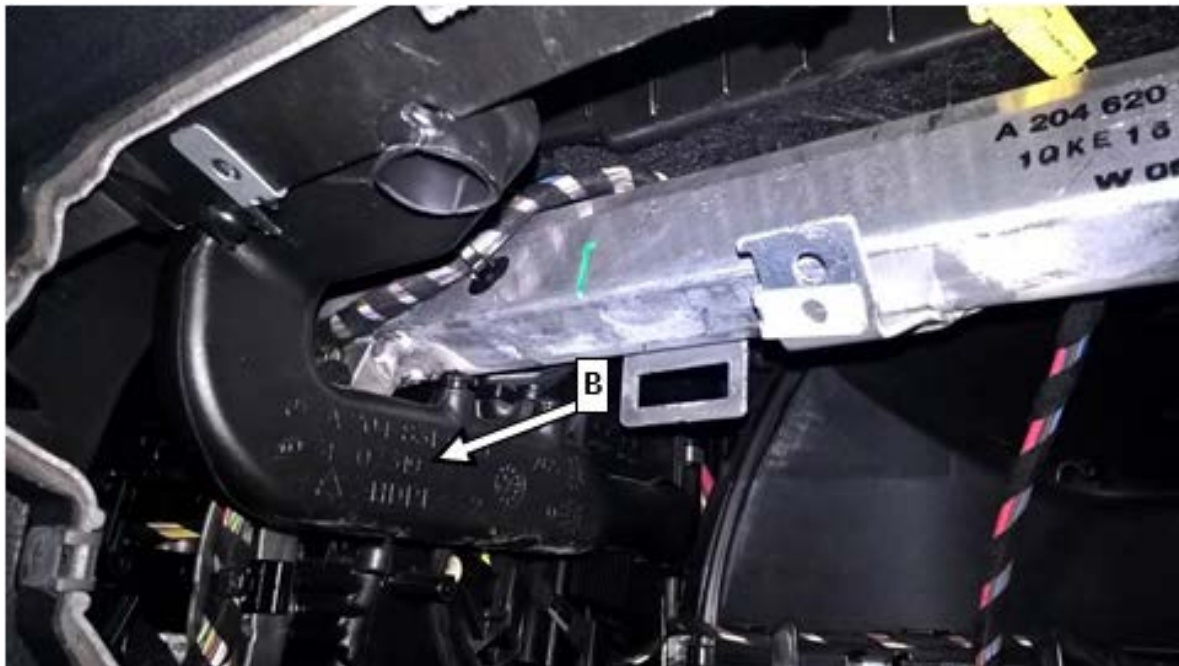
Figure 5

5. Remove air duct (**B**, figure 5) above the glove compartment.

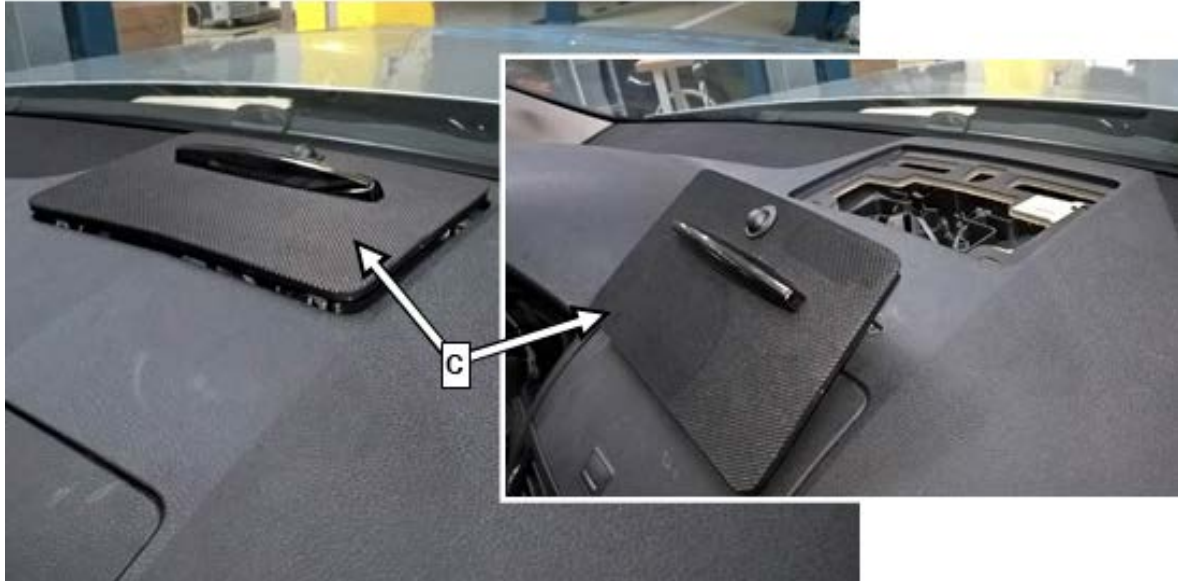
Figure 6

6. Unclip and remove cover (**C**, figure 6) at the instrument panel on top.  
**i** With a sound system, also remove speaker under the cover.

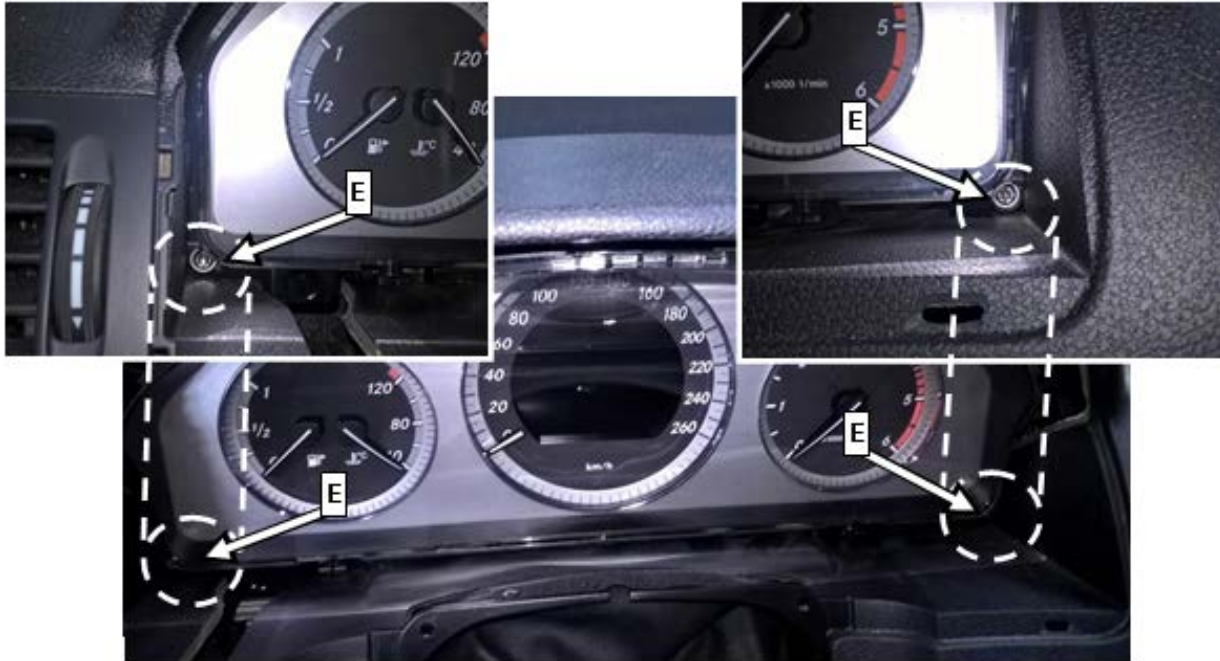
**Figure 8**

10. Remove the two bottom threaded connections (**E, figure 8**) of the instrument cluster.

**i** These screws are simultaneously fasteners for the instrument panel.

**i** The upper two screws do not need to be removed.

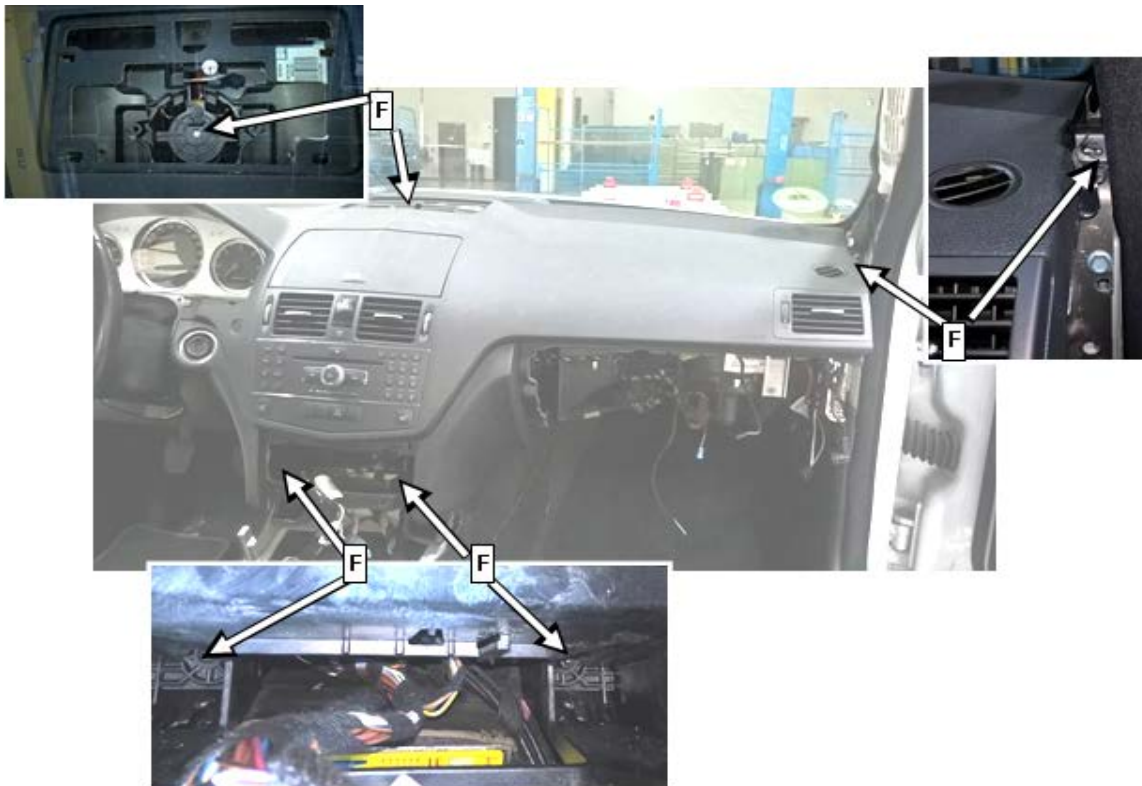
**Figure 9**

11. Remove four screws (**F, figure 9**) for fastening the instrument panel

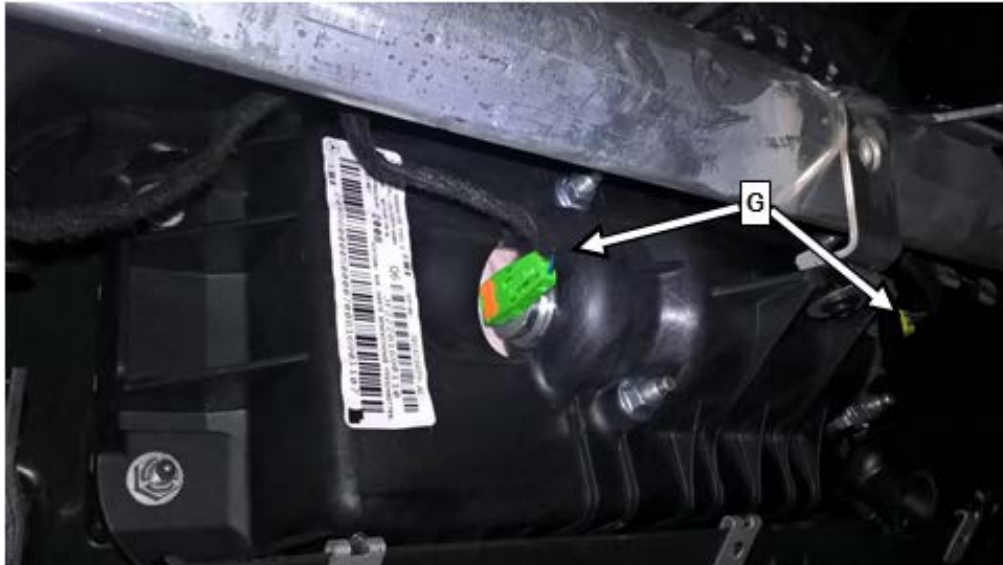
Figure 10

12. Disconnect electrical contacts (**G**, **figure 10**) at the front passenger airbag.

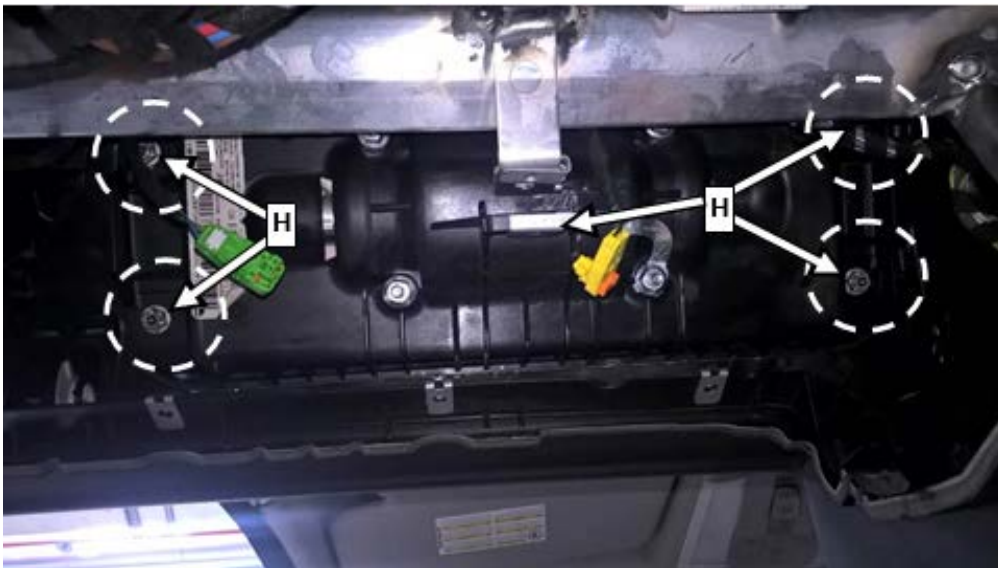
Figure 11

13. Remove lock nuts (**H**, **figure 11**) for the front the passenger airbag.

**i** Lock nuts should only be replaced if they are damaged. For more info see: **AH00.00-N-0001-01A / Modification notes 27.10.2016**

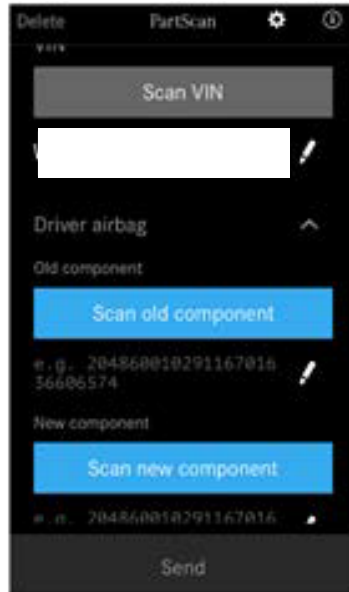
**Figure 13**

16. Scan barcodes of the removed driver airbag using the button "Scan old component" (**figure 13**).

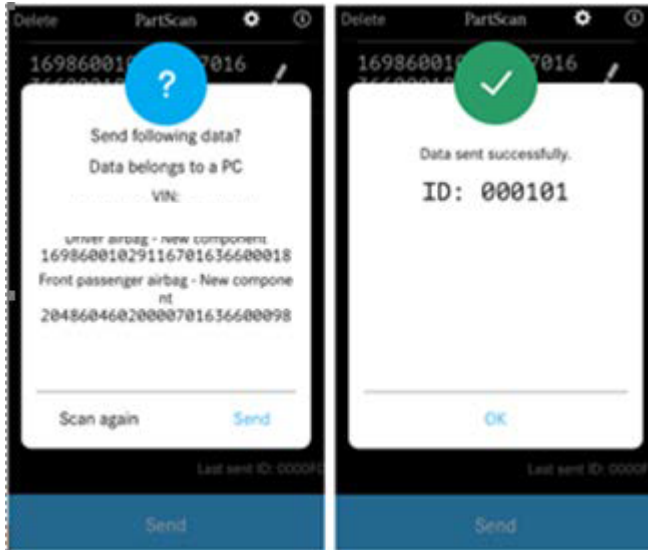
Figure 15

19. Create a scan ID via the "Send" button (**figure 15**).

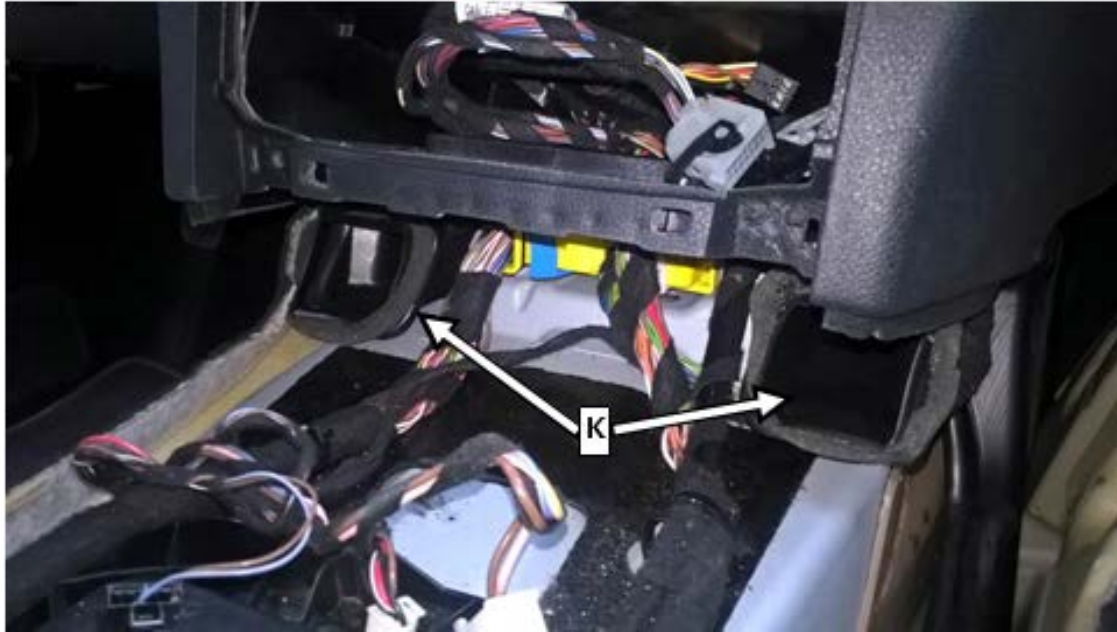
Figure 17

**22.** Place instrument panel back into position and install the air ducts (**K, figure 17**) correctly.

**i** The air ducts are pulled out when the instrument panel is raised.

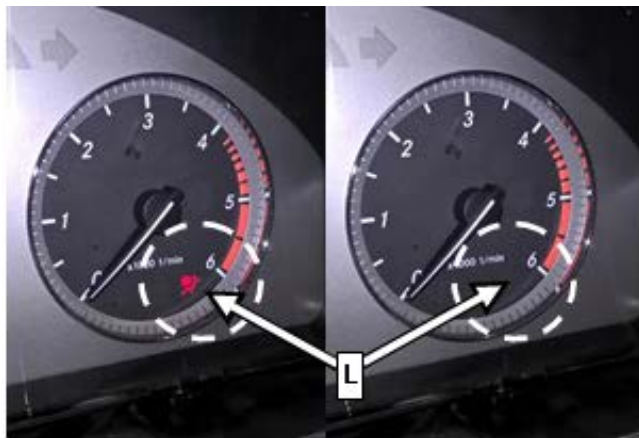
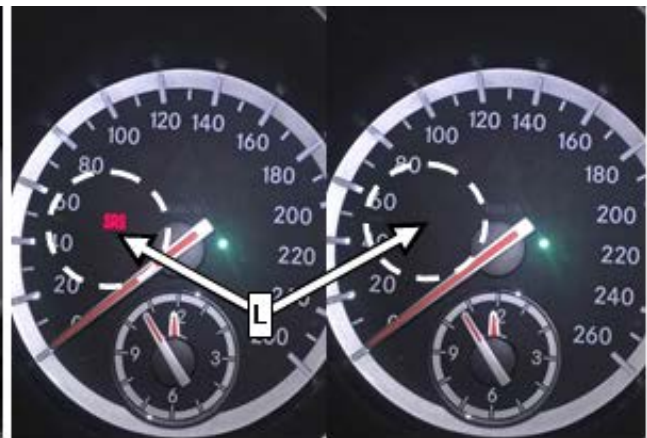
25. Turn the transmitter key in the electronic ignition lock to **position 1** and check whether the airbag indicator lamp (**L**, **figure 18 or 19**) correctly switches off after a few seconds.

**i** The SRS check is thus completely ensured after airbag replacement.

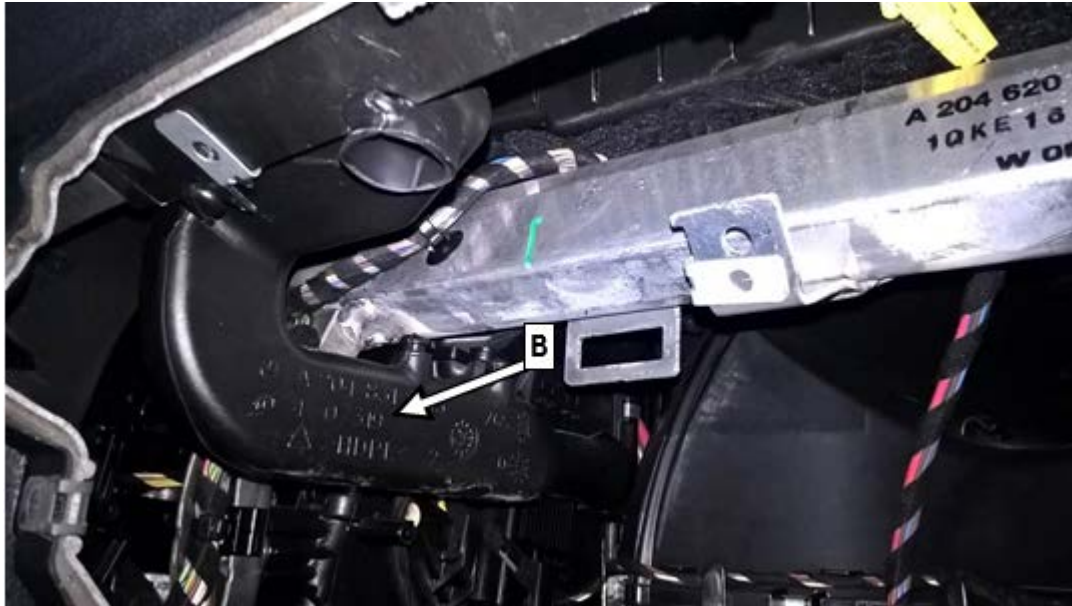
**Figure 1**

1. Disconnect ground line from the on-board electrical system battery.
2. Remove driver airbag at the steering wheel.  
**i** For basic data of model X 204, see **AR91.60-P-0660CW**
3. Remove glove compartment housing (**AR68.10-P-1200CY**).
4. Remove air duct (**B**, **figure 1**) above the glove compartment.

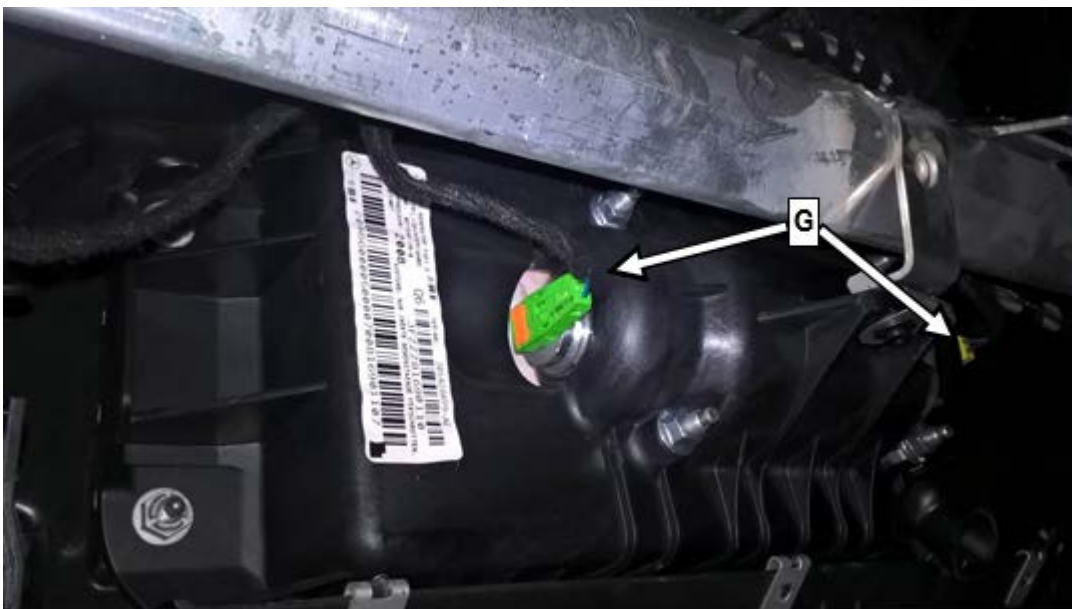
**Figure 2**

5. Disconnect electrical contacts (**G**, **figure 2**) at the front passenger airbag.

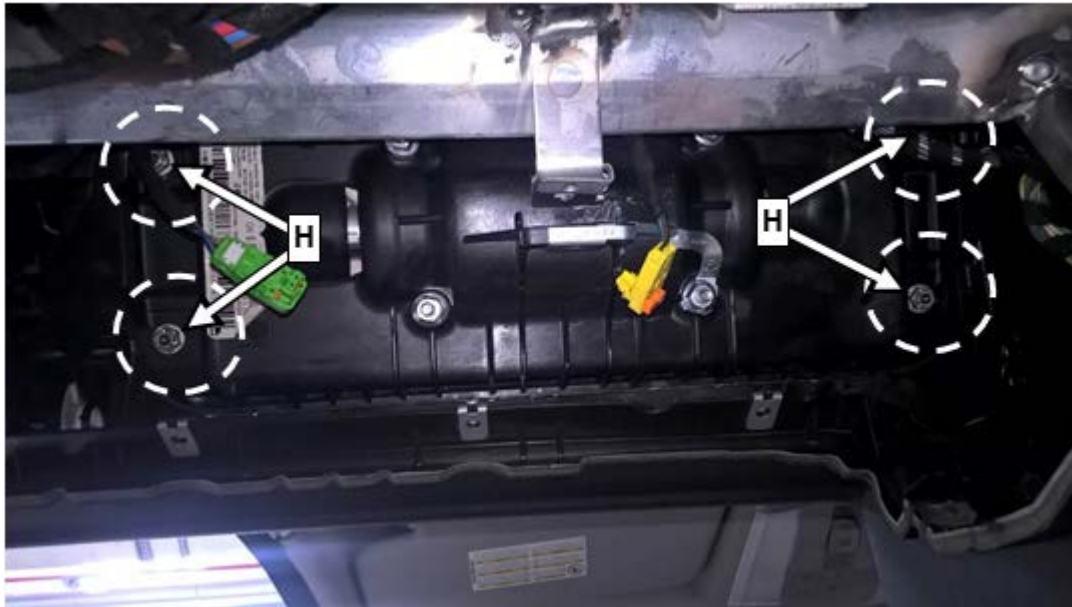
Figure 3

6. Remove threaded connections (**H**, figure 3) for the front the passenger airbag.

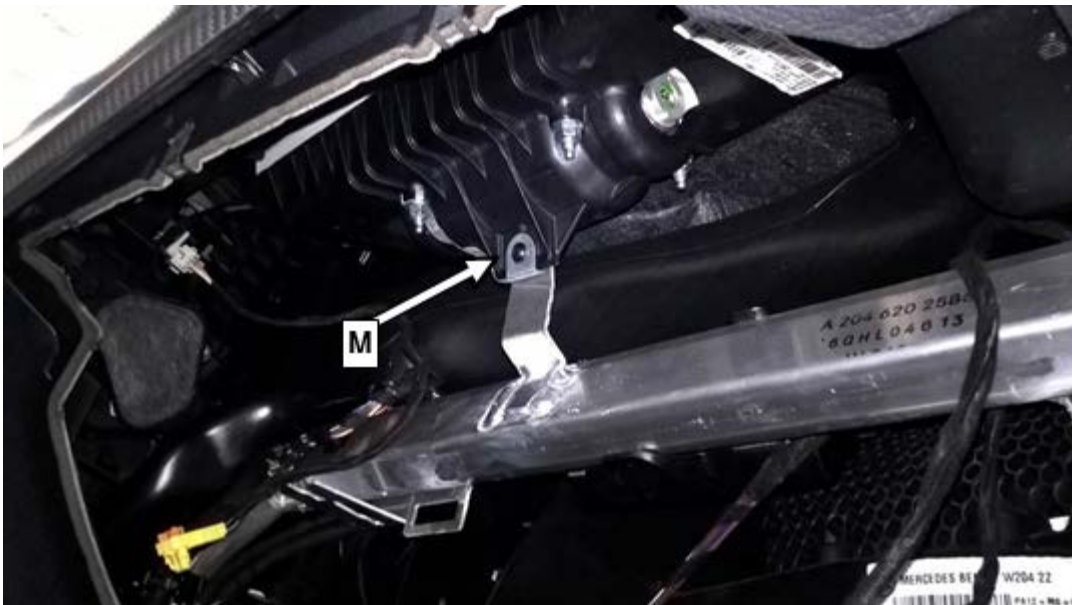
Figure 4

7. Remove Screw (**M**, figure 4) for the front passenger airbag.

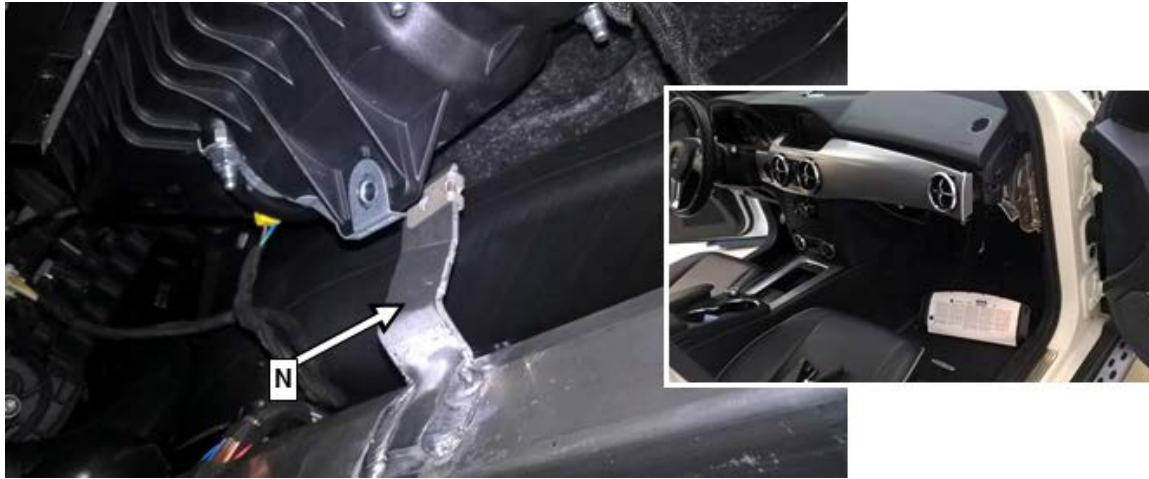
Figure 5

**i** To remove the front passenger airbag, slightly push the bracket (**N**, **figure 5**) forward.

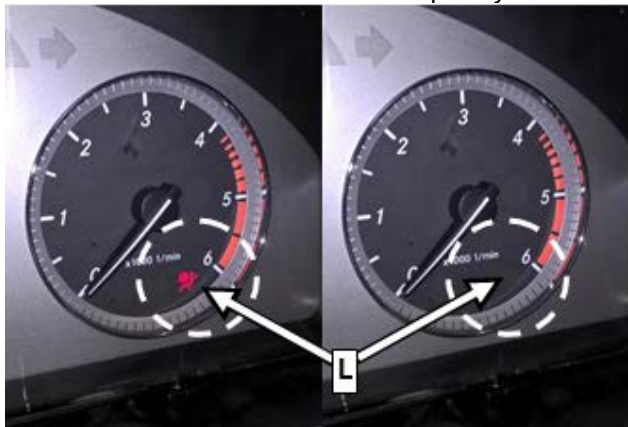
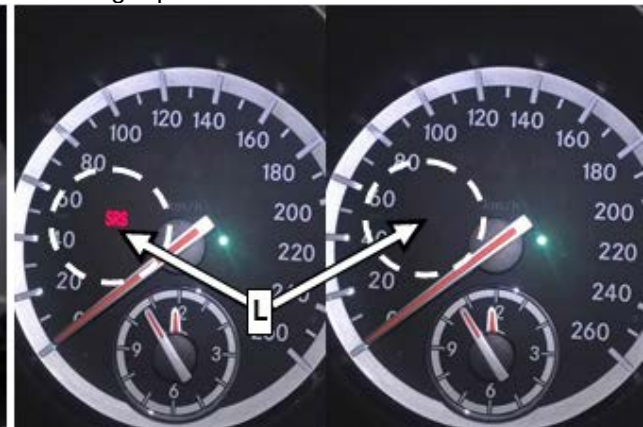
14. Turn the transmitter key in the electronic ignition lock to **position 1** and check whether the airbag indicator lamp (**L**, **figure 6 or 7**) correctly switches off after a few seconds.

**i** The SRS check is thus completely ensured after airbag replacement!
