David J. Johnson
 Director
 Service Engineering Operations
 Ford Customer Service Division

March 14, 2018

SUBJECT: **Safety Recall 16S26 – Supplement #1**
 Certain 2005-2006 Ford GT, 2005-2011 Mustang, 2006-2011 Fusion and Milan,
 2006 Zephyr, 2007-2011 MKZ, 2007-2010 Edge and MKX, and 2007-2011 Ranger
 Vehicles
 Passenger Airbag Inflator Replacement

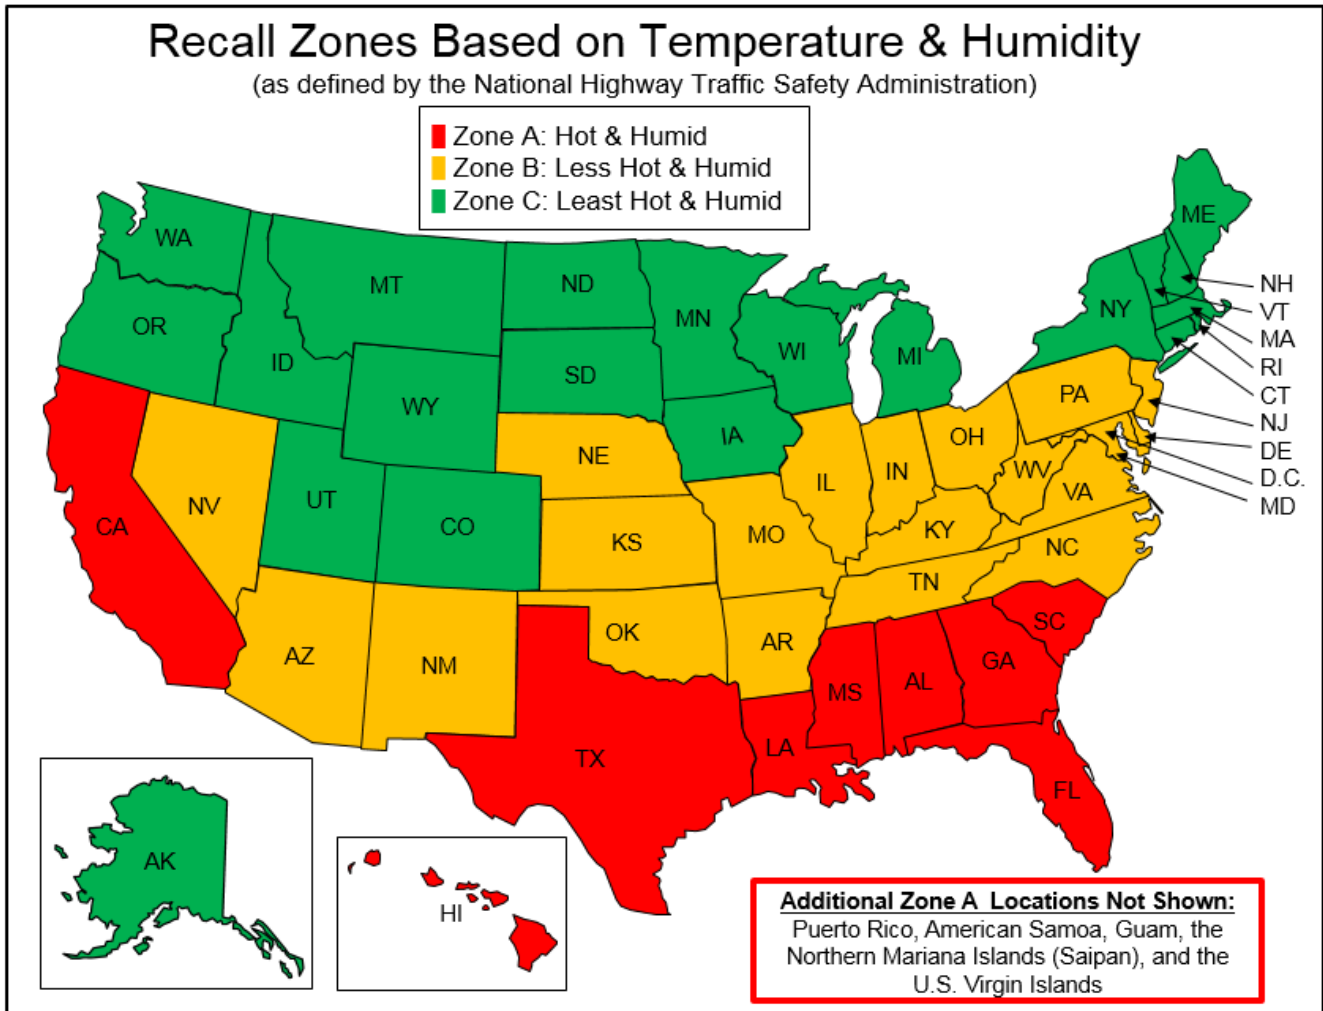
FIGURE 1

The Takata airbag recall zones have been defined by the NHTSA, based on temperature and humidity.
