Dealer Service Instructions for:

Safety Recall S51 / NHTSA 16V-401

Passenger Sun Visor

2001-2002 (ST) Chrysler Sebring and Dodge Stratus

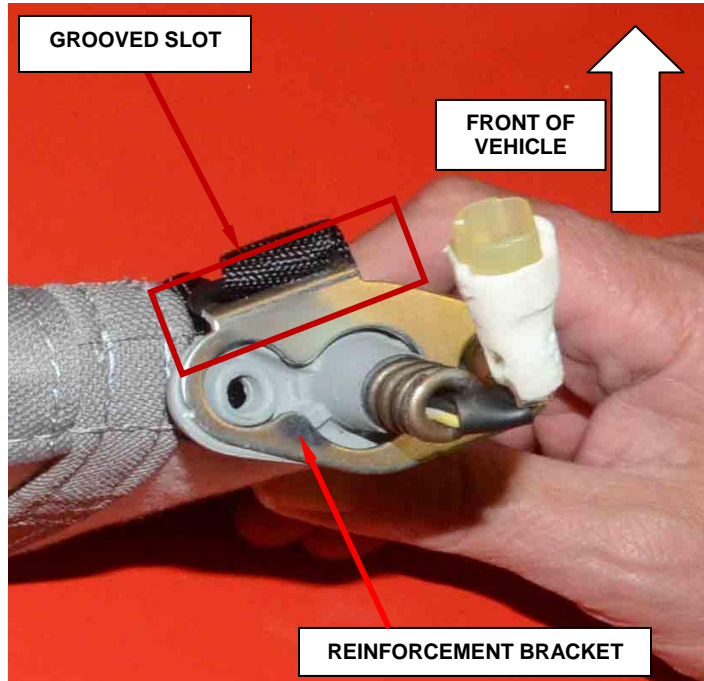
Figure 3 – Reinforcement Bracket

NOTE: The tether strap’s reinforcement bracket (silver finish) has a grooved slot that seats over the mounting bracket and indicates the mounting bracket’s position during sun visor installation (grooved slot must be facing towards front of the vehicle).

- d. Position the tether strap’s reinforcement bracket (silver finish) on top of the sun visor’s mounting bracket (Figure 3).

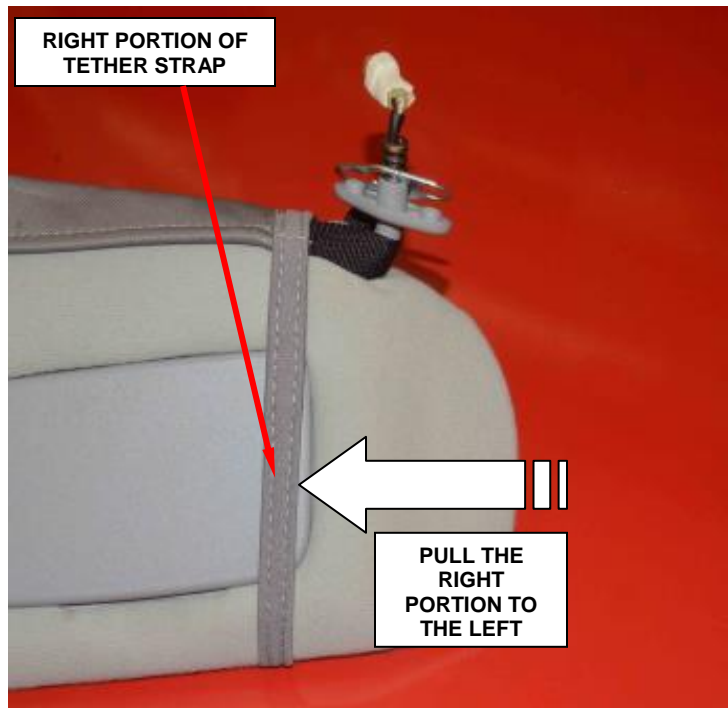
Figure 4 – Tether Strap

CAUTION: During tether strap install on the right side of the visor, do not damage the tether strap or the sun visor. Be careful, patient, and gentle during installation. The tether strap is designed to be a tight fit over the sun visor.

- e. Install the right portion of the tether strap over the right side of the sun visor (Figure 4).
- f. Pull the right portion of the tether strap across the sun visor in the direction indicated. Doing this provides additional slack to install the left portion of the tether strap (Figures 3 and 4).
