NISSAN BULLETIN

Front Passenger Airbag Connector Voluntary Safety Recall Campaign

Reference: PC467, PM655

Date: June 21, 2016

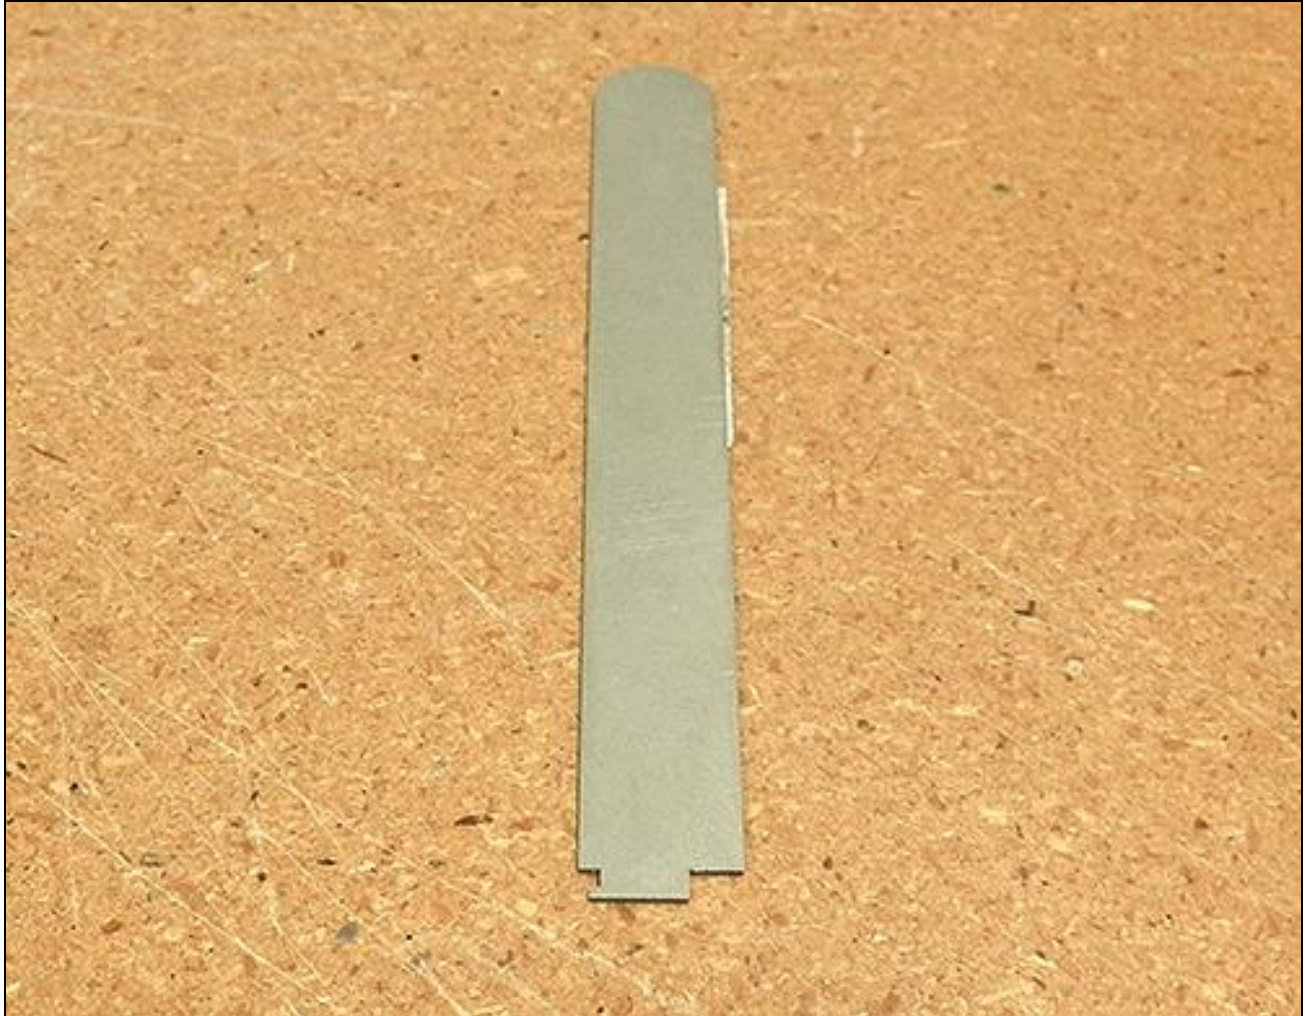
Figure 1

- One Airbag Socket Depth Gauge shown in Figure 1, was sent to each dealer.
- This tool is used to confirm the correct groove position (depth within the socket) of the front passenger airbag harness connector socket.

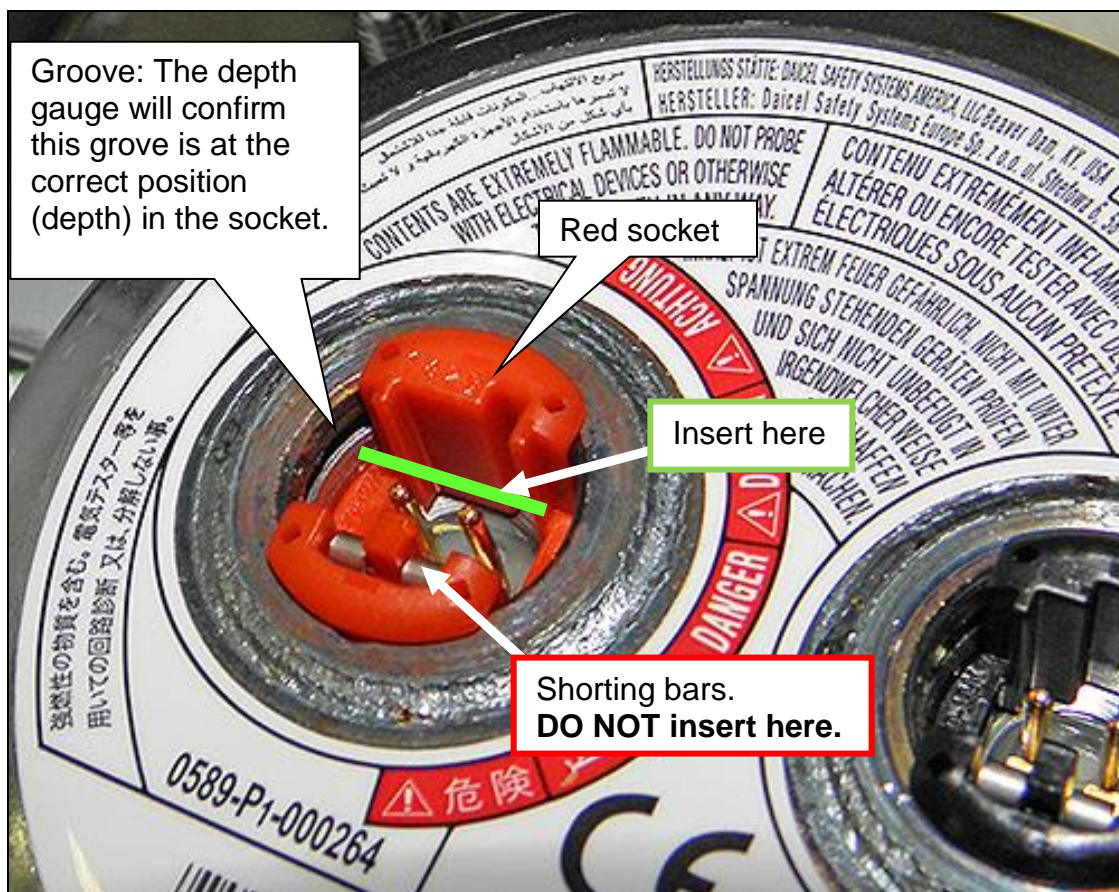
a. Insert the depth gauge into the red socket shown in Figure 2 between the terminal pins and collar.

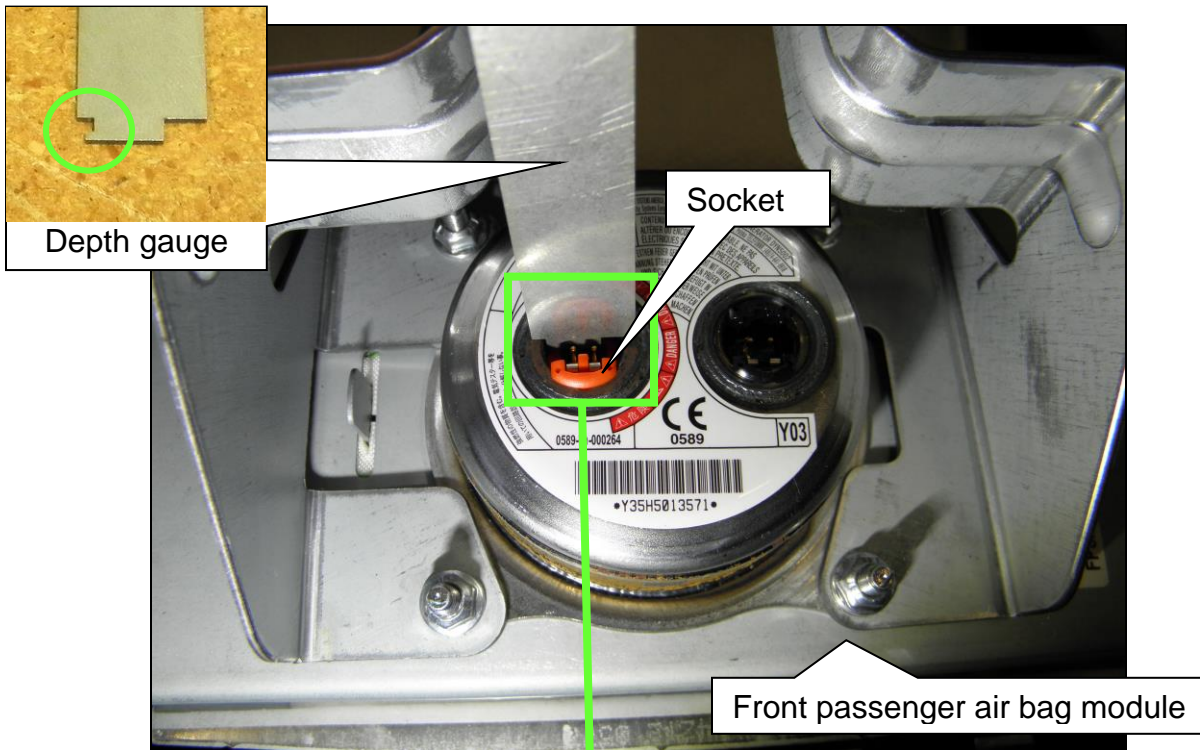
- b. Slide the depth gauge sideways into the socket groove as shown in Figure 3 and 4 below and Figure 5 on the next page.

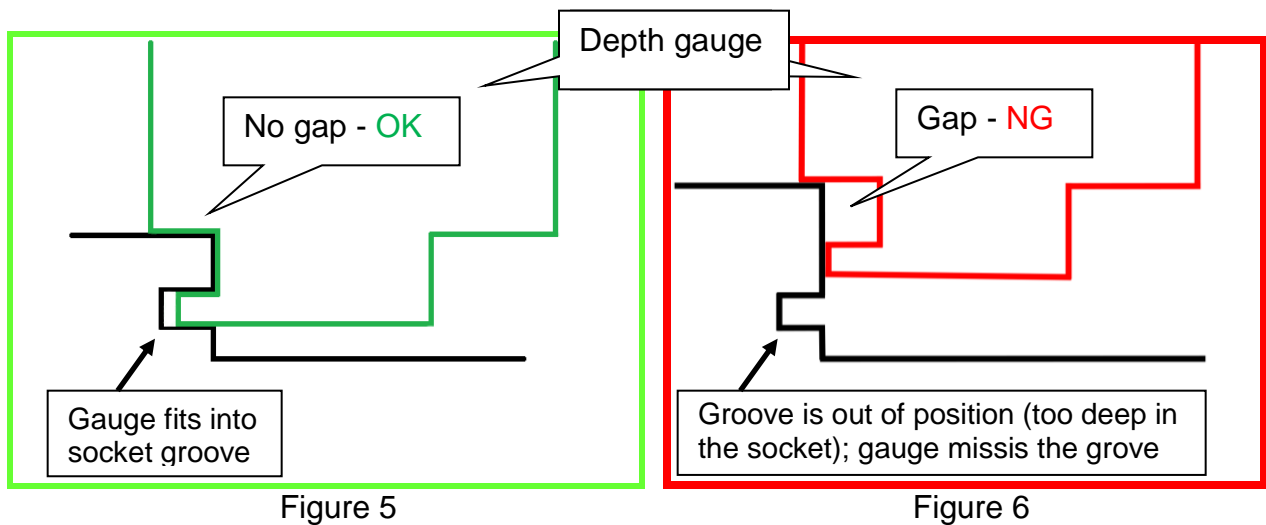
NOTE: If the groove is at the correct position (depth), the tool will fit into the groove. If the groove is not in the correct position, the tool will hit the side of the socket causing a gap between the tool and the socket as shown in Figure 6 on then next page.

c. Does the depth gauge fit into the socket groove as shown in Figure 5?

NOTE: Figures 5 and 6 show a side view of the socket with the depth gauge measuring the position (depth) of the groove.

YES: Proceed to step 11.

NO: Refer to Contact Information on page 6 and then, when instructed, proceed to step 11.
