SB-08-200

IMPORTANT NON-COMPLIANCE EQUIPMENT RECALL NOTICE – Dealer Notification

Subject: BENDIX SR-5 VALVE Recall – INTERIM NOTIFICATION

Bendix SR-5 Trailer Spring Brake Relay Valve Recall

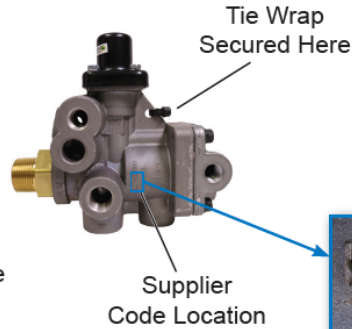
Bendix® SR-5™ Valve

To verify that the Bendix® SR-5™ valve has been repaired per the recall campaign, look for the presence of a black or green tie wrap secured to the valve body. **No further action is required.**

Green Tie Wrap
(supplied in recall repair kit)

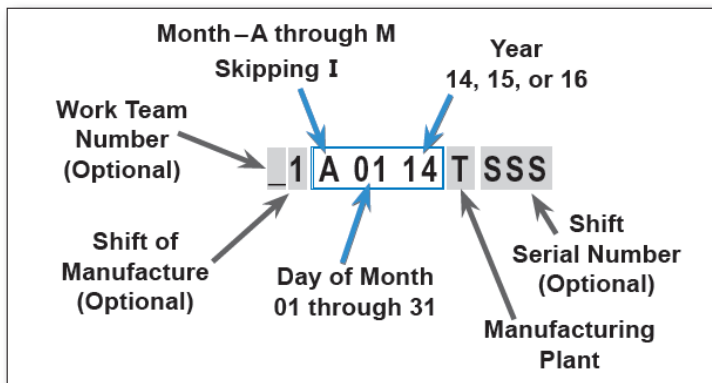
Interpreting the Date Code

A date code is stamped (not cast) on the SR-5 valve body housing. *Locate the date code – removing the paint coating, if necessary – to read the code.* Disregard the Work Team Number, Shift of Manufacture, Manufacturing Plant and Shift Serial Number codes shown in gray below. The portion of the date code that determines the date of manufacture is highlighted and can be interpreted as follows:

- The first field is the month (A=January, B=February, etc. – excluding the letter I – so that J=September, and so on),
- The next two fields are the day of the month (e.g. 01 = 1st); and
- The next two fields are the year (e.g. 14=2014)

Valves included in this field action were manufactured during the period:

That is, A0114T through C0416T

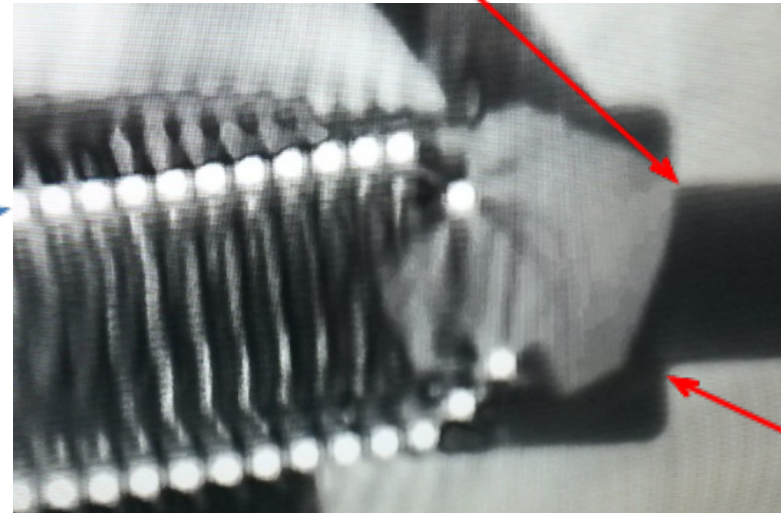
Sectional view of check valve assembly in seated position

Missing Radius on Aluminum valve Body

When combined with certain field conditions – causes misalignment of internal Check Valve

Caught on Sharp Edge
