Revised **December** 2016

Dealer Service Instructions for:

Safety Recall S55 / NHTSA 16V-529 Transaxle Range Sensor Wire Harness

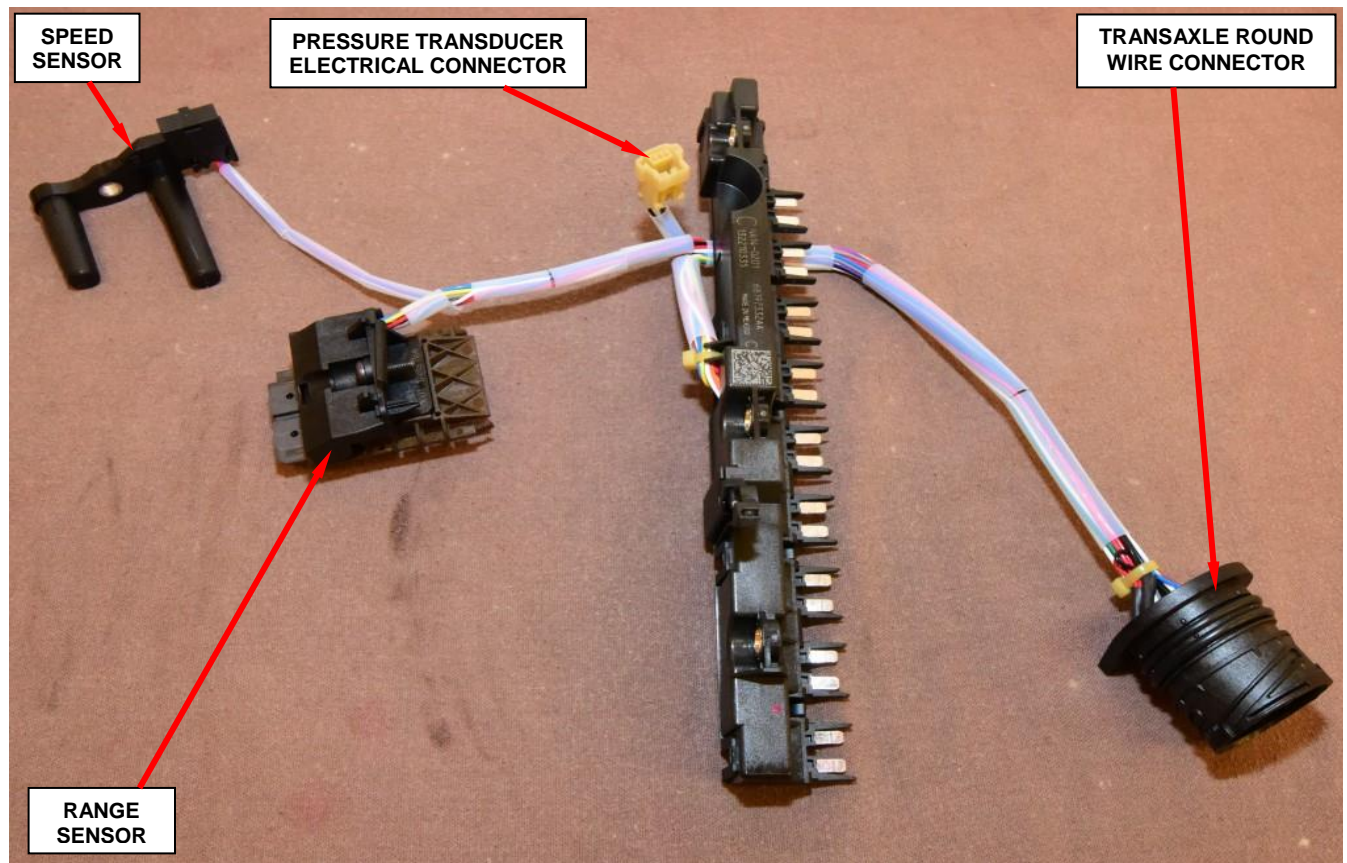
Figure 9 – Transaxle Range Sensor Wire Harness

The transaxle range sensor wire harness on about 323,400 of the above vehicles may have been built with insufficient wire terminal crimps. This may cause an intermittent high electrical resistance in the transaxle range sensor wire harness circuit(s). A high resistance circuit(s) in this transaxle range sensor wiring harness will cause the on-board diagnostic system to set a Diagnostic Trouble Code (DTC). When the DTC is set, the system defaults the transaxle to neutral and the customer experiences a loss of motive power. Motive power can usually be regained upon an engine restart. The loss of motive power could cause a crash without warning.

26. Remove and discard the original transaxle range sensor wire harness (Figure 9).
27. Place the new transaxle range sensor wire harness into position (Figure 9).
28. Install the three transaxle range sensor wire harness retaining screws (Figure 8). Tighten the screws to 50 in. lbs. (6 N·m).
29. Connect the electrical connector for the pressure transducer (Figure 9).
30. Replace both rubber O-rings on all the valve body fluid crossover tubes.
