## **IMPORTANT SAFETY RECALL**

### **NHTSA Recall Campaign # 16V555**

## Service Bulletin

### 503067 Rev. A

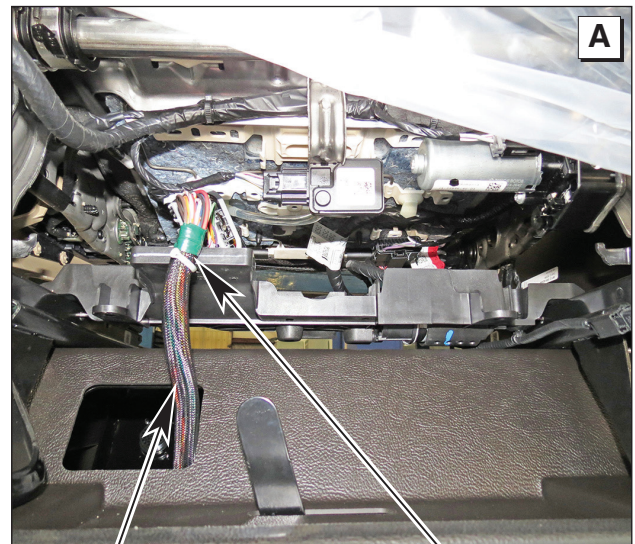
Harness must be secured at location shown in Photo A.

**Correct**

Harness Secured Here  
No Further Action Required

If harness is secured at location shown in Photo A, no further action is required.

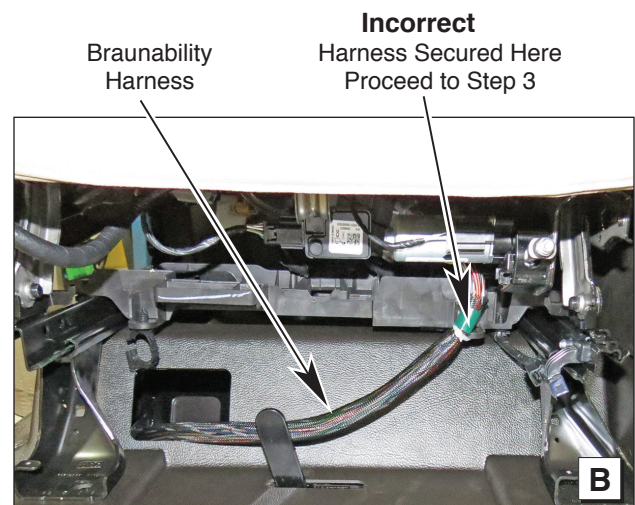
BraunAbility will be recalling certain Ford MXV® mobility conversion units manufactured from February 8, 2016 – June 23, 2016. The affected vehicles' passenger seat harness could be routed incorrectly, potentially crushing the harness between the OEM seat structure and the conversion's seat base. The consequence of the noncompliance could lead to loss of power seat function controls, seat temperature controls, supplemental restraint warning indicator activating, and possible inability to properly classify an occupant for correct airbag deployment.

**Incorrect**

Harness Secured Here  
Proceed to Step 3

If seat harness is secured at location shown in Photo B, proceed to Step 3.

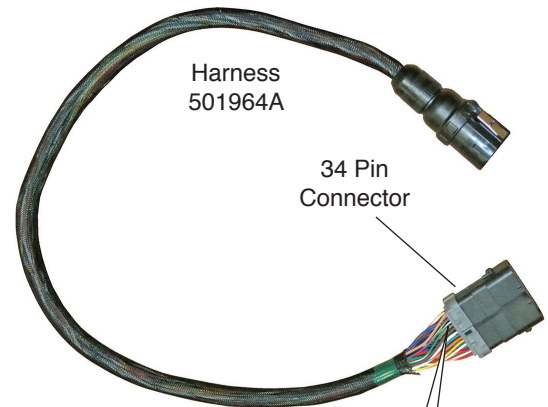
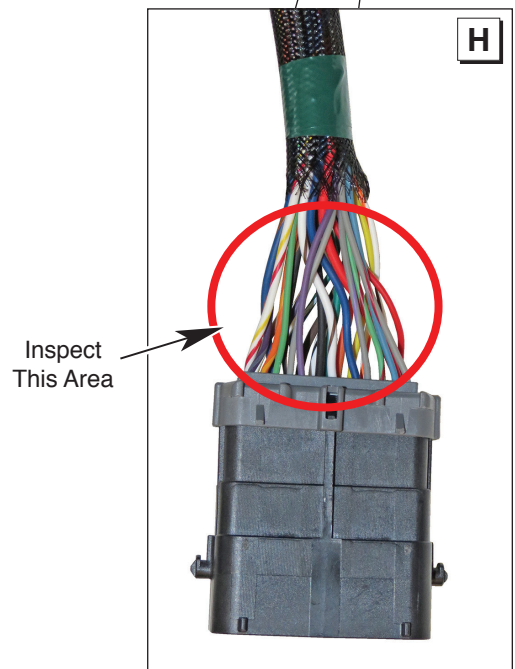
8. At 34 pin connector, inspect harness 501964A for damage. See Photo H.

If any wires are damaged, harness 501964A must be replaced with 16V555KS.

Note: If damaged, discontinue use of seat until harness is replaced.
