TO: All Mazda Dealership General Managers, Service and Parts Managers
DATE: October 2016
SUBJECT: 2009-2010 Mazda6 SAS Unit Concern – Safety Recall 9816H

**ATTACHMENT II
SAFETY RECALL 9816H**

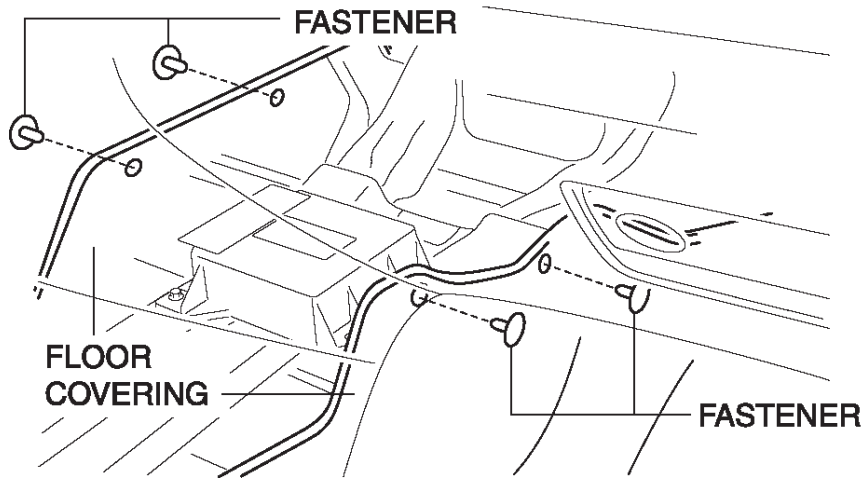
2. Switch the ignition to OFF.
3. Disconnect the negative battery cable and wait for **1 min or more**.
4. Remove the fasteners shown below and partially peel back the floor covering so that the SAS control module can be removed.

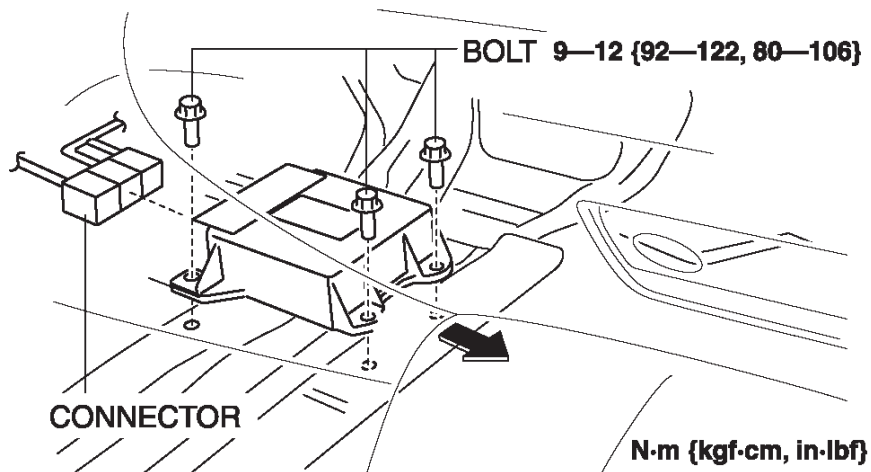
5. Disconnect the connector.
Remove the bolts and remove the SAS control module in the direction of the arrow shown below.

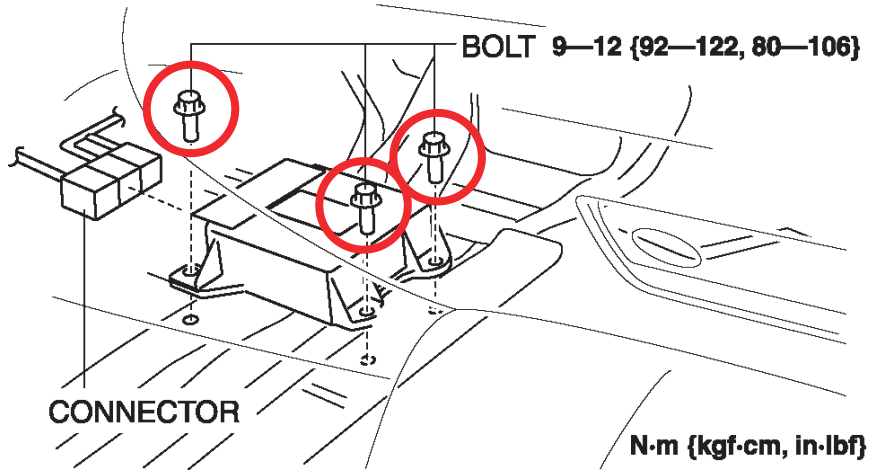
1. Install in the new SAS control module.
2. Install the bolts as shown below.

Tightening Torque: 80-106 in-lb (9 - 12 Nm)

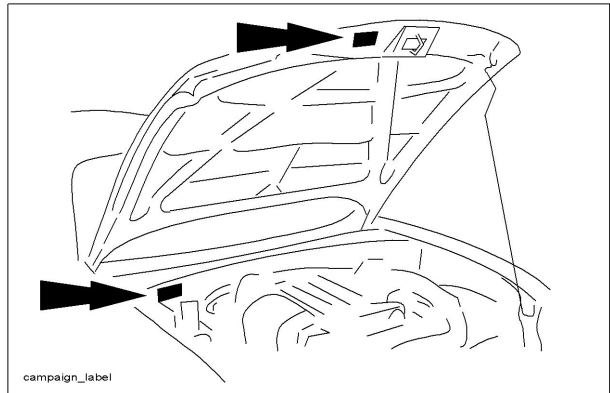
2. Affix the Campaign Label to the hood or bulkhead as shown:
