SAFETY RECALL

ABS Actuator

Voluntary Safety Recall Campaign

Reference: PC482

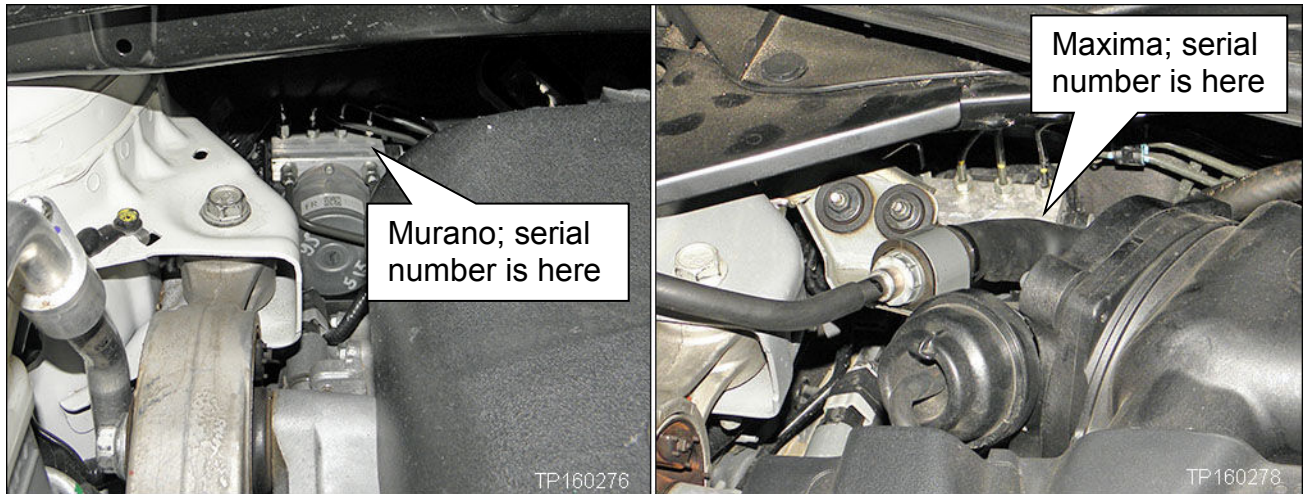
Figure 1

1. Open the engine hood and locate the ABS Actuator and Electric Unit (ABS control unit).
 - ABS control unit is on the passenger side of the engine compartment next to the engine wall Service Procedure.

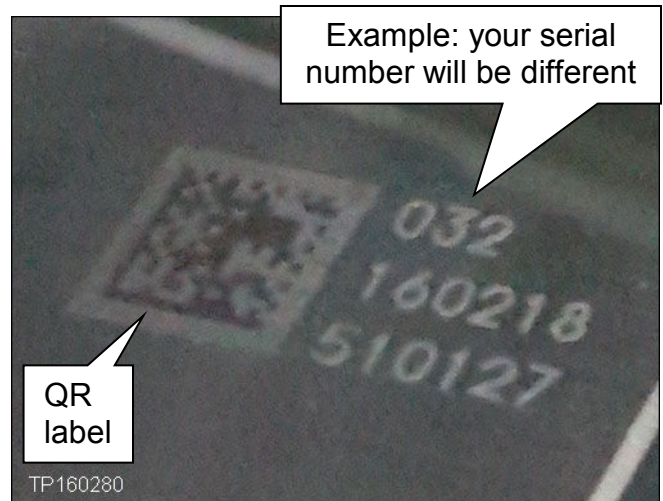
2. Locate the serial number on the top of the ABS control unit next to the QR label (see Figures 1 and 2).
 - If there is NO serial number (the area shown in Figure 2 is blank), **skip to step 9** for ABS control unit replacement.

3. Write the 15 digit serial number on the repair order.
 - In the **example** in Figure 2, the serial number is **032160218510127** (this is an example, your serial number will be different).

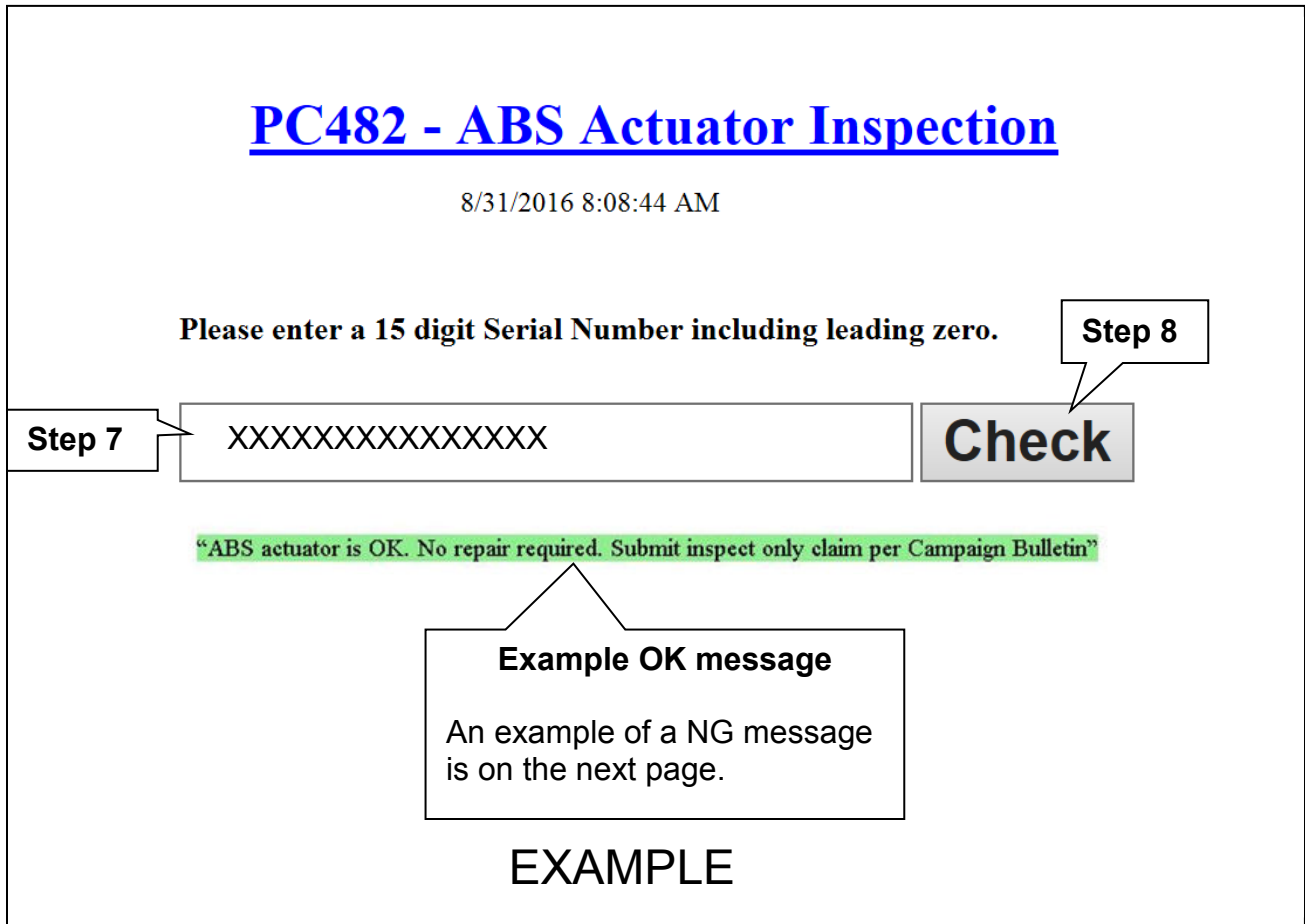
- If your ABS control unit (ABS Actuator) is OK, the **OK** message shown in Figure 5 will display.
- **The screen in Figure 5 showing the 15 digit serial number and the OK message, MUST be printed and attached to the repair order for warranty documentation.**

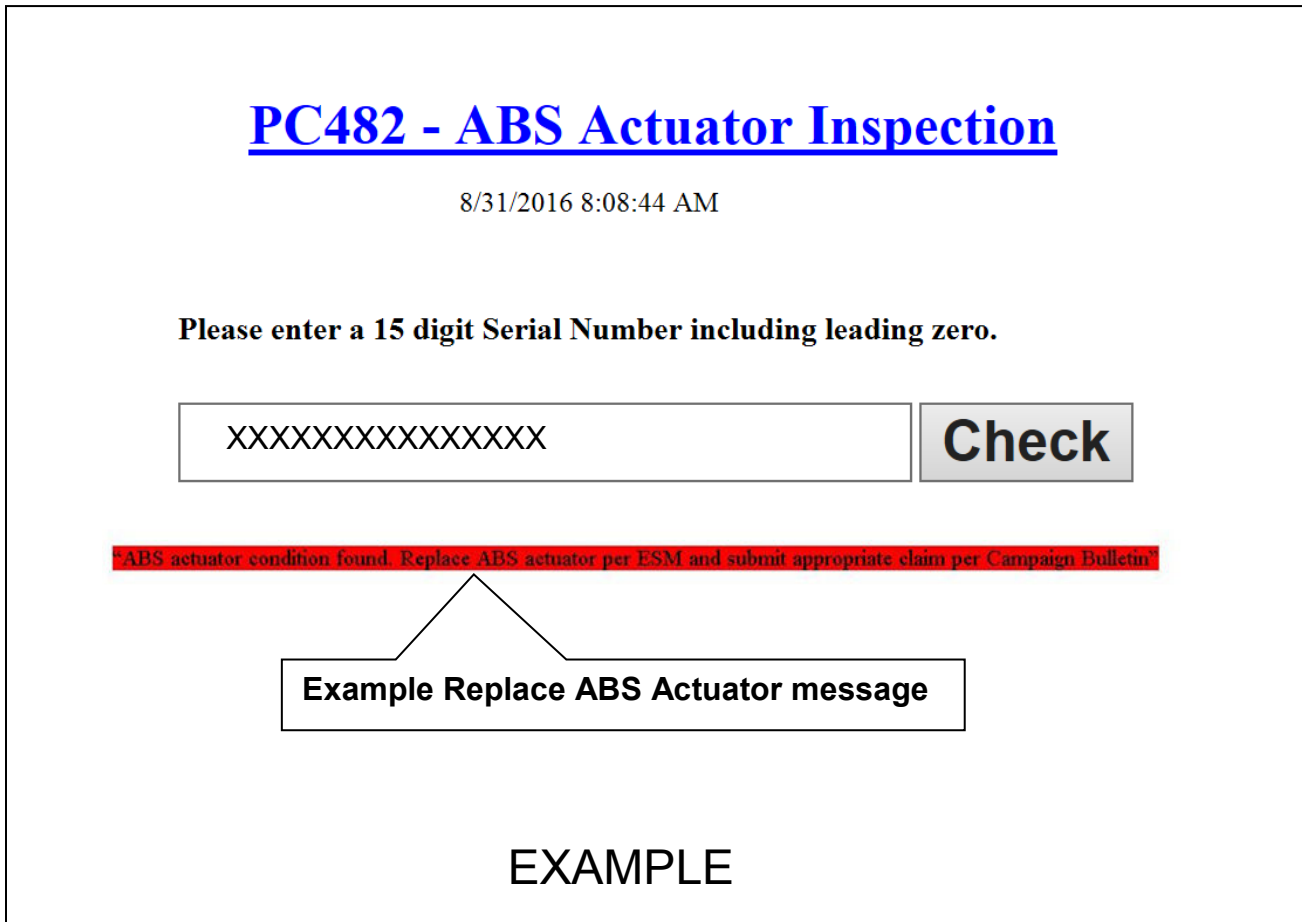
- If your ABS control unit (ABS Actuator) is NG, the **Replace ABS Actuator** message shown in Figure 6 will display.
- **The screen in Figure 6 showing the 15 digit serial number and the Replace ABS Actuator message, MUST be printed and attached to the repair order for warranty documentation.**

9. If the ABS Actuator and Electric Unit (ABS control unit) requires replacement:

- Refer to the Electronic Service Manual, section BRC-Brake Control System, for replacement information.

IMPORTANT: If there is a delay between inspection and replacement of the ABS control unit; disconnect the vehicle 12 volt battery, and leave it disconnected while the vehicle is parked waiting for service.
