November 2016
INT FL721-01
NHTSA #16V-656
Transport Canada #2016-441
INTERIM RECALL BULLETIN

Subject: CNG Fuel Tank and CPDM Mounting Location

Models Affected: Specific Freightliner Cascadia vehicles manufactured September 24, 2012, through May 27, 2015, built with CNG fuel tanks

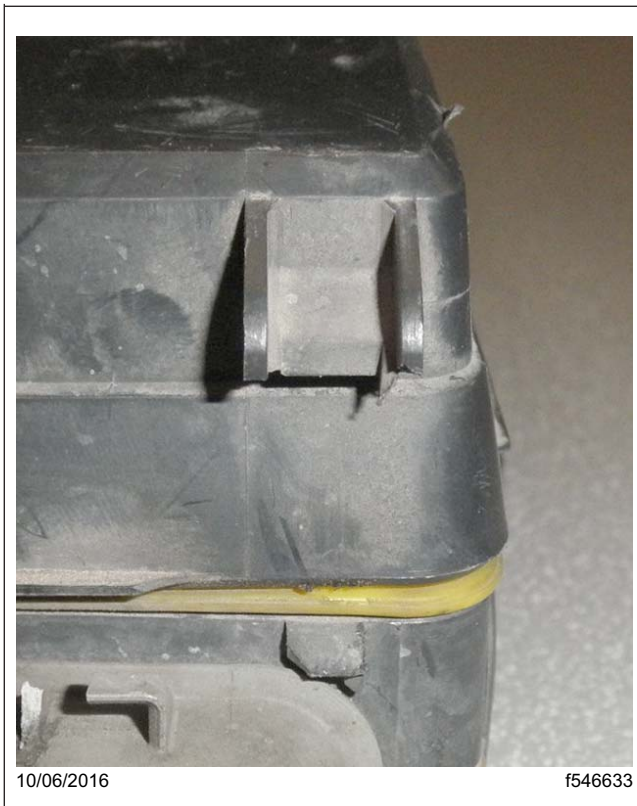
Fig. 1, Incorrect: Broken Latch Cover

2. Replace all covers that are missing completely, have cracks, or missing hinges/latches. See [Fig. 1](#) and [Fig. 2](#).

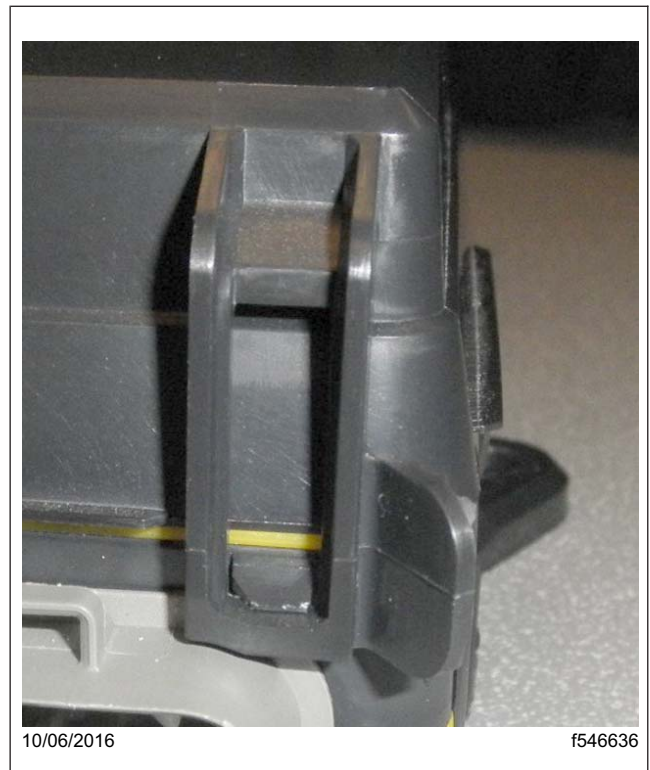
Fig. 2, Correct: Latch Cover Intact

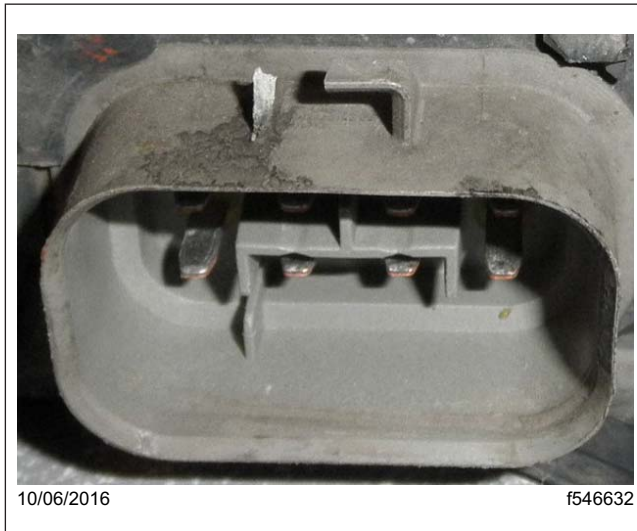
Fig. 3, Incorrect: Broken connector locking tab

Replace all CPDMs that lack the features mentioned above, or have visible damage like cracked cases or seals protruding. See **Fig. 3** and **Fig. 4**.

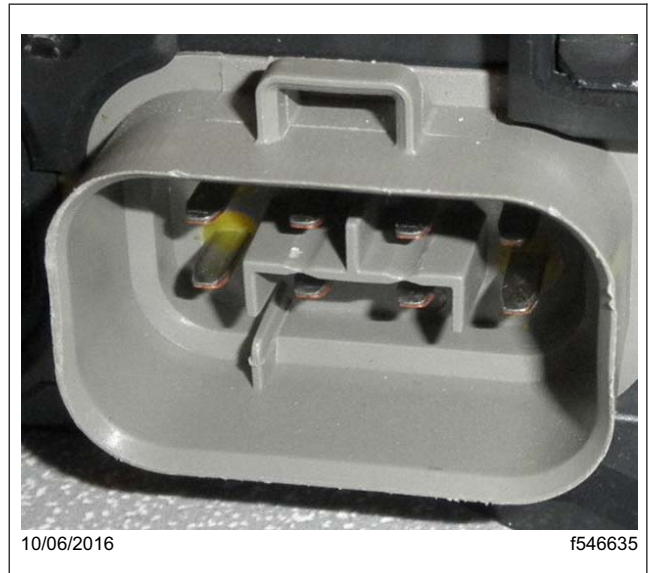
Fig. 4, Correct: Connector locking tab intact

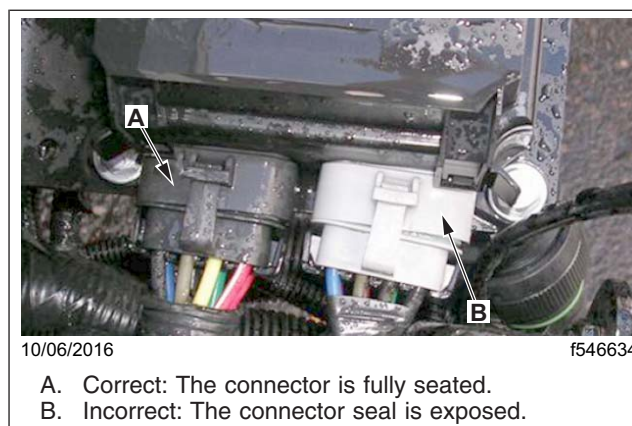
Fig. 5, CPDM Connectors

A. Correct: The connector is fully seated.
B. Incorrect: The connector seal is exposed.

2. Replace all connectors that are missing the latch barb or do not seal properly when connected. Make sure that the connector harness is secured properly and is not pulling on the connector (neutral harness tension). See **Fig. 5**.

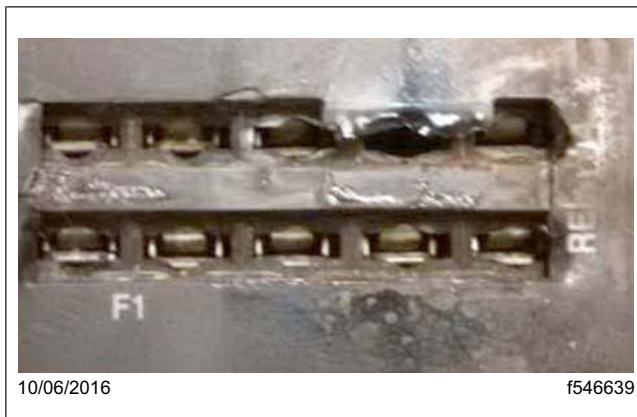
10/06/2016 f546639
Fig. 7, Incorrect: Heat damaged socket, debris accumulation

2. Remove and inspect the yellow case seal for damage.
Inspect the groove where the yellow seal attaches for cracks or breaks in the case.
Inspect the relays and fuses for signs of overheating.
Remove and replace each piece, one at a time.
Replace the CPDM if there is any sign of heat damage or water intrusion.

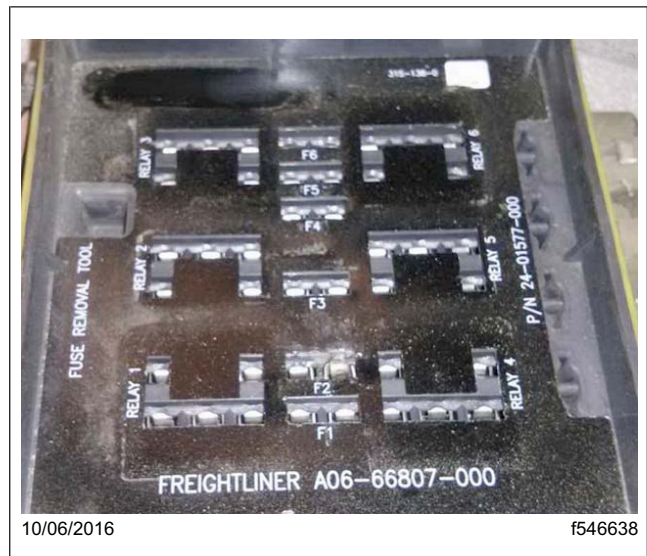
10/06/2016 f546638
Fig. 8, Incorrect: Heat damaged socket, debris accumulation

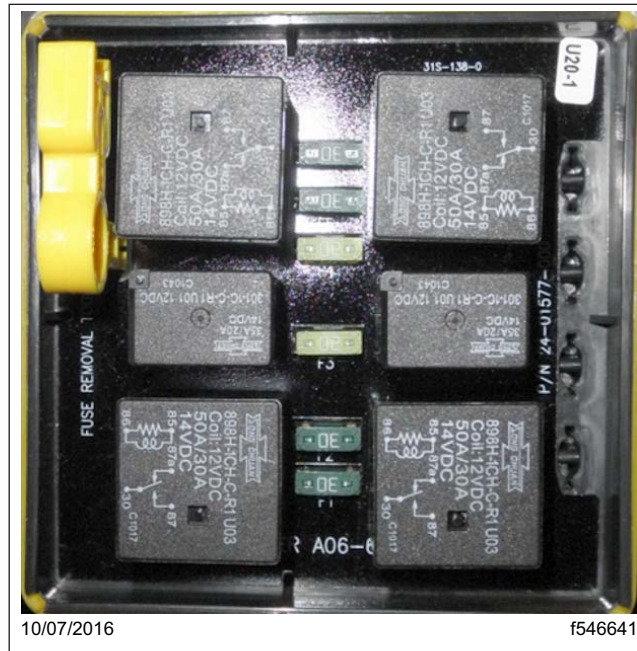
Fig. 10, Correct: No damaged socket or debris accumulation
