February 2017
FL721A-E
NHTSA #16V-656
Transport Canada #16-441
REVISED NOTICE

Subject: CNG Fuel Tank and CPDM Mounting Location

Models Affected: Specific Freightliner Cascadia vehicles manufactured September 24, 2012, through May 27, 2015, built with CNG fuel tanks

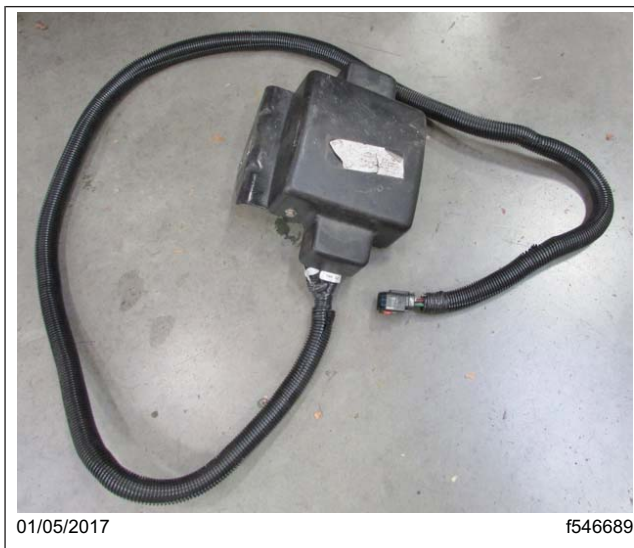
Fig. 29, CPDM Removed from the Vehicle

The chassis power distribution module (CPDM) is located at the back of the cab and beneath the compressed natural gas (CNG) fuel tank. Due to the location of the CPDM, it may be subject to higher than expected levels of water spray and contamination from the road, which may lead to localized melting or burning of the CPDM in close proximity to the CNG fuel tanks. This may increase the risk of a vehicle fire.

NOTE: The CPDM should be discarded after it is removed from the vehicle. It will not be used again.

36. Remove the CPDM from the vehicle. See [Fig. 29](#).
