February 2017  
FL721A-E  
NHTSA #16V-656  
Transport Canada #16-441  
FIFTH REVISED NOTICE

**Subject: CNG Fuel Tank and CPDM Mounting Location**

**Models Affected: Specific Freightliner Cascadia vehicles manufactured September 24, 2012, through May 27, 2015, built with CNG fuel tanks**

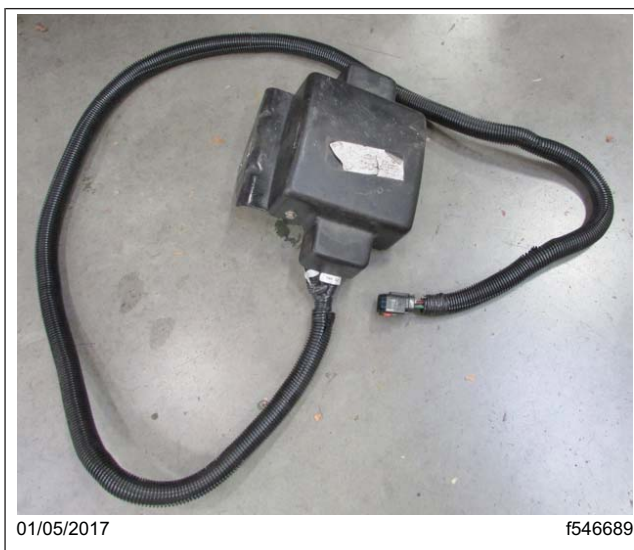
**Fig. 29, CPDM Removed from the Vehicle**

The chassis power distribution module (CPDM) is located at the back of the cab and beneath the compressed natural gas (CNG) fuel tank. Due to the location of the CPDM, it may be subject to higher than expected levels of water spray and contamination from the road, which may lead to localized melting or burning of the CPDM in close proximity to the CNG fuel tanks. This may increase the risk of a vehicle fire.

The CPDM will be removed and new wiring will be installed.

36. Remove the CPDM from the vehicle. See [Fig. 29](#).
