January 2017
FL722AB
NHTSA #16V-658
Transport Canada #16-442

Subject: Freightliner Brake Caliper Bolts

**Models Affected: Specific Freightliner 114SD and Business Class
M2 vehicles manufactured March 10, 2015, through July 7, 2016.**

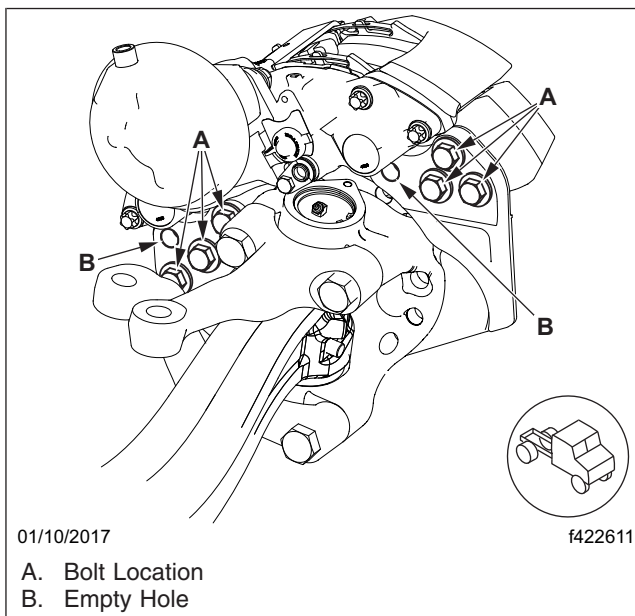
Fig. 1, Caliper Bolts, Front Axle

1. Raise the axle being serviced, and support it on a jack stand.
2. Remove the wheels. For instructions, refer to [Group 40](#) of the vehicle's workshop manual.
3. Inspect each brake caliper (front and rear) to make sure the caliper has all six caliper mounting bolts installed, that the bolts are all in the correct locations (see [Fig. 1](#) and [Fig. 2](#)), and that they are not loose.

If any of the bolts are in the wrong position, relocate them to the correct position.

- Using a 30 mm socket, tighten the six caliper mounting bolts using an inside out torque pattern to 400 ± 40 lbf·ft (543 ± 54 N·m). Use the special torque adaptor, (p/n 3256B1354), shown in **Table 3** where needed for access to the caliper mounting bolts. When using the special torque adaptor, use the settings shown in **Table 3**, for torque compensation.
