**SUBJECT:** **NEW VEHICLE DEMONSTRATION / DELIVERY HOLD**

**Compliance Recall 16C14 - Supplement #1**

Certain 2015-2016 Model Year Edge Vehicles Serviced with an Anti-Lock Brake System Repair

*Anti-Lock Brake System Module Inspection and Reprogram*

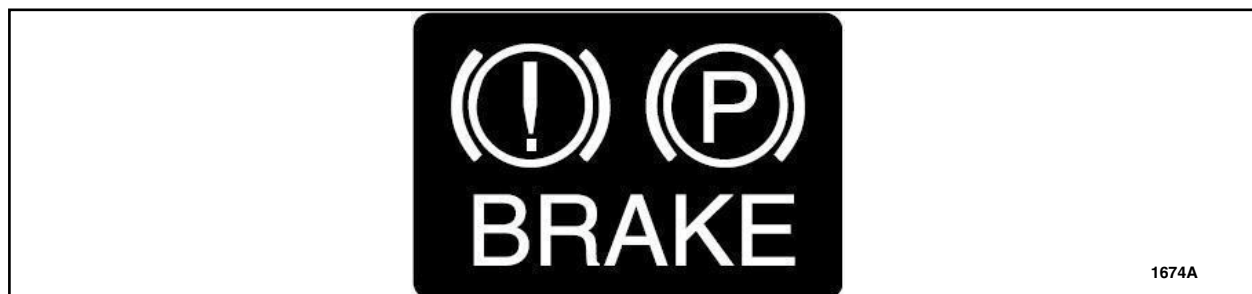
FIGURE 1

1. Apply the EPB and check the operation of the brake system warning lamp. See Figure 1.
  - If the brake system warning lamp **is** illuminated, the recall is complete, no further action is needed.
  - If the brake system warning lamp **is not** illuminated, *proceed to ABS Module Reprogramming*.
