SUBJECT: NEW VEHICLE DEMONSTRATION / DELIVERY HOLD

Compliance Recall 16C14

Certain 2015-2016 Model Year Edge Vehicles Serviced with an Anti-Lock Brake System Repair

Anti-Lock Brake System Module Repair

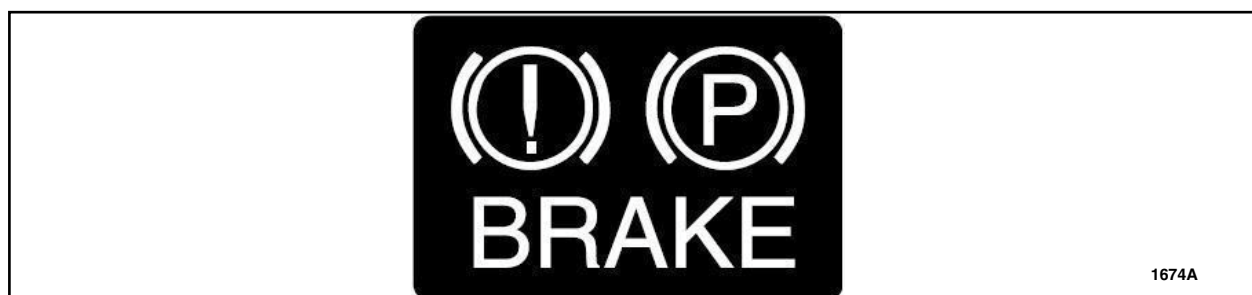
FIGURE 1

1. Apply the EPB and check the operation of the brake system warning lamp. See Figure 1.
 - If the brake system warning lamp **is** illuminated, the recall is complete, no further action is needed.
 - If the brake system warning lamp **is not** illuminated, proceed to ABS Module Replacement.

1. Prior to ABS Module replacement, ensure that the Integrated Diagnostic Software (IDS) is updated to release 102.02 or higher.
2. Replace the ABS Module. Please follow the Workshop Manual (WSM) procedures in Section 206-09.
3. Apply the EPB and recheck to verify brake system warning lamp illumination.
