October 27, 2017

SUBJECT: **Safety Recall 16S41 – Supplement #1**
Certain 2010-2012 Model Year Escape and 2010-2011 Model Year Mariner Vehicles
with a 3.0L Engine
Fuel Delivery Module Flange Replacement

CERTAIN 2010-2012 MODEL YEAR ESCAPE AND 2010-2011 MODEL YEAR MARINER VEHICLES WITH A 3.0L ENGINE — FUEL DELIVERY MODULE FLANGE REPLACEMENT

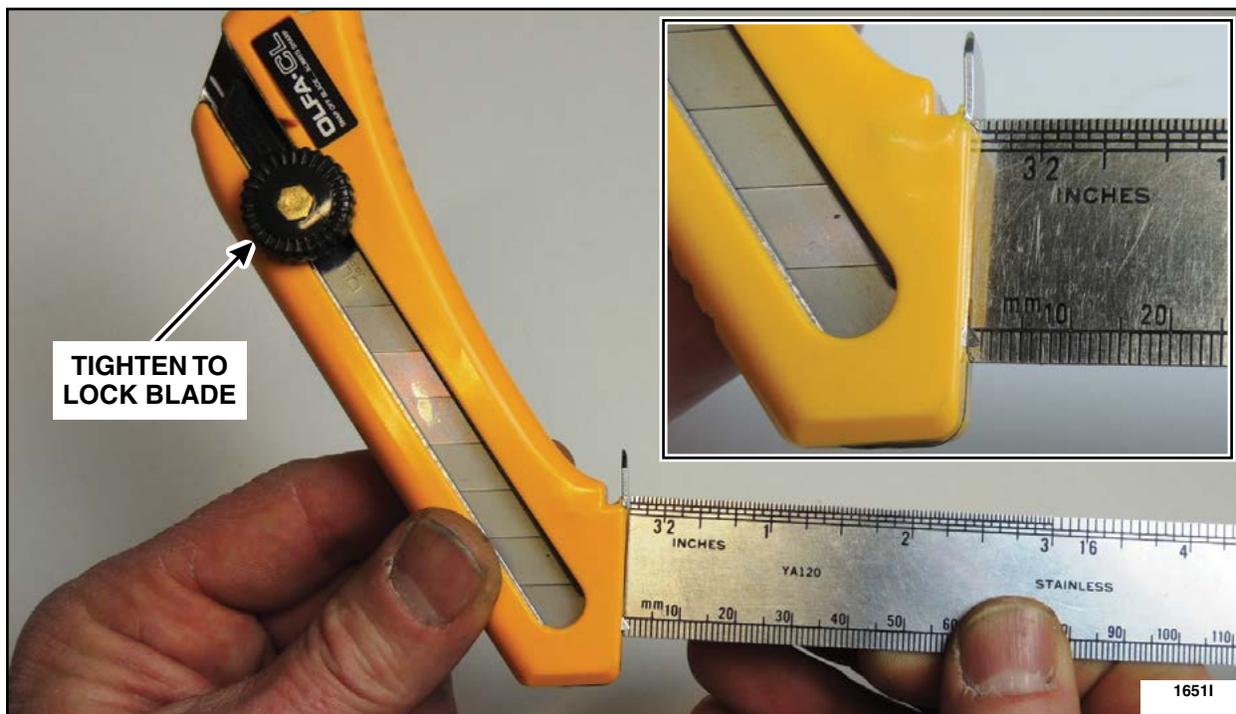
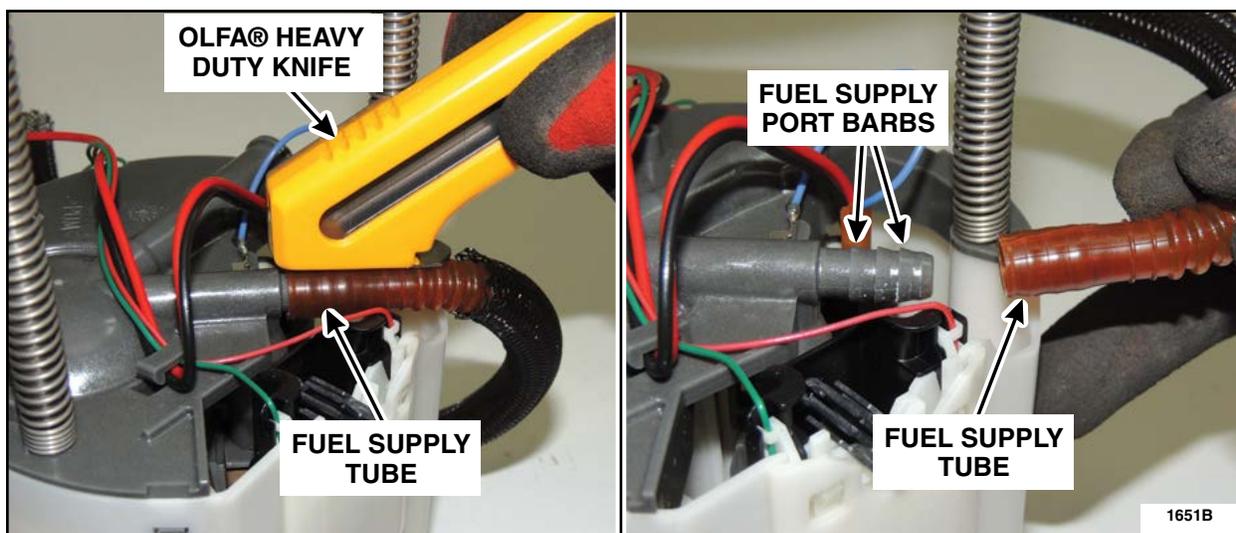
NOTE: Cut or damaged barbs on the fuel supply port may result in a long crank or hard start concern due to fuel pressure bleed down.

- Using an adjustable blade tool (Olfa® heavy duty knife shown) set to 1/16 in (1 mm) depth, carefully cut the fuel supply tube to release it from the supply port. See Figures 3 and 4.

NOTICE: Use caution not to cut or damage the barbs on the fuel supply port when cutting the fuel supply tube.

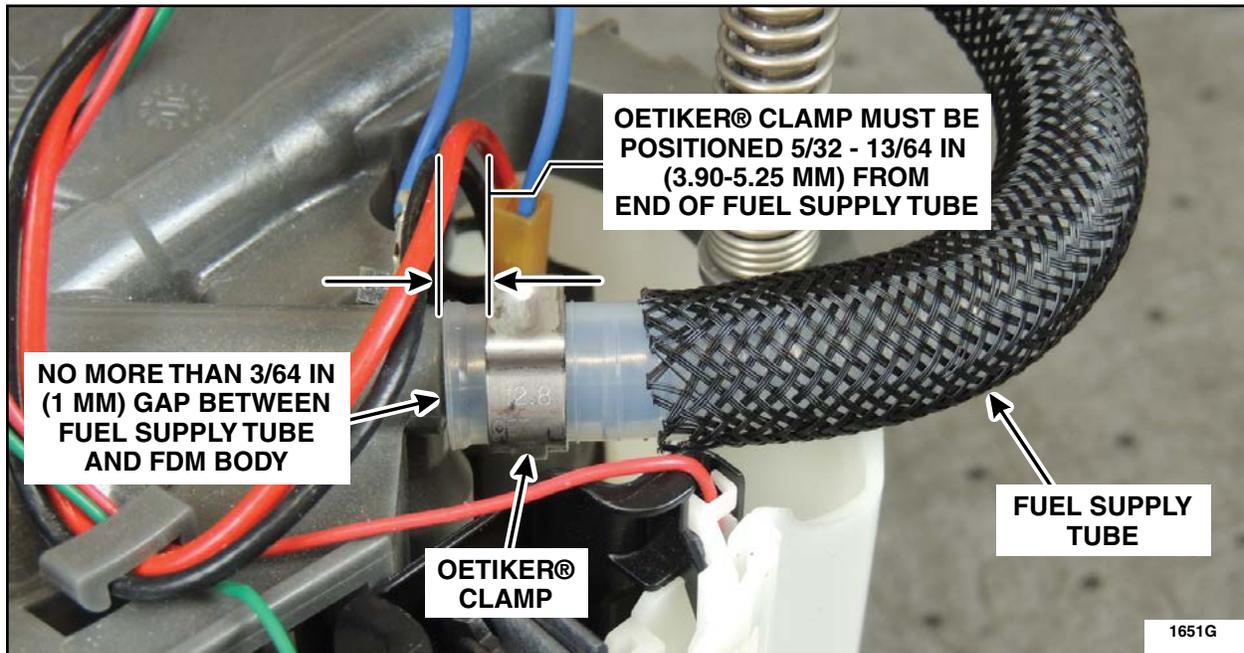
FIGURE 9

NOTE: The Oetiker® clamp must be positioned properly and tightened using Oetiker® clamp pliers only. Do not use side-cutter pliers to tighten the Oetiker® clamp. If the fuel supply tube or clamp are not positioned properly or the clamp is tightened using anything other than Oetiker® clamp pliers, this may result in a long crank or hard start concern due to fuel pressure bleed down.

9. Connect the new fuel supply tube to the supply port and tighten the Oetiker® clamp using Oetiker® clamp pliers. See Figure 9.
