December 2016  
FL727A  
NHTSA #16V-809

## **Subject: FCCC Motorhome Power Steering Hose Routing**

**Models Affected: Specific Freightliner Custom Chassis XBR, XCL,  
XCM, and XCR chassis equipped with Cummins ISL engines,  
and manufactured January 1, 2016, through October 13, 2016.**

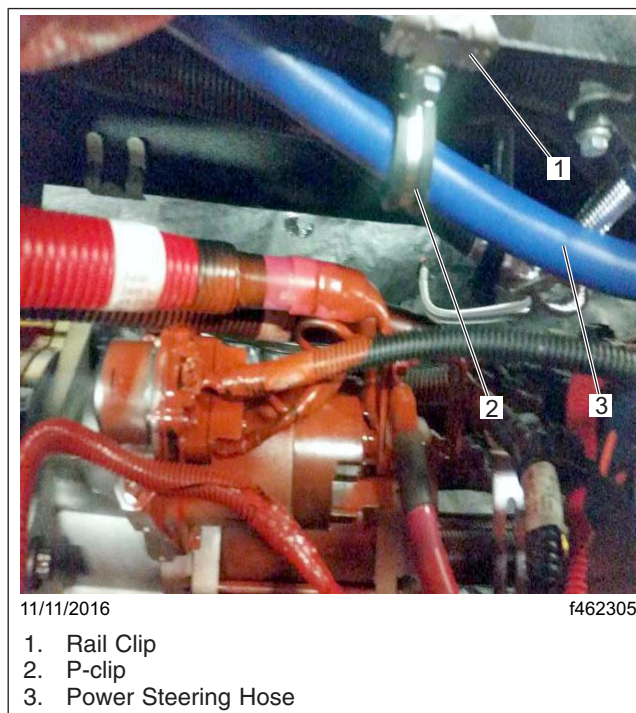
On certain motorhome chassis, the high pressure power steering hose may be routed with inadequate clearance between the hose and a power stud on the starter motor. This may cause the hose to chafe against the power stud on the starter, potentially leading to arcing and, in addition, may cause loss of fluid, short circuit, and melting. Electrical arcing in the presence of leaking power steering fluid can increase the risk of a fire.

**Fig. 1, Power Steering Hose with P-Clip (body removed for clarity)**

- 6.1 If the power steering hose is held with a P-clip near the starter stud, no work is needed. See [Fig. 1](#). Clean a spot on the base label (Form WAR259). Write the recall number, FL727, on a completion sticker (Form WAR260), and attach it to the base label.

1. Install a rail clip on the top flange of the frame rail, just above the starter.
2. Using a P-clip, bolt, nut, and washer, secure the power steering hose on the rail clip. See [Fig. 1](#). Tighten the nut 72 lbf-in (813 N-cm).
3. For additional security, install tie bands around the hose to the harness near the frame rail within 18 inches (46 cm) of the P-clip.
4. Clean a spot on the base label (Form WAR259). Write the recall number, FL727, on a completion sticker (Form WAR260), and attach it to the base label.
