**\* \* TECHNICAL INFORMATION NOTICE \* \***

**RE:** Second Repairs After Completion of Lift Gate Gas Spring Corrosion Safety Recall Campaign

**TIN NO.** TIN-16-SR-011-C

**AFFECTED VEHICLES:** Certain 2011, 2012, 2016 Outlander Sport

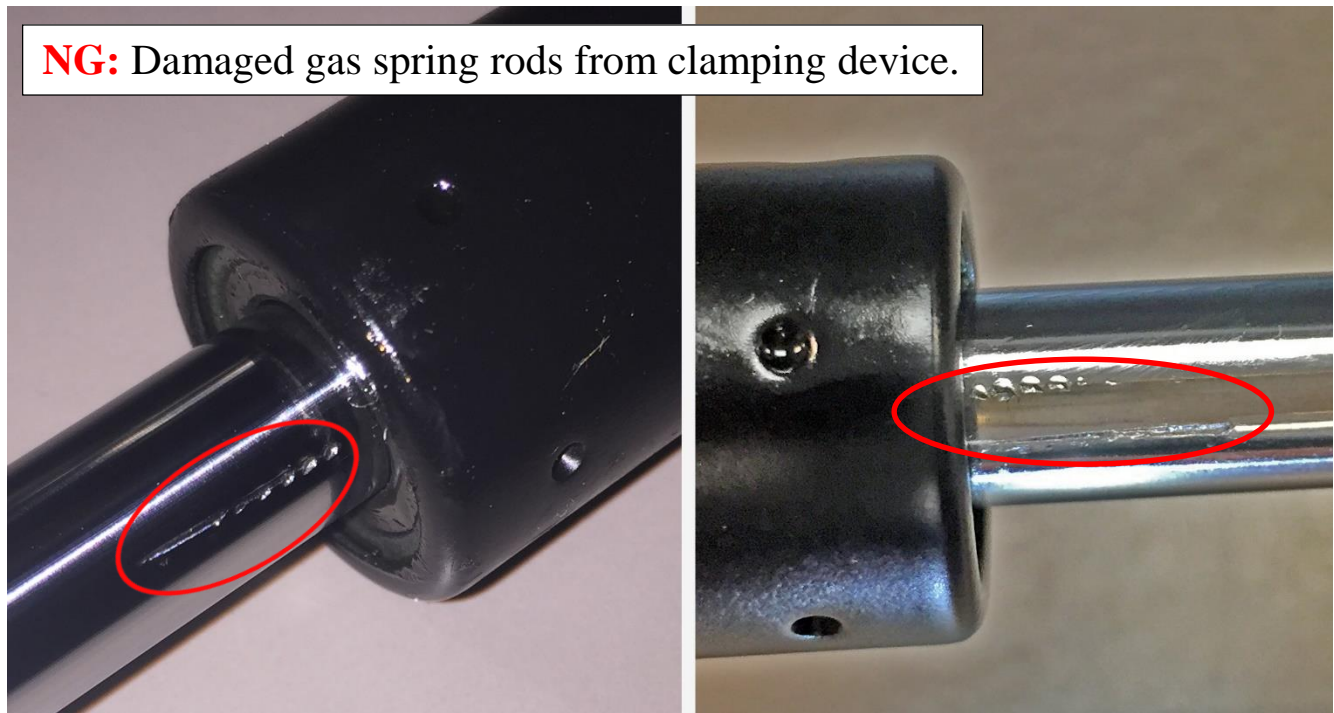
It has come to our attention that some dealership personnel may have been using vice grips or a similar clamping device on the new, replacement lift gate gas springs when performing this recall remedy. Mitsubishi Motors North America, Inc. (MMNA) would like to remind everyone that the procedures outlined in SR-16-011 (available on MEDIC and MDL) must be followed when performing this recall remedy. Clamping devices must **never** be used on the replacement lift gate gas springs. Usage of clamping devices on the replacement lift gate gas spring(s) could cause them to develop a leak.

Always properly support the lift gate prior to removal of the old lift gate gas springs. **Do NOT take any shortcut by clamping the lift gate gas springs.**
