SAFETY RECALL CAMPAIGNS 2A67 AND 2A68 CORRECT CKP SENSOR INSTALLATION

Affected Models: 2012-2016 DL650A/XA, 2016-2017 LT-A750X/XP

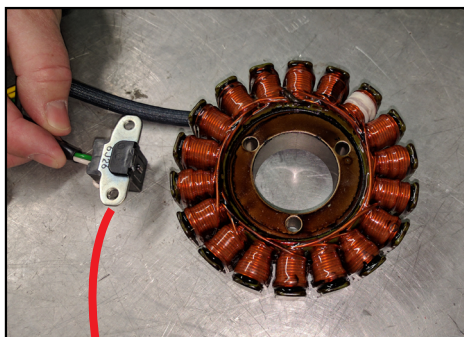
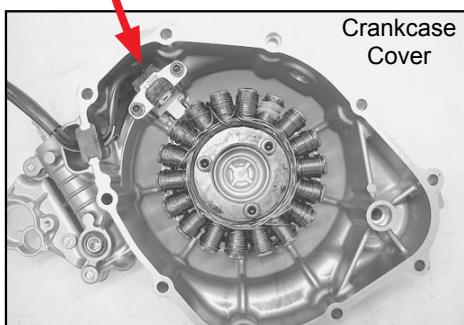
In the DL650X/XA, the CKP sensor's flat mounting plate must be positioned away from the crankcase cover.

Mounting plate is positioned away from the crankcase cover.

When disassembling the stator assembly in the DL650X/XA or LT-A750X/XP, be sure you look closely at how the CKP sensor is installed in the crankcase cover, then install the new CKP sensor in the same exact position.

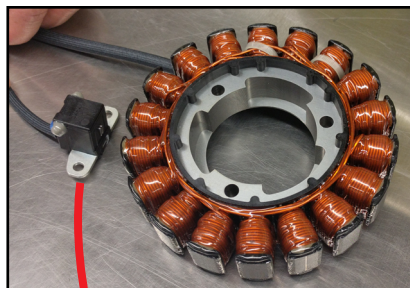
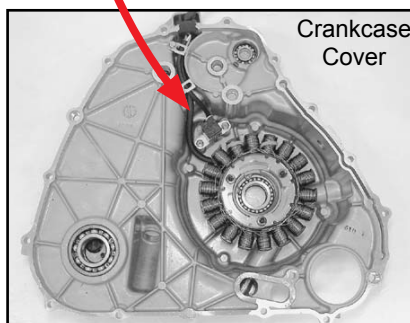
LT-A750X/XP

In the LT-A750X/XP, the CKP sensor's flat mounting plate must be positioned toward the crankcase cover.

Mounting plate is positioned toward the crankcase cover.
