Dealer Service Instructions for:

Safety Recall S92 / NHTSA 16V-947 Driver Airbag Inflator

2010	(DC) Dodge RAM 3500 Cab Chassis
2009	(HB) Dodge Durango
2009	(HG) Chrysler Aspen

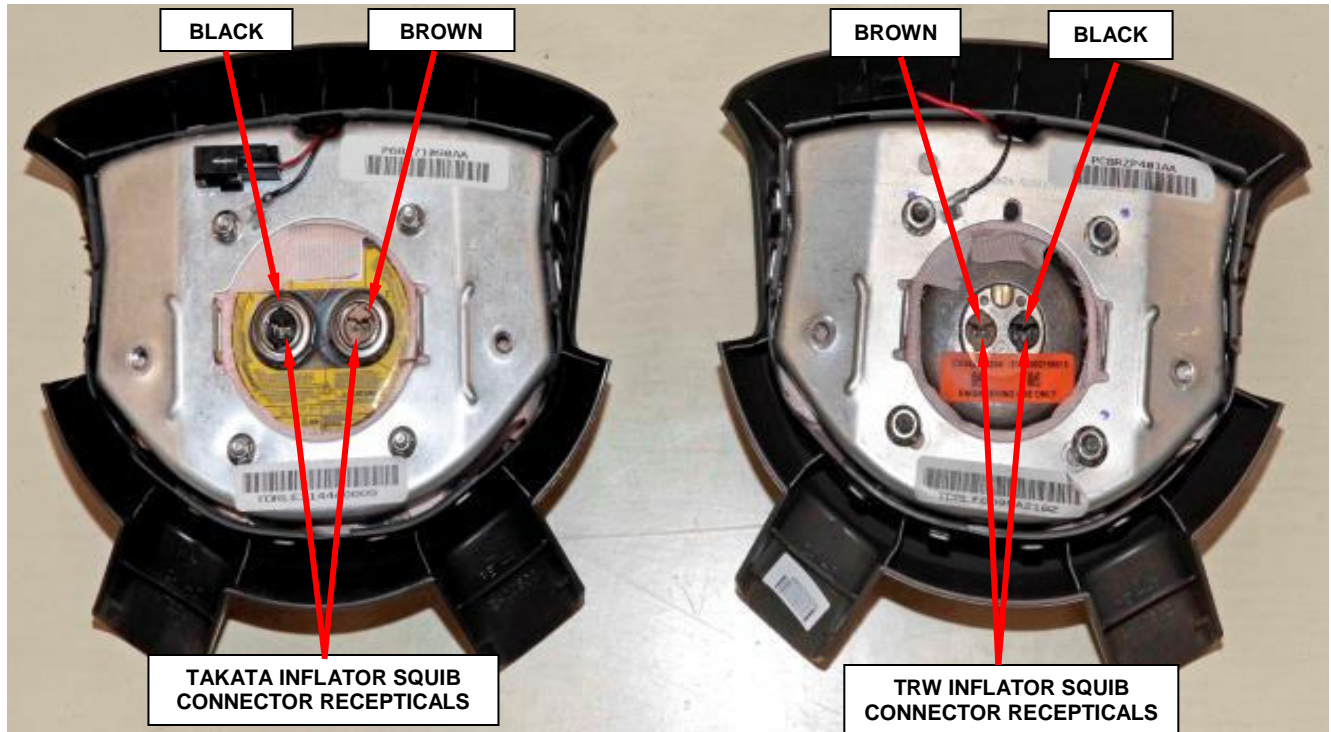
Figure 14 – Squib Connector Receptacles

NOTE: The squib connector receptacle locations on the driver airbag inflators are switched between the original Takata inflator and the TRW replacement inflator kits. Squib connectors are keyed and color coded for error proofing (Figure 14).
