Technical Service Bulletin

Ref: TSB 01-009-15 Date 9/2/15 Page 1 of 7

Subject: Potential improper securement of central steering ball joints.

Applies To: Commander Chassis with Reyco Granning IFS.

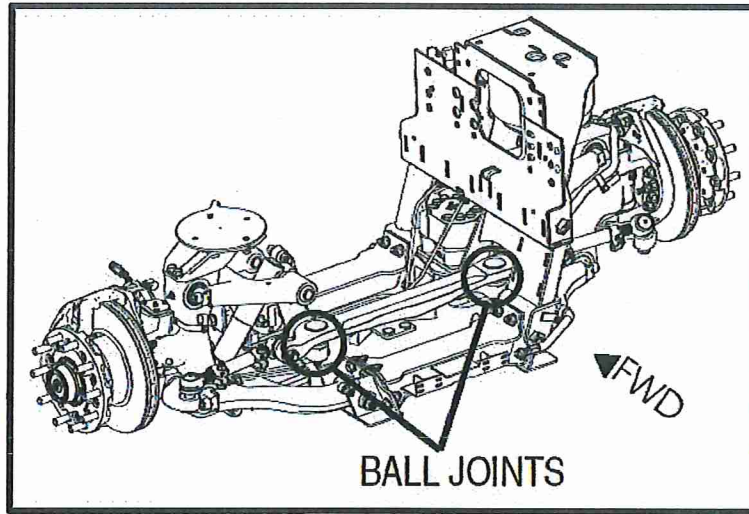
FIG. 2-1

1. Follow normal maintenance and safety procedures to gain access to the pitman arm ball joints. Refer to FIG. 2-1.

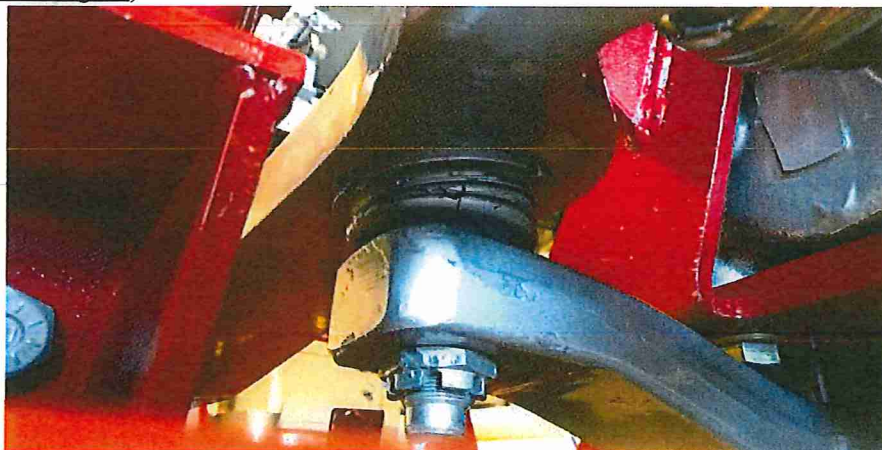
2. Visually inspect the ball joints located in pitman arms, the ball joints will be seated in both pitman arms off of the steering gears. The ball joint shall be fully engaged with the notched flange in contact with the spot face surface of the relay rod. If it is not, please proceed to the repair procedure. Refer to FIG. 2-2 and 3-1 (pictures may not represent suspension you are working on).

3. If the ball joint appears to be seated, using a 0.001 inch feeler gauges to check under the notched flange. If the feeler gauge slides under the flange, please proceed to the step by step instructions.
4. With a punch and hammer use moderate force in an effort to tighten the ball joint in place (clockwise). If it moves proceed to the step by step instructions. If it is tight this will finish the inspection and vehicle can be returned to service.
