IMPORTANT SAFETY RECALL NOTICE

Notice: Defect Information Report relating to drive axles with improperly torque hex nuts.

NHTSA File: 15E-065

TB0018 - Checking the Flange Yoke Bolt Torque on Marmon-Herrington Drive-Steer and Rear Drive Axles

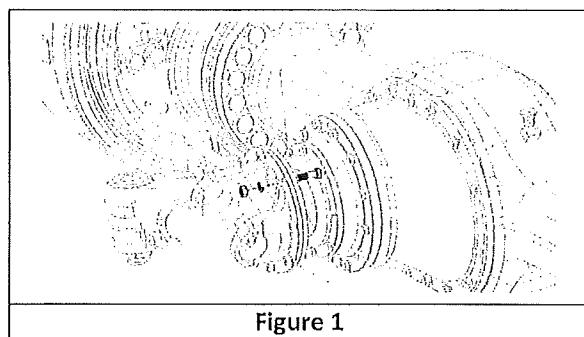
Approximately 377 of a 525 axle lot are equipped with hex nuts on the flange yoke that may not have been properly tightened. If the hex nuts are not tightened to specification, the driveshaft may disconnect from the drive axle, resulting in a loss of propulsion and increasing the risk of a crash.

1. Wear safety glasses. Park the vehicle on a level surface
2. Block the wheels and perform necessary lockout/tagout procedures.
3. Locate the eight (8) 3/8" bolts at the flange yoke joint (Figure 2).

This technical bulletin provides instructions to check torque and, if required, tighten the flange yoke bolts on MT14, MT17, MT22, R17 and R22 axles.

The flange yoke bolts may be tightened to the proper torque without replacement. If replacement bolts, washers or nuts are needed, contact Marmon-Herrington at (800) 227-0727.
