SAFETY RECALL NOTICE

IMPORTANT SAFETY RECALL RVXX1603 NHTSA RECALL # 16V-097 FINAL SOLUTION

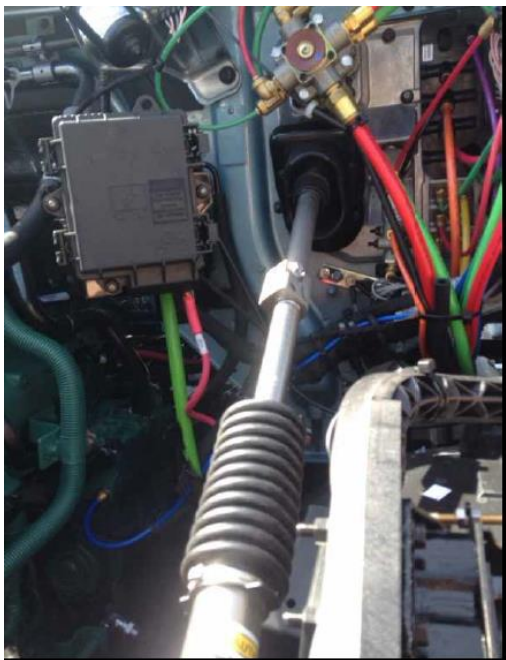
Pictures to be able to identify a two-piece shaft design

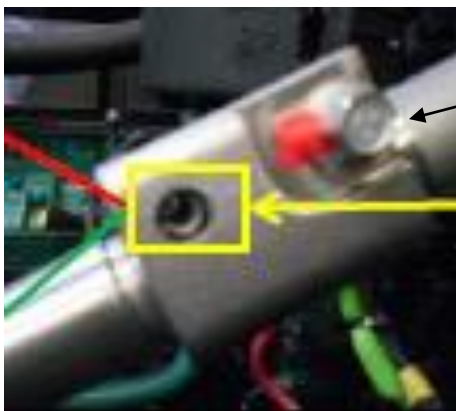
SAFETY DEFECT: The bolt connecting the upper steering shaft to the lower steering shaft at the junction block may not properly secure the upper steering shaft. Also the roll pin that secures the lower shaft may have not been installed.

Two piece shaft design
