**IMPORTANT SAFETY RECALL SC0402
NHTSA RECALL # 16V-156**

Mack Trucks, Inc. has decided that a defect, which relates to motor vehicle safety, exists in certain 2016 and 2017 Mack Titan model trucks manufactured from February 25, 2015 through February 12, 2016 with a 2 piece steering shaft.

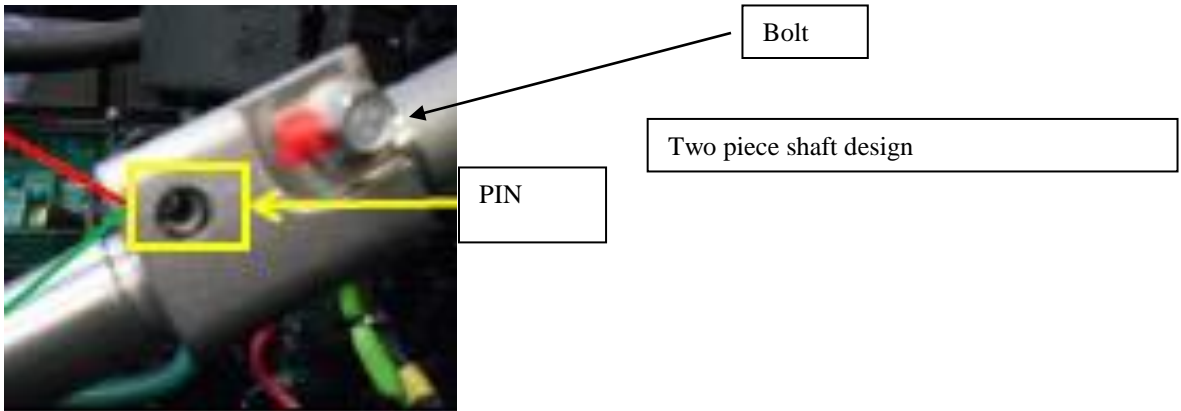
Picture to be able to identify a two-piece shaft design

SAFETY DEFECT: The bolt connecting the upper steering shaft to the lower steering shaft at the junction block may not properly secure the upper steering shaft.

Open the hood and look at the steering shaft. The shaft is a two-piece design if it has the junction block in the picture.
