IMPORTANT SAFETY RECALL
NHTSA Recall# 16V-659

Converter Dolly Inspection

TECHNICAL BULLETIN

Subject: **Converter Dollies**

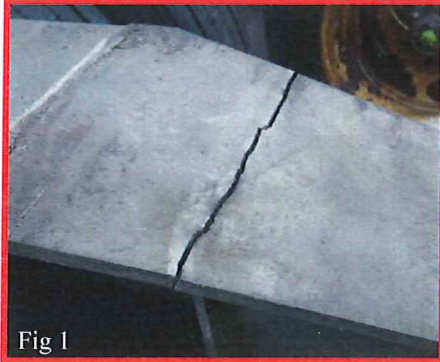
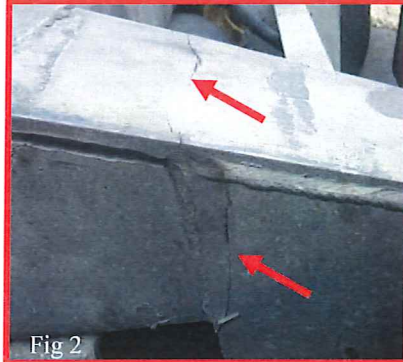
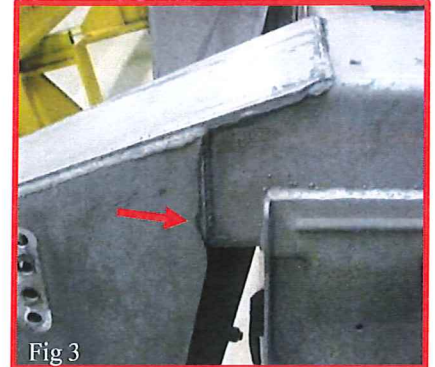
Issue Overview: Cracked dolly counterbalances (Fig 1-3). The failure of this connection is progressive in nature and inspection is required until units can be repaired.

Cracked counterbalance

- Inspect counterbalance connections for cracks (Fig 4). Dollies with cracks across top plate are to be taken out of service immediately until repairs can be made (Fig 1). These units need to be transported on flatbed to repair location.
- Outboard vertical side welds can be temporarily repaired to get units to a repair location, coordinated with WNC Warranty.
- Temporary repairs still require a final repair as soon as possible.

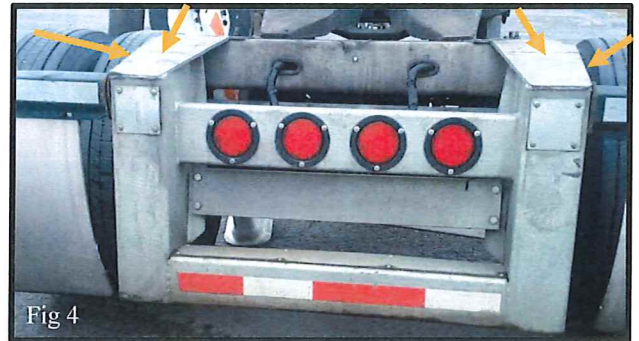
Arrows indicate areas of inspection

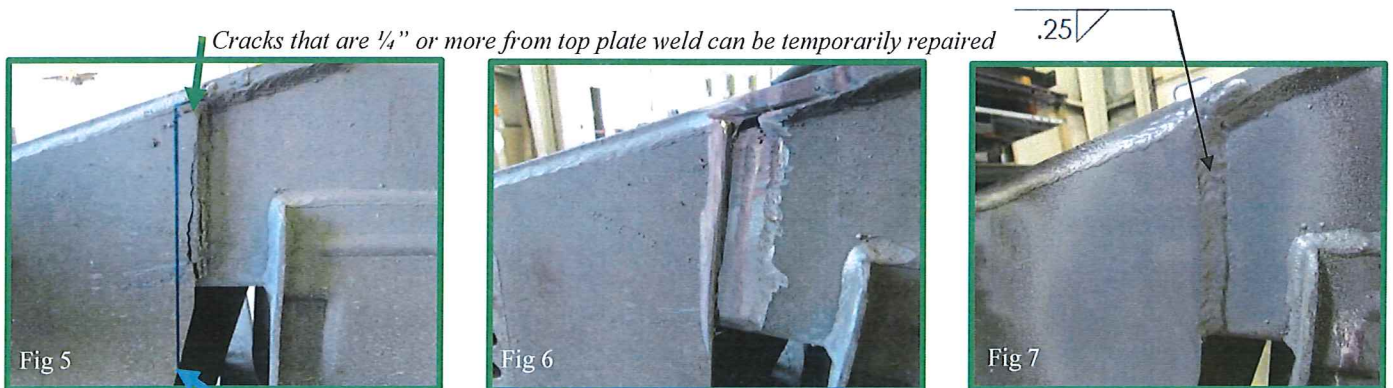
Regardless of crack length, grind to new material behind crack and through entire vertical leg. See cut line

- If crack is present only on outboard vertical weld, unit can be temporarily repaired by grinding out the entire crack. Care must be taken not to grind into top cap. Any notch to top plate must be welded and ground smooth. Grind vertical line down through entire leg (Fig 5 & 6). Re-weld with a *vertical up joint* (Fig7).
- Then coat the repair with cold galvanization.
