REPAIR DOCUMENT

Ag Hopper Trailer – Hopper Side Slope Panel to Lower Rail Connection – Recall Remedy

Repair Document #: **RD-00056**

US NHTSA Recall No. 16V050

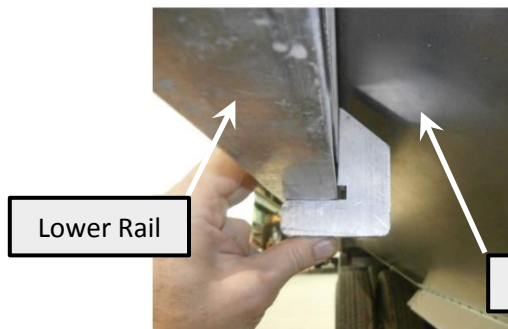
Condition #1 - Desired Result

Above figure shows the template up tight against the bottom of the lower rail prior to hitting the hopper tub.

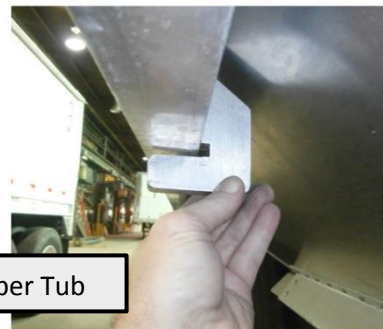
Condition #2 - Un-Desired Result

Above figure shows the template up against the bottom of the hopper tub prior to hitting the bottom of the lower rail.

Any trailer that fits condition #2 of the Hopper Side Slope Panel to Lower Rail fit inspection must have additional fasteners added per the procedure described below.

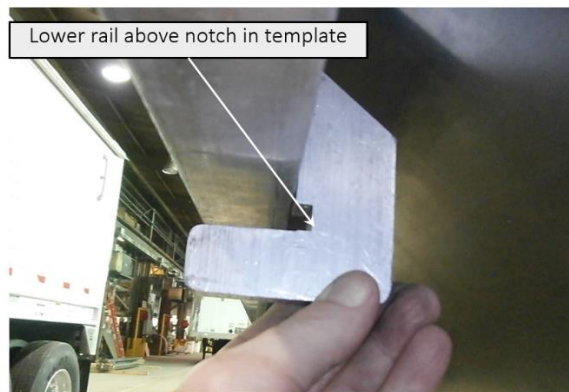
Condition #3

Above figure shows the template up against the bottom of the hopper tub and the lower rail above the notch in the template. If this condition is found, PLEASE CONTACT STOUGHTON TRAILERS CUSTOMER SERVICE for further instructions.

If condition #3 is found on any trailer during the Hopper Side Slope Panel to Lower Rail fit inspection, please contact Stoughton Trailers Customer Service for further instructions
