SIB 65 14 16

2019-10-25

**RECALL 16V-071: DRIVERS FRONT AIR BAG MODULE E70 (X5) E71 (X6) E72 (X6 HYBRID)**

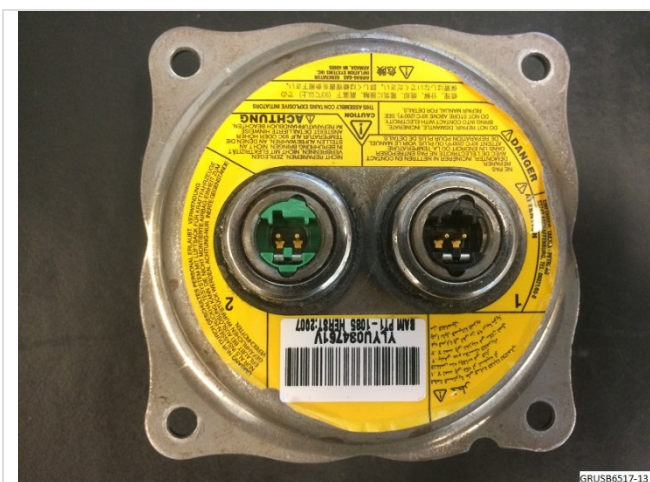
The Repair Kit gas generator P/N 32 30 6 884 813 is installed utilizing the existing wiring harness in the vehicle.

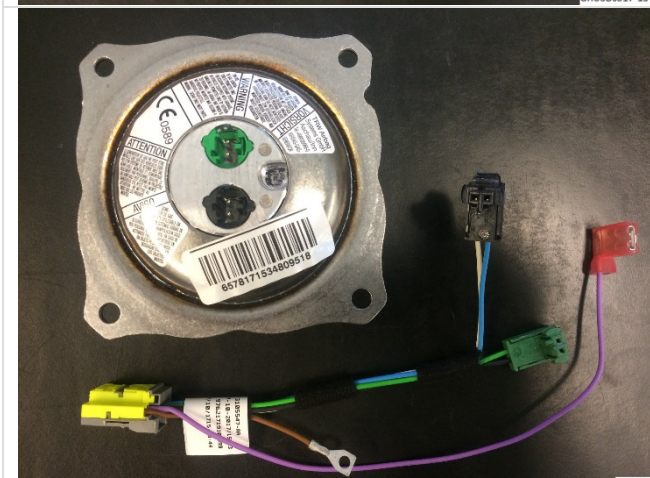
The new Repair Kit gas generator P/N 32 30 6 888 429 is installed utilizing a new jumper wiring harness that is installed between the generator and the steering wheel assembly.

Note: This harness **MUST BE USED** with this generator!

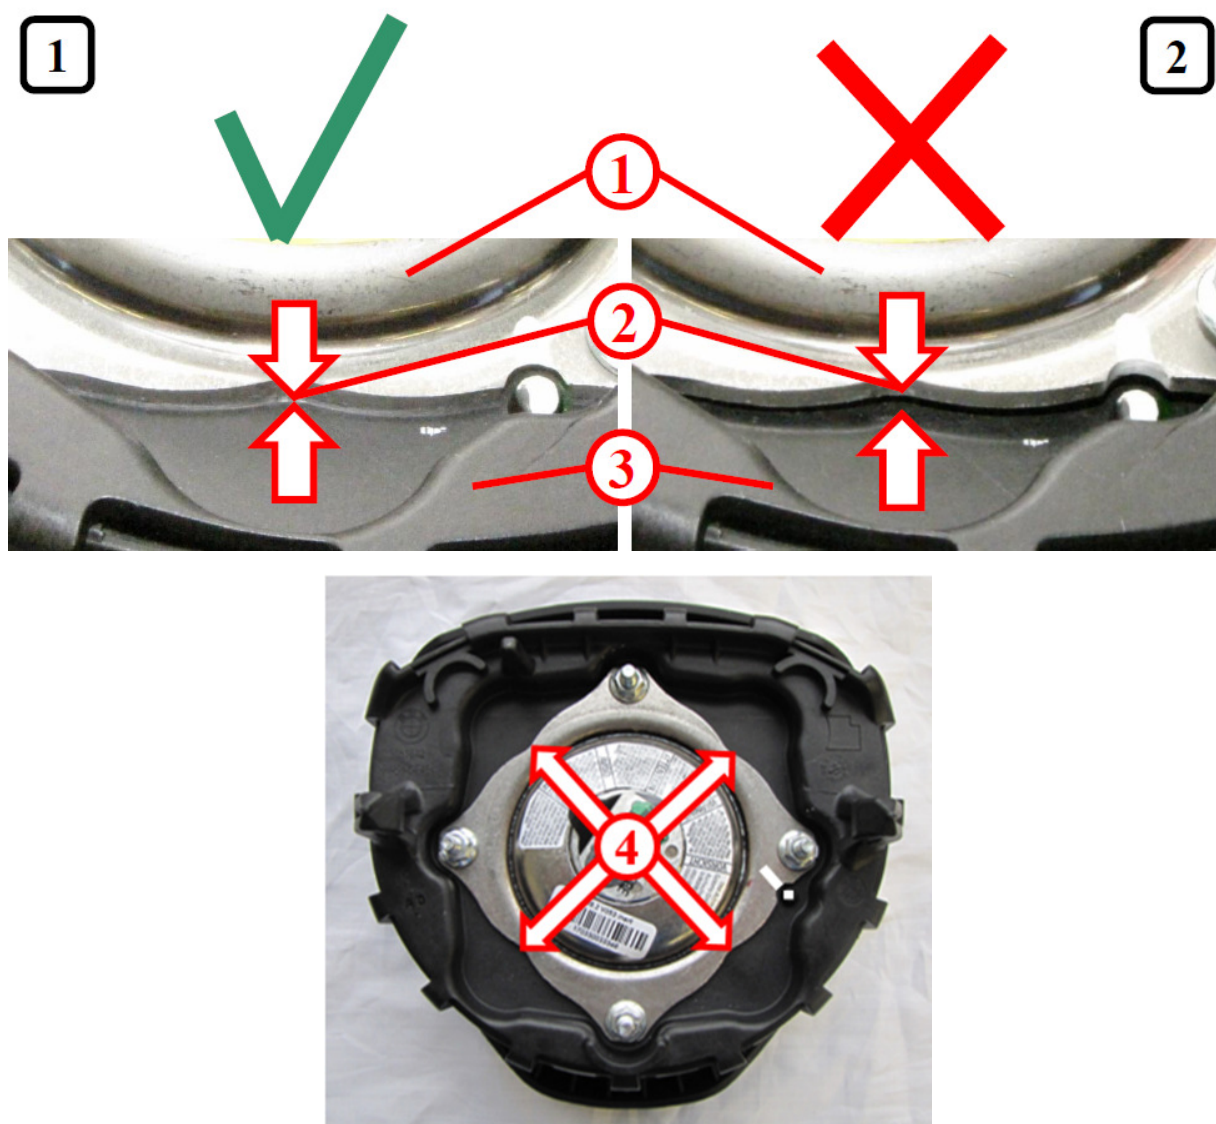
[17]

Perform a visual inspection of the gap (2) between the Generator (1) and the Air Bag (3) on all four sides of the Generator (4).

Picture (2) shows an improperly installed Generator with an excessive gap (2).

**ATTENTION:** If the gap cannot be closed up then cancel this procedure and replace the entire Air Bag assembly.
