Recall Campaign 16V-071: Driver's Front Air Bag Module

This Service Information Bulletin (Revision 9) replaces SI B65 04 16 **dated August 2017**.

SITUATION

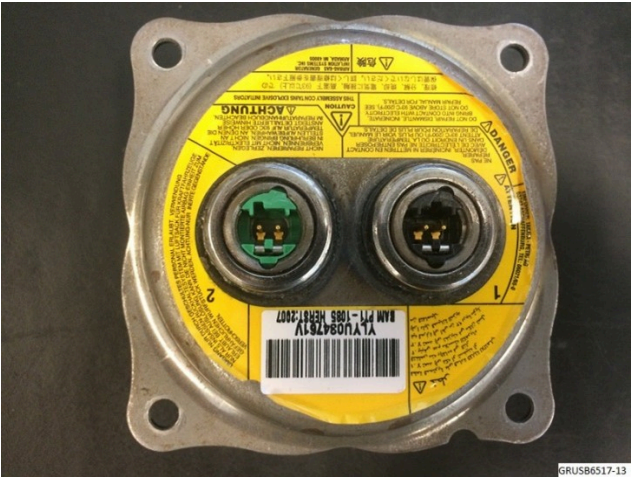
| | <p>The Repair Kit gas generator P/N 32 30 6 884 813 is installed utilizing the existing wiring harness in the vehicle.</p> |

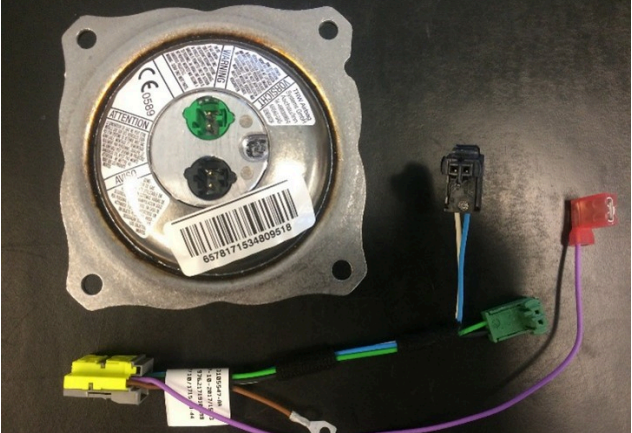
| | <p>The new Repair Kit gas generator P/N 32 30 6 888 429 is installed utilizing a new jumper wiring harness that is installed between the generator and the steering wheel assembly.</p> <p>Note: This harness <b>MUST BE USED</b> with this generator!</p> |

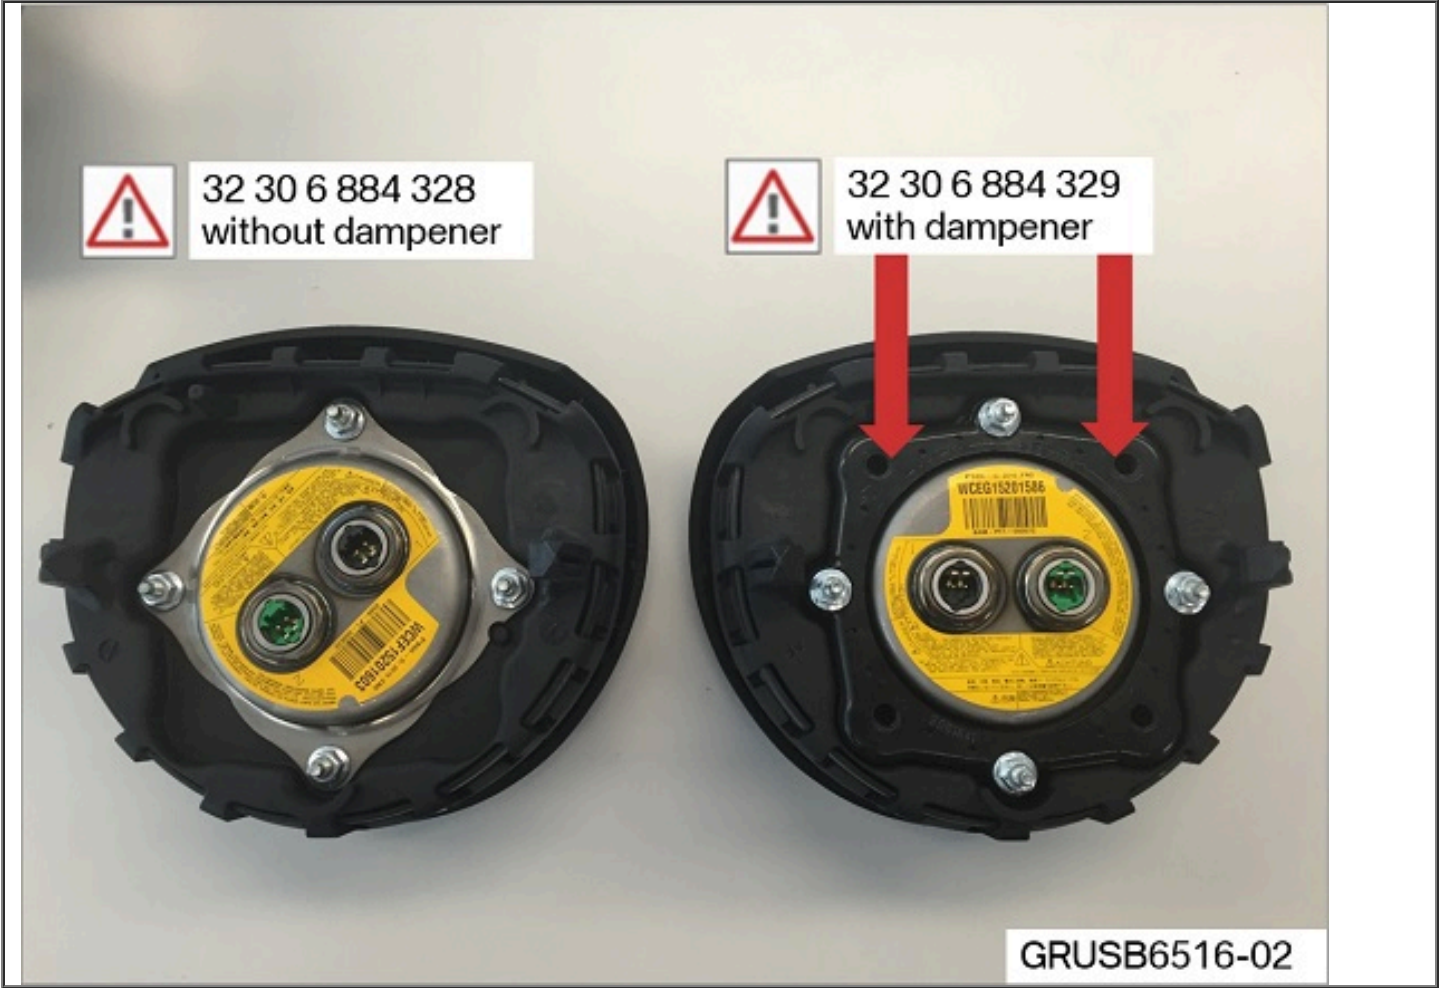
**Note: The original part removed from the vehicle may not exactly visually match the replacement part. This applies to vehicles originally equipped with or without a dampener. Refer to the photos below:**
