SI B65 14 16
Audio, Navigation, Monitors, Alarms, SRS

Recall Campaign 16V-071: Driver's Front Air Bag Module E70 E71 E72 E84

This Service Information bulletin replaces SI B65 04 16 **dated May 2016** for E70 E71 E72 E84 vehicles.

BMW AG is conducting a Voluntary Safety Recall involving Driver's Front Air Bag Module on certain BMW vehicles that are equipped with non-desiccated Takata PSDI-5 inflators. These vehicles, covering model years 2006-2015 have not been part of earlier Takata-related air bag recalls.

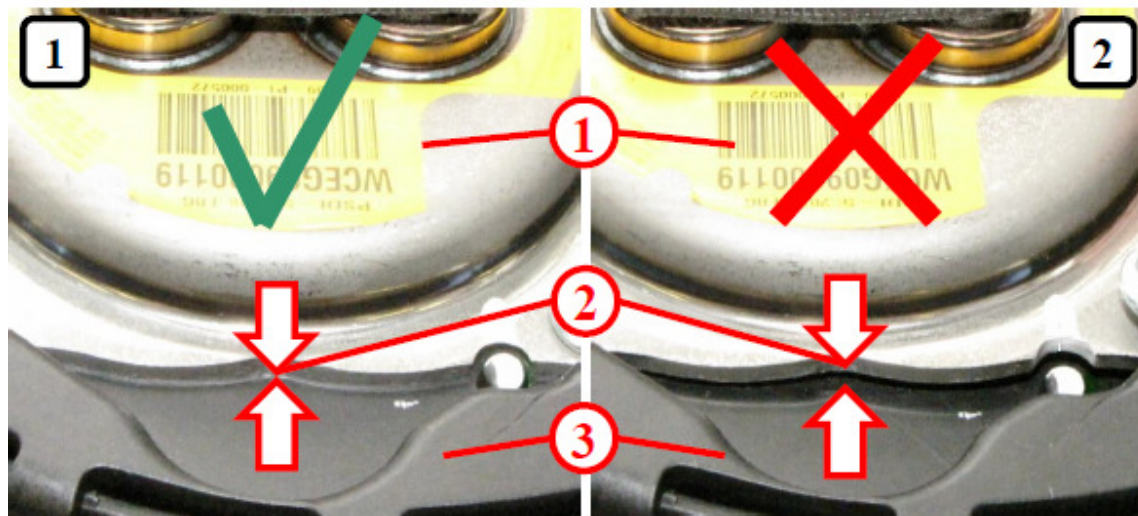
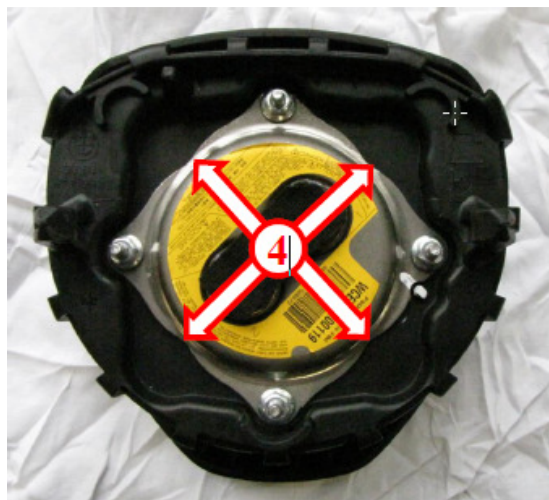
[17]

Perform a visual inspection of the gap (2) between the Generator (1) and the Air Bag (3) on all four sides of the Generator.

Picture (2) shows an improperly installed Generator with an excessive gap (2).

If the gap cannot be closed up then cancel this procedure and replace the entire Air Bag assembly.
