## Recall Campaign 16V-071: Driver's Front Air Bag Module E82 E88 E90 E91 E92 E93

This Service Information bulletin supersedes SI B65 16 16 dated July 2017.

BMW is conducting a Voluntary Safety Recall involving the driver's front air bag module on certain BMW vehicles that are equipped with non-desiccated Takata PSDI-5 inflators. These vehicles, covering model years 2006-2015 **have not been part of earlier Takata air bag recalls.**

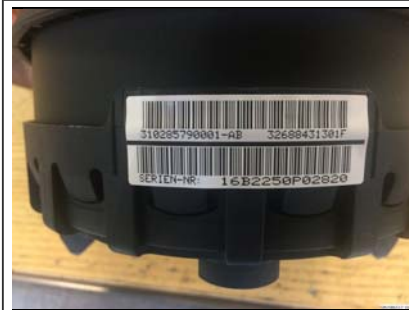
There are two different serial numbers that can be found. For this recall we only need the serial number on the label on the side of the airbag. This is the longest number on the bottom of the label. (The other number can be found on the actual gas generator below the barcode)

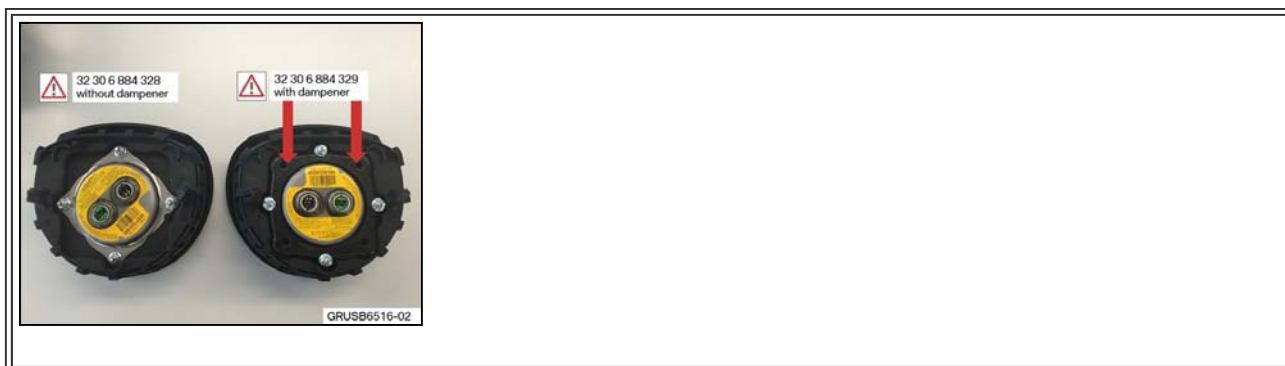
**Note: Original part coming out of the vehicle may not match the replacement part.**

**This applies to vehicles originally equipped with or without a dampener. Refer to the photos below:**
