SIB 65 16 16

2019-10-24

## RECALL CAMPAIGN 16V-071: DRIVER'S FRONT AIR BAG MODULE E82 E88 E90 E91 E92 E93

This Service Information Bulletin (Revision 5) replaces SI B65 16 16 **dated December 2018**.

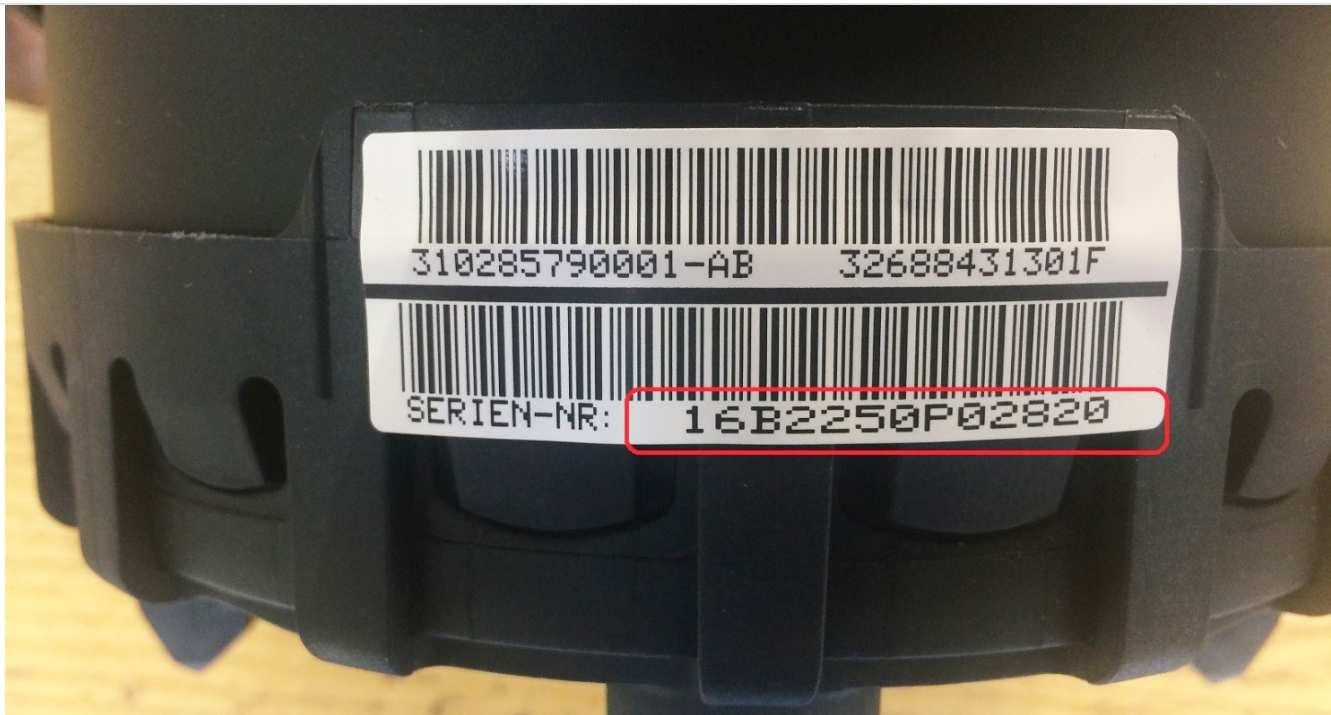
There are two different serial numbers that can be found. For this recall we only need the serial number on the label on the side of the airbag. This is the longest number on the bottom of the label (the other number can be found on the actual gas generator below the barcode).

Note: It is necessary to document which air bag goes into which vehicle. Therefore the technician is required to note on the repair order the serial number of the new air bag. The serial number must also be entered into the warranty claims comment section.

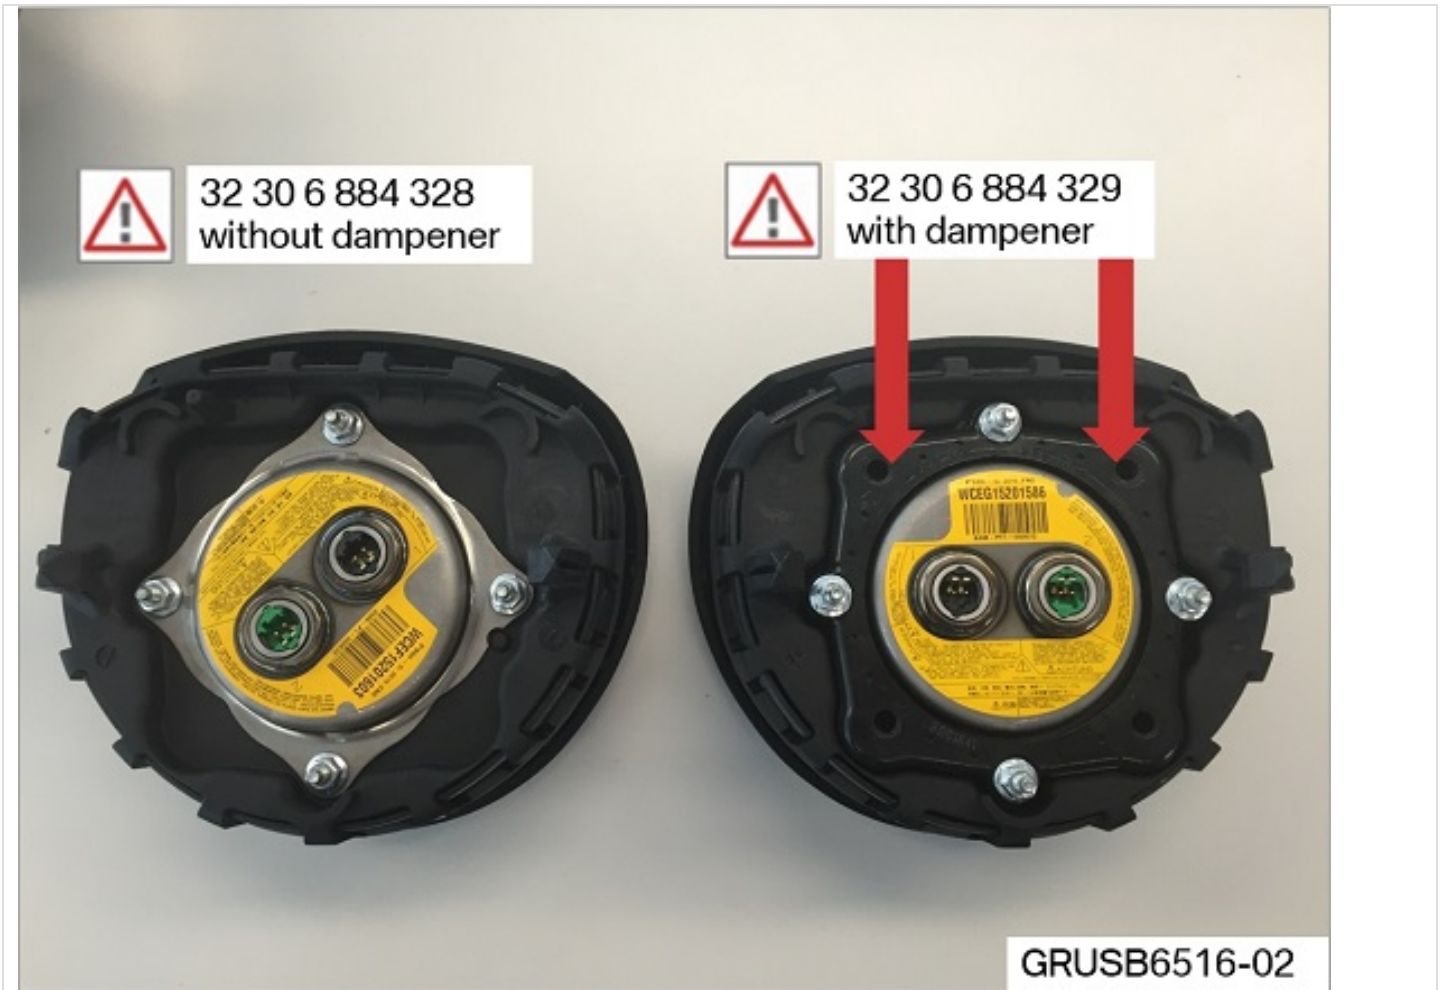
Note: **The original part removed from the vehicle may not exactly visually match the replacement part. This applies to vehicles originally equipped with or without a dampener. Refer to the photos below:**

| 32 30 6 884 664 | airbag module driver's side with a vibration absorber (on E90 only with engine S65 or M57Y) and ( on E93 only with engine S65 or N54T or N55) | 1 |
