SI B65 16 16  
Audio, Navigation, Monitors, Alarms, SRS

## Recall Campaign 16V-071: Driver's Front Air Bag Module E82 E88 E90 E91 E92 E93

This Service Information bulletin Replaces SI B65 04 16 **dated June 2016** for E82 E88 E90 E91 E92 E93 vehicles

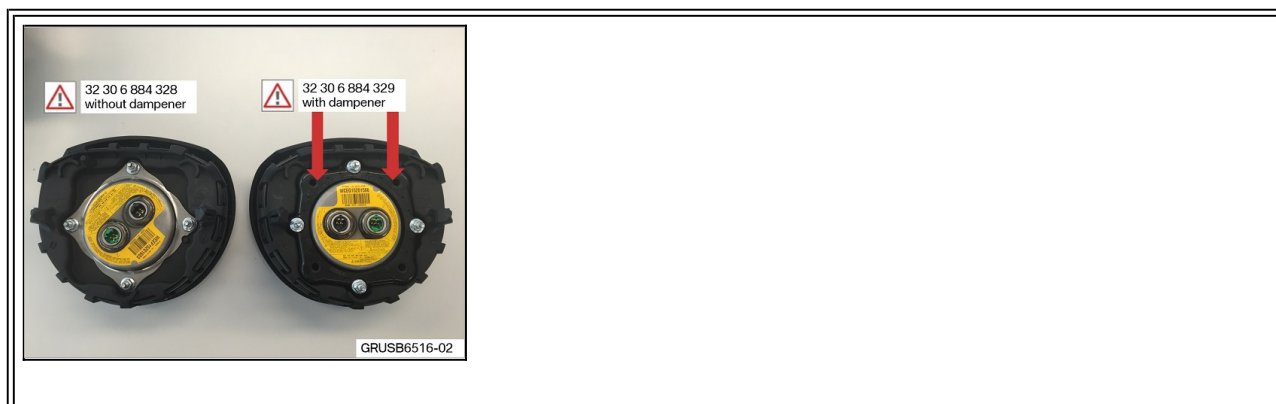
**Note:** Original part coming out of the vehicle may not match the replacement part.

This applies to vehicles originally equipped with or without a dampener.

**It is important that the correct airbag module is installed. Only install the air bag**

**module based on the model and engine variant listed in the parts information. Do not mix up the two parts. Refer to the photos above. Printing this SI in color will make it easier to see the difference in the parts.**
