SI B65 16 16  
Audio, Navigation, Monitors, Alarms, SRS

## Recall Campaign 16V-071: Driver's Front Air Bag Module E82 E88 E90 E91 E92 E93

This Service Information bulletin supersedes SI B65 16 16 **dated September 2017**

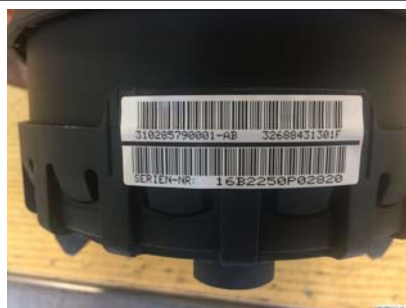
There are two different serial numbers that can be found. For this recall we only need the serial number on the label on the side of the airbag. This is the longest number on the bottom of the label. (The other number can be found on the actual gas generator below the barcode)

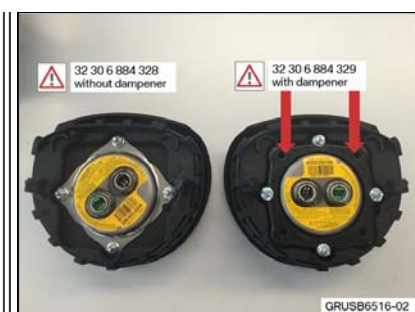
**UPDATE !** **Note:** Original part coming out of the vehicle may not match the replacement part.

This applies to vehicles originally equipped with or without a dampener. Refer to the photos below:
